Profile/Photo Observation Report

Date:	04/06/2018	Weather:		Coding:	PACP 6.0
Pipe Length (ft):	62.7	Owner:	NA	Pre Clean:	Not Known
P.O.#:		Surveyor:	Jen Costello	PSR:	P-804-065-064
Customer:		Clean Date:	01/01/1900	Shape:	C

Street:	N HOBART RD & DIVISION ST	Flow Control:	Not Controlled
City:	Hobart, IN	Year Renewed:	
Location:	Other	Tape/Media #:	
Purpose:	Not Known	Dia/Height:	10"
Use:	Sanitary	Material:	VCP
Drain Area:	NA	Lining:	
Category:	NA		
Comment:

Location Details:		Direction of Survey:	Upstream
US MH:	M-804-064	DS MH:	M-804-065
		Total Length Surveyed (ft):	11.9

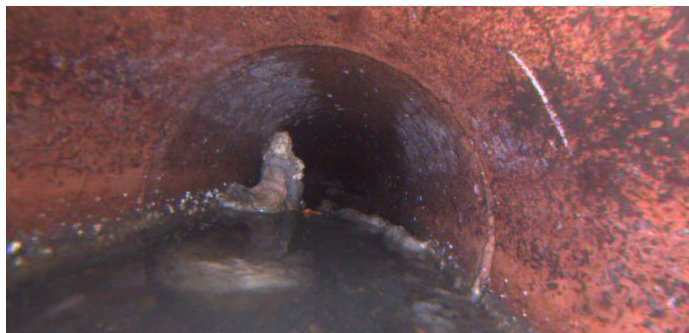
Code: **AMH**
Description: **Manhole**

Distance (ft): **.0**
Structural Grade: **0**
O&M Grade: **0**
Clock Start/From:
Clock To:
1st Value:
2nd Value:
Value Percent:
Continuous Index:
Within 8" of Joint: **NO**
Remarks: **M-804-065**

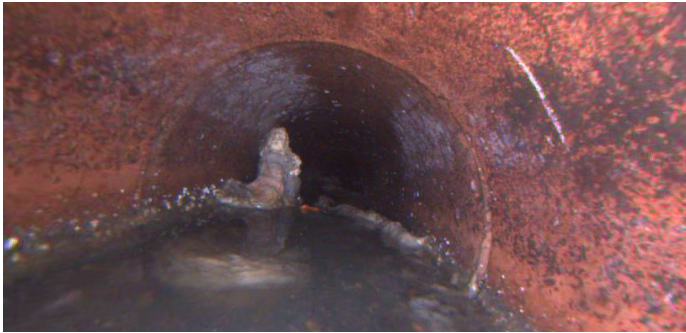
Code:	MWL
Description:	Water Level

Distance (ft):	.0
Structural Grade:	0
O&M Grade:	0
Clock Start/From:	
Clock To:	
1st Value:	
2nd Value:	
Value Percent:	20.000
Continuous Index:	
Within 8" of Joint:	NO
Remarks:

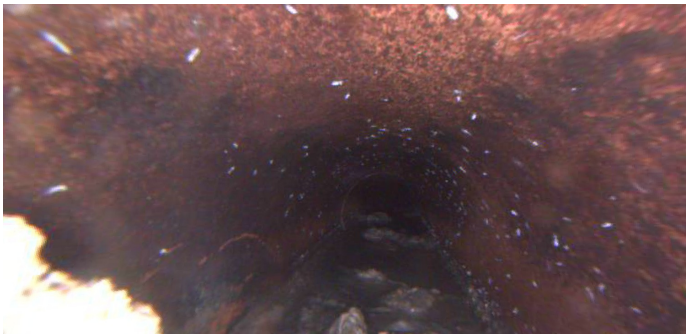
Code:	FS
Description:	Fracture Spiral

Distance (ft):	2.6
Structural Grade:	3
O&M Grade:	0
Clock Start/From:	7
Clock To:	9
1st Value:	
2nd Value:	
Value Percent:	
Continuous Index:	
Within 8" of Joint:	
Remarks:

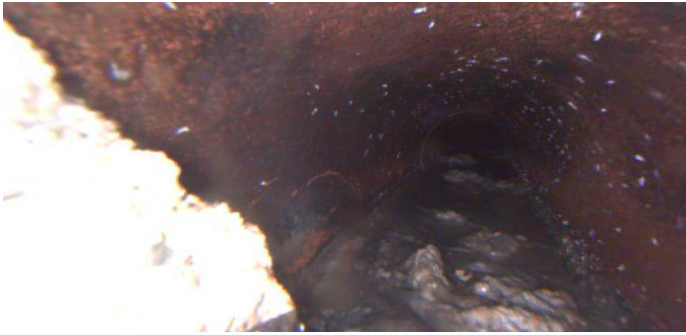
Code: **DAGS**
Description: **Deposits Attached Grease**

Distance (ft): **2.6**
Structural Grade: **0**
O&M Grade: **3**
Clock Start/From: **6**
Clock To: **10**
1st Value:
2nd Value:
Value Percent: **20.000**
Continuous Index:
Within 8" of Joint: **NO**
Remarks:

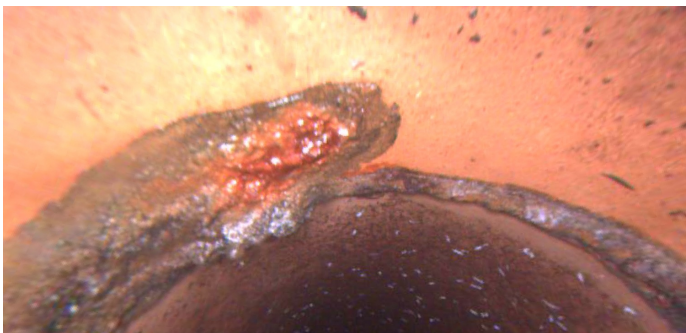
Code: **ID**
Description: **Infil Dripper**

Distance (ft): **9.6**
Structural Grade: **0**
O&M Grade: **3**
Clock Start/From: **12**
Clock To:
1st Value:
2nd Value:
Value Percent:
Continuous Index:
Within 8" of Joint: **YES**
Remarks:

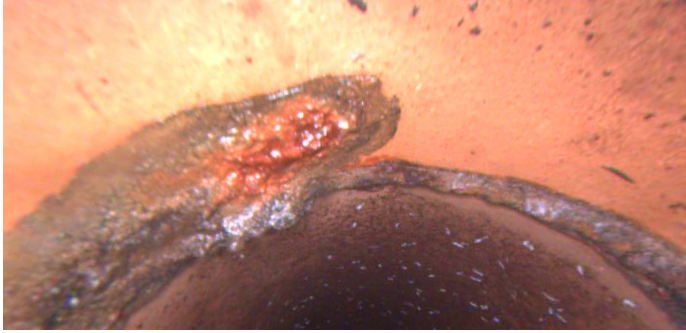
Code: **DAE**
Description: **Deposits Attached Encrustation**

Distance (ft): **9.6**
Structural Grade: **0**
O&M Grade: **2**
Clock Start/From: **8**
Clock To: **4**
1st Value:
2nd Value:
Value Percent: **5.000**
Continuous Index:
Within 8" of Joint: **YES**
Remarks:

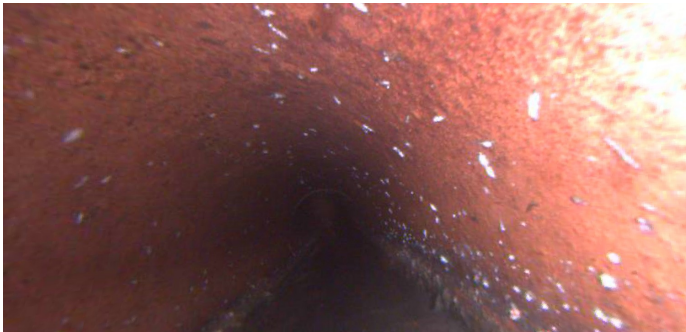
Code: **MSA**
Description: **Abandoned Survey**

Distance (ft): **11.9**
Structural Grade: **0**
O&M Grade: **0**
Clock Start/From:
Clock To:
1st Value:
2nd Value:
Value Percent:
Continuous Index:
Within 8" of Joint: **NO**
Remarks: **unknown**
