Profile/Photo Observation Report

| Street: | N HOBART RD & DIVISION ST | Flow Control: | Not Controlled |

| US MH: | M-804-064 | DS MH: | M-804-065 |

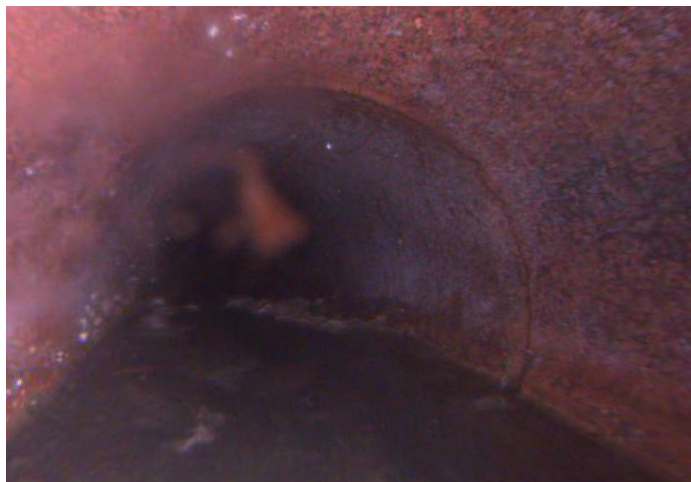
Code: **AMH**
Description: **Manhole**

Distance (ft): **.0**
Structural Grade: **0**
O&M Grade: **0**
Clock Start/From:
Clock To:
1st Value:
2nd Value:
Value Percent:
Continuous Index:
Within 8" of Joint: **NO**
Remarks: **M-804-065**

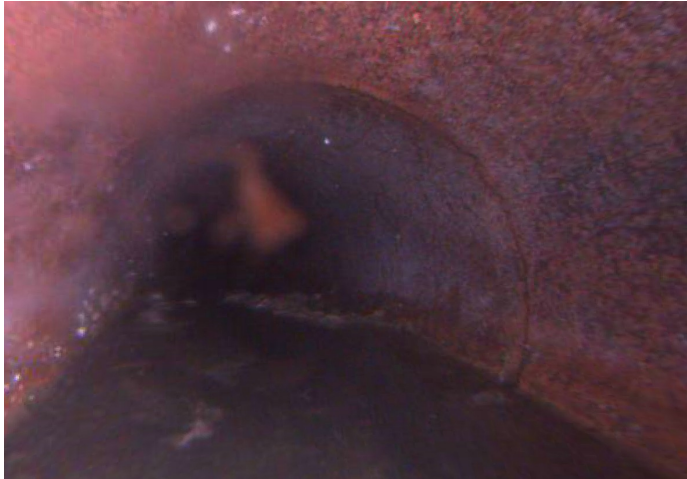
Code: **MWL**
Description: **Water Level**

Distance (ft): **.0**
Structural Grade: **0**
O&M Grade: **0**
Clock Start/From:
Clock To:
1st Value:
2nd Value:
Value Percent: **20.000**
Continuous Index:
Within 8" of Joint: **NO**
Remarks:

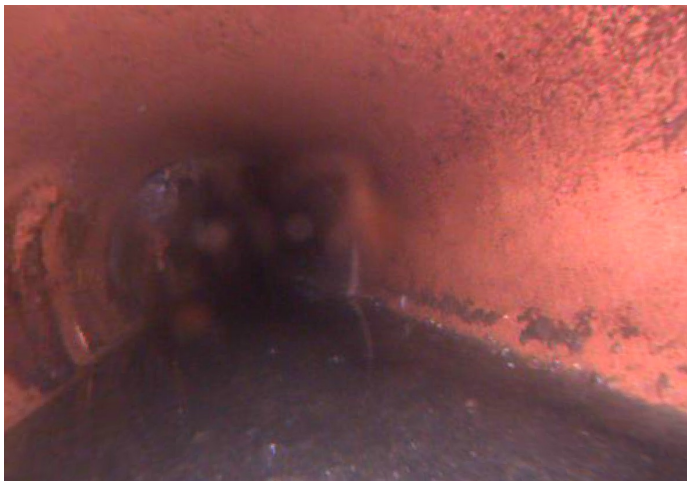
Code: **MSA**
Description: **Abandoned Survey**

Distance (ft): **19.0**
Structural Grade: **0**
O&M Grade: **0**
Clock Start/From:
Clock To:
1st Value:
2nd Value:
Value Percent:
Continuous Index:
Within 8" of Joint: **NO**
Remarks: **Possible Debris**
