## Profile/Photo Observation Report

Street:	<b>N HOBART RD</b>	Flow Control:	<b>Not Controlled</b>
City:	<b>Hobart, IN</b>	Year Renewed:	
Location:	<b>Other</b>	Tape/Media #:	
Purpose:	<b>Not Known</b>	Dia/Height:	<b>10"</b>
Use:	<b>Sanitary</b>	Material:	<b>VCP</b>
Drain Area:	<b>NA</b>	Lining:	
Category:	<b>NA</b>		
Comment:

Location Details:		Direction of Survey:	<b>Downstream</b>
US MH:	<b>M-804-065</b>	DS MH:	<b>M-804-066</b>
		Total Length Surveyed (ft):	<b>51.1</b>

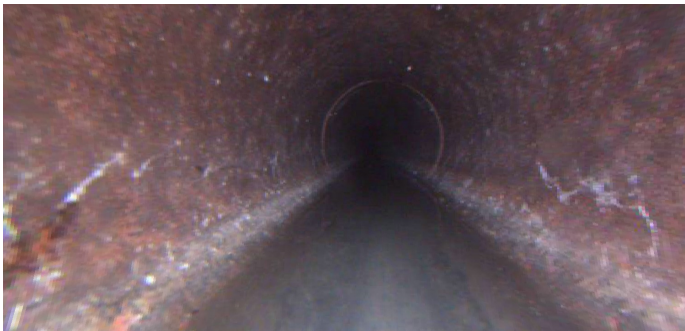
Code: **AMH**  
Description: **Manhole**

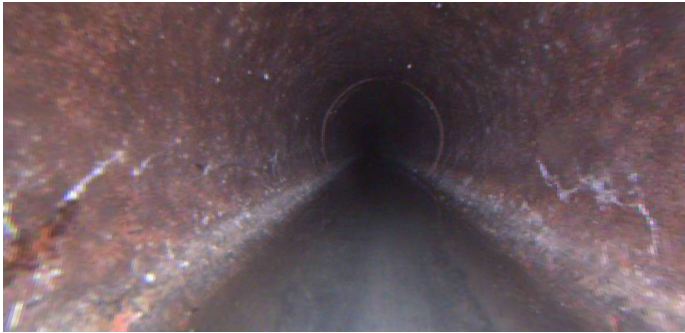
Code:	<b>MWL</b>
Description:	<b>Water Level</b>

Distance (ft):	<b>.0</b>
Structural Grade:	<b>0</b>
O&M Grade:	<b>0</b>
Clock Start/From:	
Clock To:	
1st Value:	
2nd Value:	
Value Percent:	<b>5.000</b>
Continuous Index:	
Within 8" of Joint:	<b>NO</b>
Remarks:

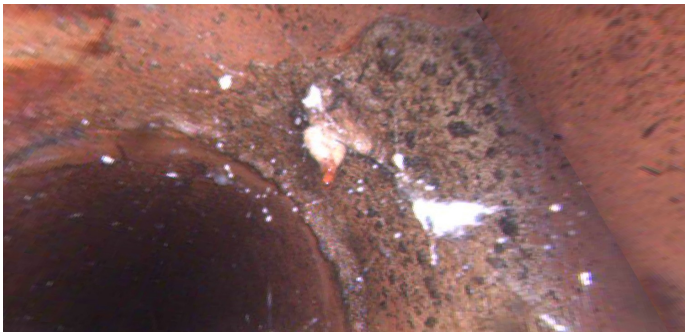
Code:	<b>ID</b>
Description:	<b>Infil Dripper</b>

Distance (ft):	<b>17.2</b>
Structural Grade:	<b>0</b>
O&M Grade:	<b>3</b>
Clock Start/From:	<b>1</b>
Clock To:	
1st Value:	
2nd Value:	
Value Percent:	
Continuous Index:	
Within 8" of Joint:	
Remarks:

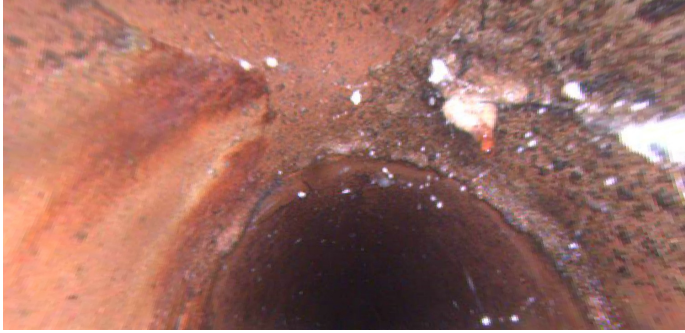
Code: **CL**  
Description: **Crack Longitudinal**

Distance (ft): **17.2**  
Structural Grade: **2**  
O&M Grade: **0**  
Clock Start/From: **11**  
Clock To:  
1st Value:  
2nd Value:  
Value Percent:  
Continuous Index:  
Within 8" of Joint: **YES**  
Remarks:

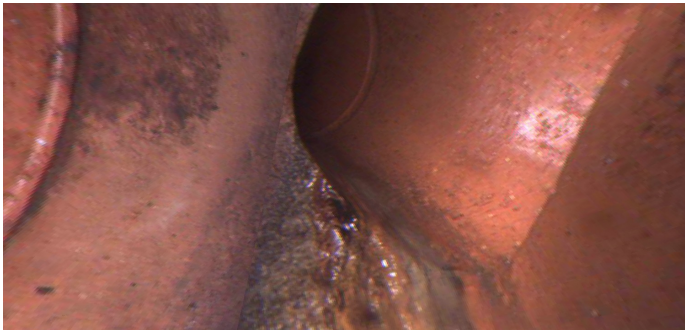
Code: **TF**  
Description: **Tap Factory**

Distance (ft): **29.3**  
Structural Grade: **0**  
O&M Grade: **0**  
Clock Start/From: **2**  
Clock To:  
1st Value: **4.000**  
2nd Value:  
Value Percent:  
Continuous Index:  
Within 8" of Joint: **YES**  
Remarks:

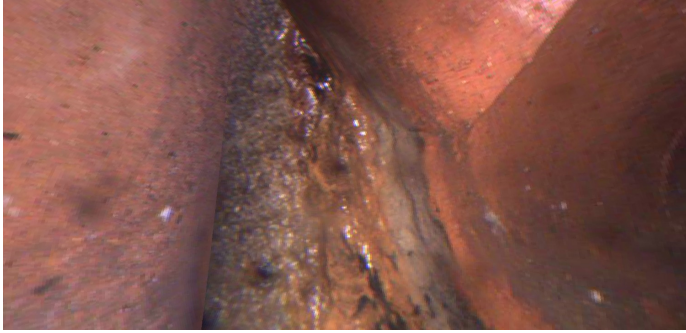
Code: **DAGS**  
Description: **Deposits Attached Grease**

Distance (ft): **29.3**  
Structural Grade: **0**  
O&M Grade: **2**  
Clock Start/From: **3**  
Clock To: **5**  
1st Value:  
2nd Value:  
Value Percent: **5.000**  
Continuous Index:  
Within 8" of Joint: **NO**  
Remarks:

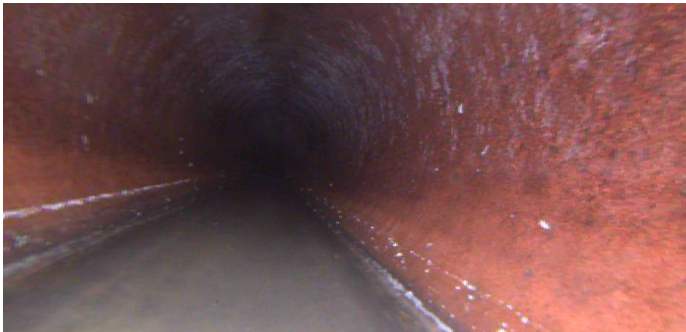
Code: **MSA**  
Description: **Abandoned Survey**

Distance (ft): **51.1**  
Structural Grade: **0**  
O&M Grade: **0**  
Clock Start/From:  
Clock To:  
1st Value:  
2nd Value:  
Value Percent:  
Continuous Index:  
Within 8" of Joint: **NO**  
Remarks: **debris**
