Profile/Photo Observation Report

Street:	N HOBART RD	Flow Control:	Not Controlled
City:	Hobart, IN	Year Renewed:	
Location:	Light Highway	Tape/Media #:	
Purpose:	Routine Assessment	Dia/Height:	10"
Use:	Sanitary	Material:	VCP
Drain Area:	NA	Lining:	
Category:	NA		
Comment:

Location Details:		Direction of Survey:	Downstream
US MH:	M-804-065	DS MH:	M-804-066
		Total Length Surveyed (ft):	13.9

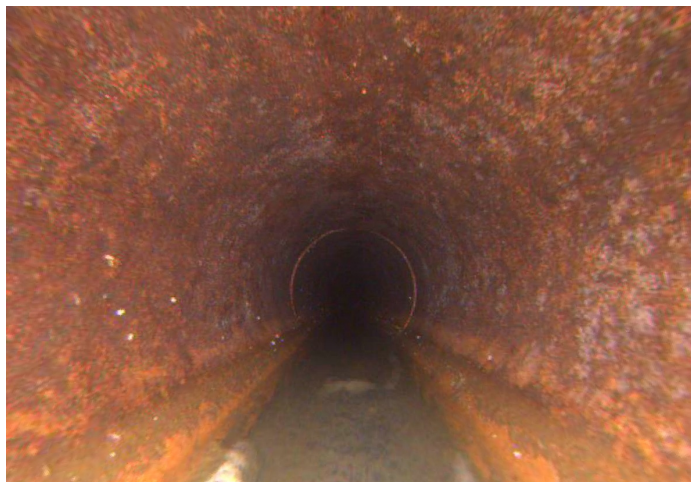
Code: **AMH**
Description: **Manhole**

Distance (ft): **.0**
Structural Grade: **0**
O&M Grade: **0**
Clock Start/From:
Clock To:
1st Value:
2nd Value:
Value Percent:
Continuous Index:
Within 8" of Joint: **NO**
Remarks: **M-804-065**

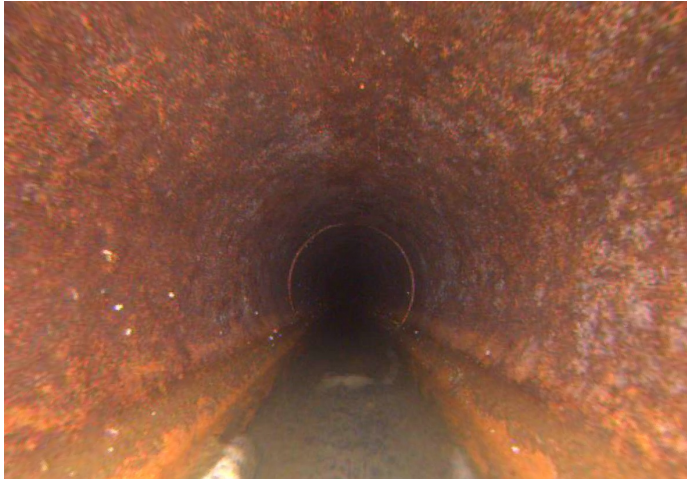
Code: **MWL**
Description: **Water Level**

Distance (ft): **.0**
Structural Grade: **0**
O&M Grade: **0**
Clock Start/From:
Clock To:
1st Value:
2nd Value:
Value Percent: **10.000**
Continuous Index:
Within 8" of Joint: **NO**
Remarks:

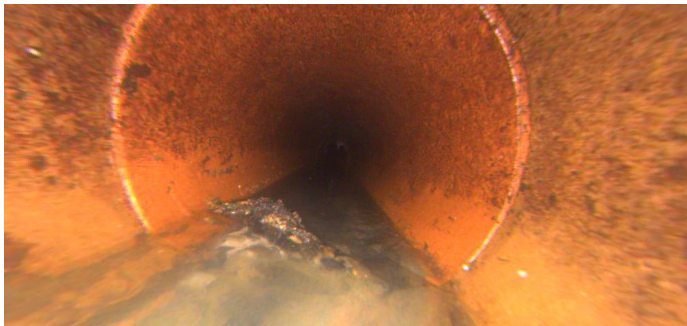
Code: **DSZ**
Description: **Deposits Settled Other**

Distance (ft): **12.5**
Structural Grade: **0**
O&M Grade: **2**
Clock Start/From: **5**
Clock To: **7**
1st Value:
2nd Value:
Value Percent: **10.000**
Continuous Index:
Within 8" of Joint: **YES**
Remarks: **mixed material**

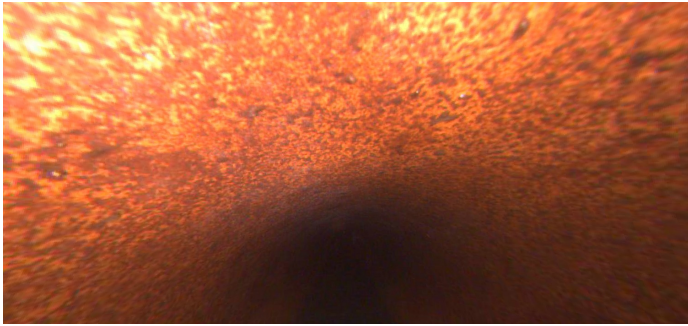
Code:	MSA
Description:	Abandoned Survey
Distance (ft):	13.9
Structural Grade:	0
O&M Grade:	0
Clock Start/From:	
Clock To:	
1st Value:	
2nd Value:	
Value Percent:	
Continuous Index:	
Within 8" of Joint:	NO
Remarks:	DSZ
