Profile/Ph	oto Observation	Report			RedZon
Date:	10/05/2018	Weather:		Coding:	PACP 6.0
Pipe Length (ft): 236.8	Owner:	NA	Pre Clean:	Not Known
P.O.#:		Surveyor:	Michael Carling	PSR:	P-804-066-065
Customer:		Clean Date:	01/01/1900	Shape:	С
Street:	Hobart Rd.		Flow Control:	Not Controlled	
City:	Hobart, IN		Year Renewed:		
Location:	Light Highway		Tape/Media #:		
Purpose:	Routine Assessmen	t	Dia/Height:	10"	
Use:	Sanitary		Material:	VCP	
Drain Area:	NA		Lining:		
Category:	NA				
Comment:					
Location Detail	ls:		Direction of Surv	ey: Downstream	
US MH:	M-804-065	DS MH:	M-804-066	Total Length Surveyed (ft)	: 13.9
0&M Index:	2.00	O&M Quick:	210	0 O&M Rating:	2.00
tructural Index:	0.00	 Structural Qu	ick: 000	0 Structural Rating:	0.00
Overall Index:	2.00	Overall Quick	. 210	0 Overall Rating:	2.00

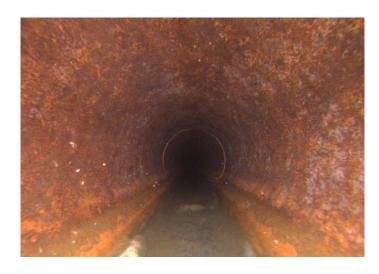
Code: Description:	AMH Manhole
Distance (ft):	.0
Structural Grade:	0
O&M Grade:	0
Clock Start/From:	
Clock To:	
1st Value:	
2nd Value:	
Value Percent:	
Continuous Index:	
Within 8" of Joint:	NO
Remarks:	M-804-065

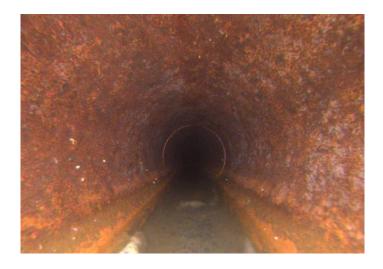
Code:	MWL
Description:	Water Level
Distance (ft):	.0
Structural Grade:	0
O&M Grade:	0
Clock Start/From:	
Clock To:	
1st Value:	
2nd Value:	
Value Percent:	10.000
Continuous Index:	
Within 8" of Joint:	NO
Remarks:
