## Profile/Photo Observation Report

Street:	<b>N HOBART RD</b>	Flow Control:	<b>Not Controlled</b>
City:	<b>Hobart, IN</b>	Year Renewed:	
Location:	<b>Light Highway</b>	Tape/Media #:	
Purpose:	<b>Routine Assessment</b>	Dia/Height:	<b>10"</b>
Use:	<b>Sanitary</b>	Material:	<b>VCP</b>
Drain Area:	<b>NA</b>	Lining:	
Category:	<b>NA</b>		
Comment:

Location Details:		Direction of Survey:	<b>Upstream</b>
US MH:	<b>M-804-065</b>	DS MH:	<b>M-804-066</b>
		Total Length Surveyed (ft):	<b>92.7</b>

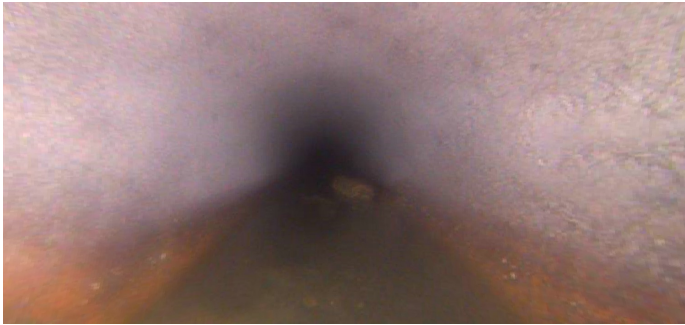
Code:	<b>MWL</b>
Description:	<b>Water Level</b>

Distance (ft):	<b>.0</b>
Structural Grade:	<b>0</b>
O&M Grade:	<b>0</b>
Clock Start/From:	
Clock To:	
1st Value:	
2nd Value:	
Value Percent:	<b>10.000</b>
Continuous Index:	
Within 8" of Joint:	<b>NO</b>
Remarks:

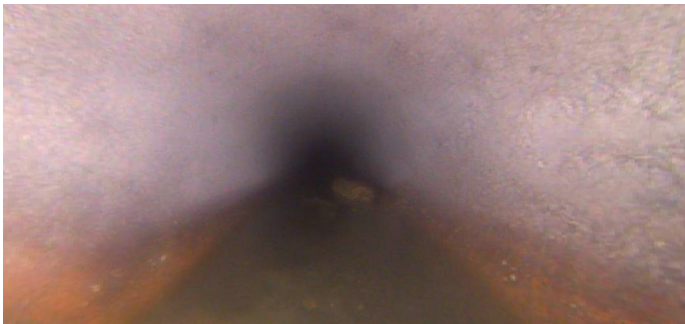
Code:	<b>DAGS</b>
Description:	<b>Deposits Attached Grease</b>

Distance (ft):	<b>.0</b>
Structural Grade:	<b>0</b>
O&M Grade:	<b>2</b>
Clock Start/From:	<b>7</b>
Clock To:	<b>5</b>
1st Value:	
2nd Value:	
Value Percent:	<b>5.000</b>
Continuous Index:	<b>S01</b>
Within 8" of Joint:	<b>YES</b>
Remarks:	<b>WANDER</b>

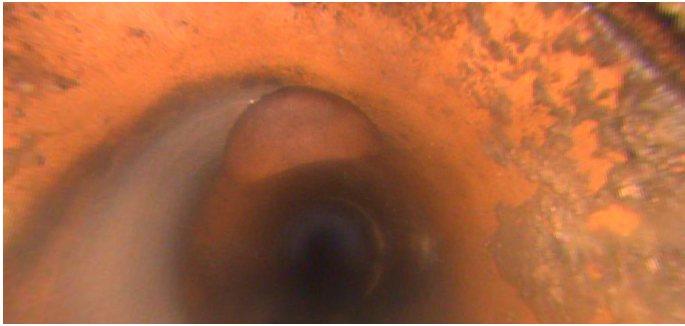
Code: **TF**  
Description: **Tap Factory**

Distance (ft): **34.2**  
Structural Grade: **0**  
O&M Grade: **0**  
Clock Start/From: **11**  
Clock To:  
1st Value: **4.000**  
2nd Value:  
Value Percent:  
Continuous Index:  
Within 8" of Joint:  
Remarks:

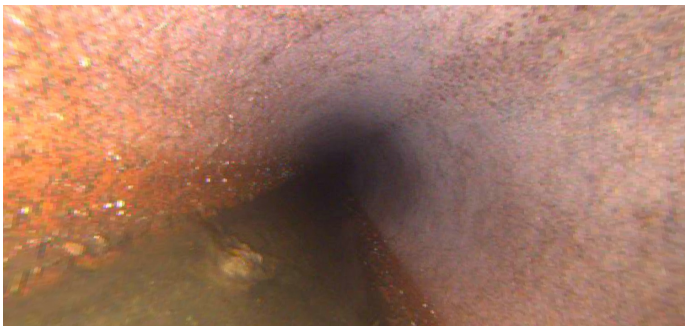
Code: **DAGS**  
Description: **Deposits Attached Grease**

Distance (ft): **92.7**  
Structural Grade: **0**  
O&M Grade: **2**  
Clock Start/From: **7**  
Clock To: **5**  
1st Value:  
2nd Value:  
Value Percent: **5.000**  
Continuous Index: **F01**  
Within 8" of Joint: **YES**  
Remarks: **WANDER**

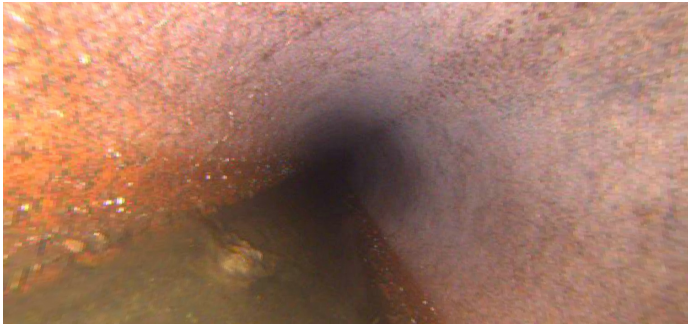
Code:	<b>MSA</b>
Description:	<b>Abandoned Survey</b>
Distance (ft):	<b>92.7</b>
Structural Grade:	<b>0</b>
O&M Grade:	<b>0</b>
Clock Start/From:	
Clock To:	
1st Value:	
2nd Value:	
Value Percent:	
Continuous Index:	
Within 8" of Joint:	<b>NO</b>
Remarks:	<b>ROBOT HAS STOPPED</b>
