## Profile/Photo Observation Report

Street:	<b>N HOBART RD</b>	Flow Control:	<b>Not Controlled</b>
City:	<b>Hobart, IN</b>	Year Renewed:	
Location:	<b>Other</b>	Tape/Media #:	
Purpose:	<b>Not Known</b>	Dia/Height:	<b>10"</b>
Use:	<b>Sanitary</b>	Material:	<b>VCP</b>
Drain Area:	<b>NA</b>	Lining:	
Category:	<b>NA</b>		
Comment:

Location Details:		Direction of Survey:	<b>Downstream</b>
US MH:	<b>M-804-066</b>	DS MH:	<b>M-804-067</b>
		Total Length Surveyed (ft):	<b>37.6</b>

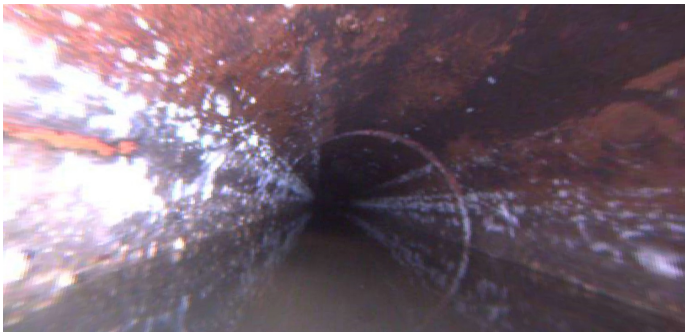
Code:	<b>MWL</b>
Description:	<b>Water Level</b>

Distance (ft):	<b>3.3</b>
Structural Grade:	<b>0</b>
O&M Grade:	<b>0</b>
Clock Start/From:	
Clock To:	
1st Value:	
2nd Value:	
Value Percent:	<b>5.000</b>
Continuous Index:	
Within 8" of Joint:	<b>NO</b>
Remarks:

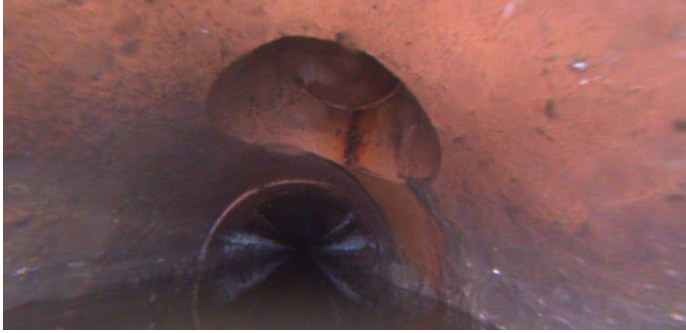
Code: **TF**  
Description: **Tap Factory**

Distance (ft): **10.0**  
Structural Grade: **0**  
O&M Grade: **0**  
Clock Start/From: **1**  
Clock To:  
1st Value: **4.000**  
2nd Value:  
Value Percent:  
Continuous Index:  
Within 8" of Joint: **YES**  
Remarks:

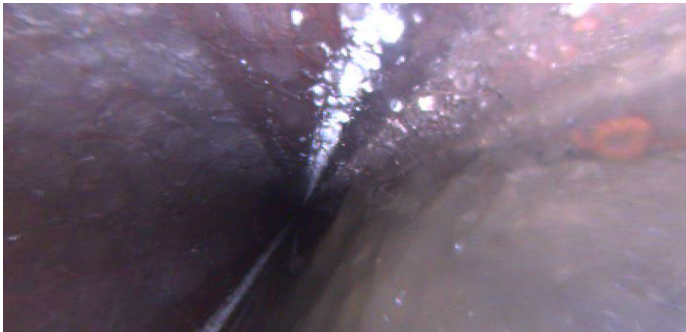
Code: **MSA**  
Description: **Abandoned Survey**

Distance (ft): **37.6**  
Structural Grade: **0**  
O&M Grade: **0**  
Clock Start/From:  
Clock To:  
1st Value:  
2nd Value:  
Value Percent:  
Continuous Index:  
Within 8" of Joint: **NO**  
Remarks: **camera flipped**
