## Profile/Photo Observation Report

Street:	<b>N HOBART RD</b>	Flow Control:	<b>Not Controlled</b>
City:	<b>Hobart, IN</b>	Year Renewed:	
Location:	<b>Other</b>	Tape/Media #:	
Purpose:	<b>Not Known</b>	Dia/Height:	<b>10"</b>
Use:	<b>Sanitary</b>	Material:	<b>VCP</b>
Drain Area:	<b>NA</b>	Lining:	
Category:	<b>NA</b>		
Comment:

Location Details:		Direction of Survey:	<b>Upstream</b>
US MH:	<b>M-804-066</b>	DS MH:	<b>M-804-067</b>
		Total Length Surveyed (ft):	<b>261.2</b>

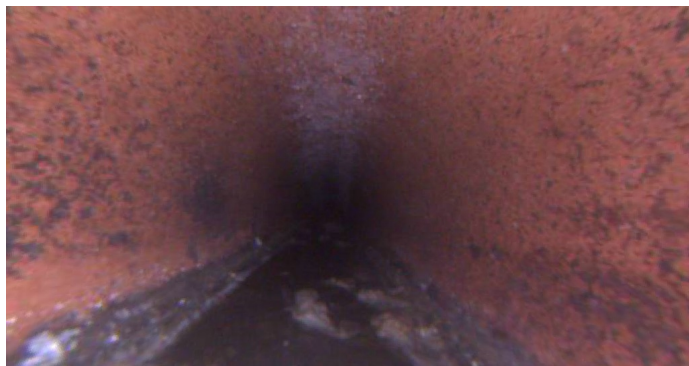
Code: **AMH**  
Description: **Manhole**

Distance (ft): **.0**  
Structural Grade: **0**  
O&M Grade: **0**  
Clock Start/From:  
Clock To:  
1st Value:  
2nd Value:  
Value Percent:  
Continuous Index:  
Within 8" of Joint: **NO**  
Remarks: **M-804-067**

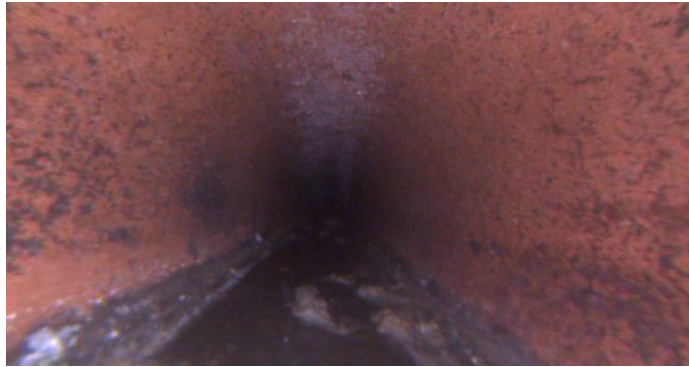
Code:	<b>MWL</b>
Description:	<b>Water Level</b>
Distance (ft):	<b>.0</b>
Structural Grade:	<b>0</b>
O&M Grade:	<b>0</b>
Clock Start/From:	
Clock To:	
1st Value:	
2nd Value:	
Value Percent:	<b>10.000</b>
Continuous Index:	
Within 8" of Joint:	<b>NO</b>
Remarks:

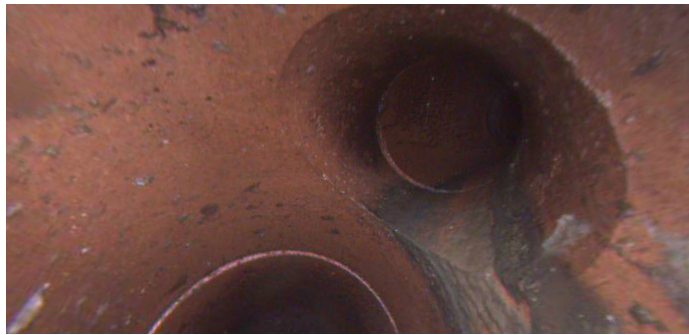
Code:	<b>TF</b>
Description:	<b>Tap Factory</b>
Distance (ft):	<b>40.4</b>
Structural Grade:	<b>0</b>
O&M Grade:	<b>0</b>
Clock Start/From:	<b>2</b>
Clock To:	
1st Value:	<b>4.000</b>
2nd Value:	
Value Percent:	
Continuous Index:	
Within 8" of Joint:	
Remarks:

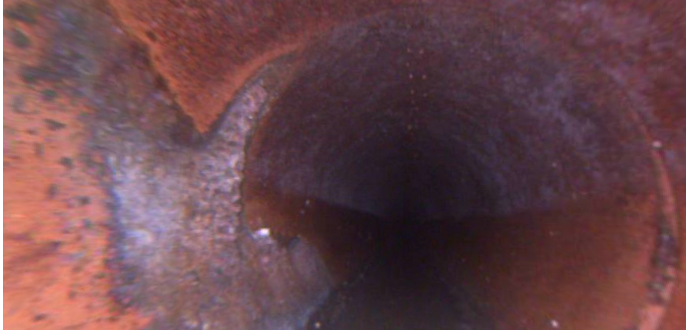
Code: **DAE**  
Description: **Deposits Attached Encrustation**

Distance (ft): **45.7**  
Structural Grade: **0**  
O&M Grade: **2**  
Clock Start/From: **8**  
Clock To: **11**  
1st Value:  
2nd Value:  
Value Percent: **5.000**  
Continuous Index:  
Within 8" of Joint: **YES**  
Remarks:

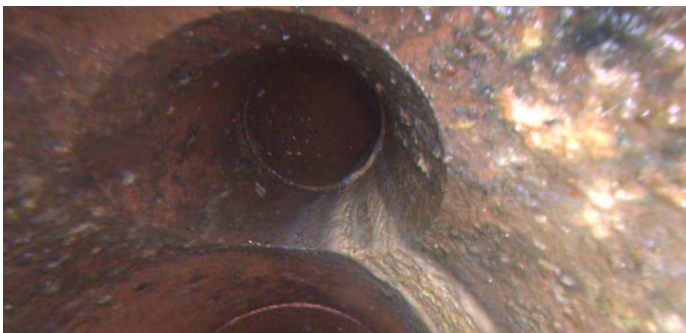
Code: **TF**  
Description: **Tap Factory**

Distance (ft): **132.8**  
Structural Grade: **0**  
O&M Grade: **0**  
Clock Start/From: **12**  
Clock To:  
1st Value: **4.000**  
2nd Value:  
Value Percent:  
Continuous Index:  
Within 8" of Joint:  
Remarks:

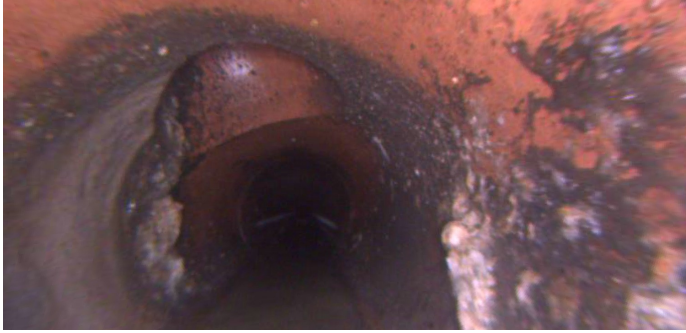
Code: **DAGS**  
Description: **Deposits Attached Grease**

Distance (ft): **208.4**  
Structural Grade: **0**  
O&M Grade: **2**  
Clock Start/From: **8**  
Clock To: **4**  
1st Value:  
2nd Value:  
Value Percent: **5.000**  
Continuous Index:  
Within 8" of Joint: **NO**  
Remarks:

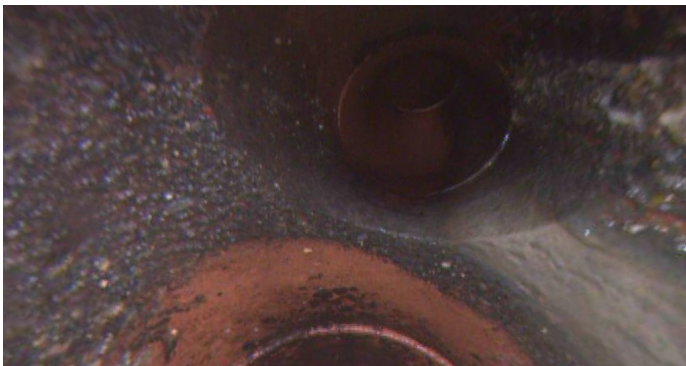
Code: **TF**  
Description: **Tap Factory**

Distance (ft): **209.4**  
Structural Grade: **0**  
O&M Grade: **0**  
Clock Start/From: **11**  
Clock To:  
1st Value: **4.000**  
2nd Value:  
Value Percent:  
Continuous Index:  
Within 8" of Joint:  
Remarks: **Photo taken from rear camera.**

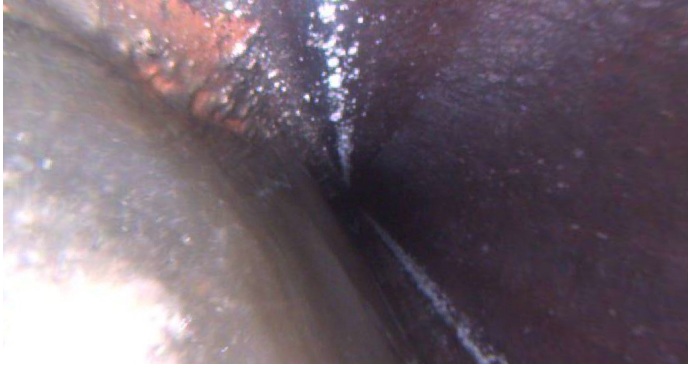
Code:	<b>MSA</b>
Description:	<b>Abandoned Survey</b>
Distance (ft):	<b>261.2</b>
Structural Grade:	<b>0</b>
O&M Grade:	<b>0</b>
Clock Start/From:	
Clock To:	
1st Value:	
2nd Value:	
Value Percent:	
Continuous Index:	
Within 8" of Joint:	<b>NO</b>
Remarks:	<b>Roll max</b>
