## Profile/Photo Observation Report

Date:	<b>04/07/2018</b>	Weather:		Coding:	<b>PACP 6.0</b>
Pipe Length (ft):	<b>235.2</b>	Owner:	<b>NA</b>	Pre Clean:	<b>Not Known</b>
P.O.#:		Surveyor:	<b>Mark Ruby</b>	PSR:	<b>P-804-067-066</b>
Customer:		Clean Date:	<b>01/01/1900</b>	Shape:	<b>C</b>

Street:	<b>N Hobart St.</b>	Flow Control:	<b>Not Controlled</b>
City:	<b>Hobart, IN</b>	Year Renewed:	
Location:	<b>Other</b>	Tape/Media #:	
Purpose:	<b>Not Known</b>	Dia/Height:	<b>10"</b>
Use:	<b>Sanitary</b>	Material:	<b>VCP</b>
Drain Area:	<b>NA</b>	Lining:	
Category:	<b>NA</b>		
Comment:

Location Details:		Direction of Survey:	<b>Upstream</b>
US MH:	<b>M-804-066</b>	DS MH:	<b>M-804-067</b>
		Total Length Surveyed (ft):	<b>261.2</b>

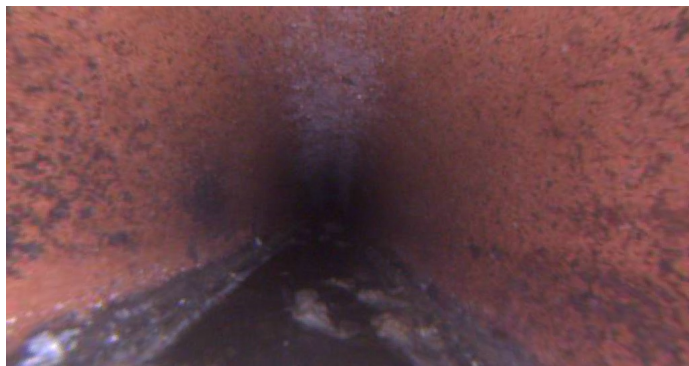
Code: **AMH**  
 Description: **Manhole**

Distance (ft): **.0**  
 Structural Grade: **0**  
 O&M Grade: **0**  
 Clock Start/From:  
 Clock To:  
 1st Value:  
 2nd Value:  
 Value Percent:  
 Continuous Index:  
 Within 8" of Joint: **NO**  
 Remarks: **M-804-067**

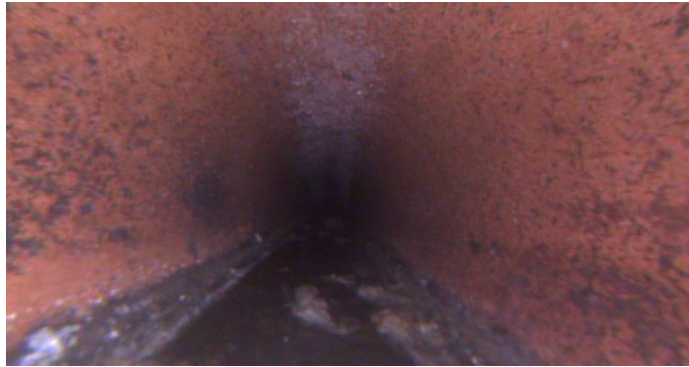
Code:	<b>MWL</b>
Description:	<b>Water Level</b>
Distance (ft):	<b>.0</b>
Structural Grade:	<b>0</b>
O&M Grade:	<b>0</b>
Clock Start/From:	
Clock To:	
1st Value:	
2nd Value:	
Value Percent:	<b>10.000</b>
Continuous Index:	
Within 8" of Joint:	<b>NO</b>
Remarks:

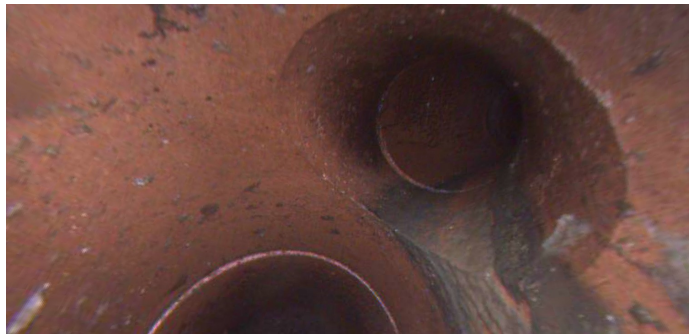
Code:	<b>TF</b>
Description:	<b>Tap Factory</b>
Distance (ft):	<b>40.4</b>
Structural Grade:	<b>0</b>
O&M Grade:	<b>0</b>
Clock Start/From:	<b>2</b>
Clock To:	
1st Value:	<b>4.000</b>
2nd Value:	
Value Percent:	
Continuous Index:	
Within 8" of Joint:	
Remarks:

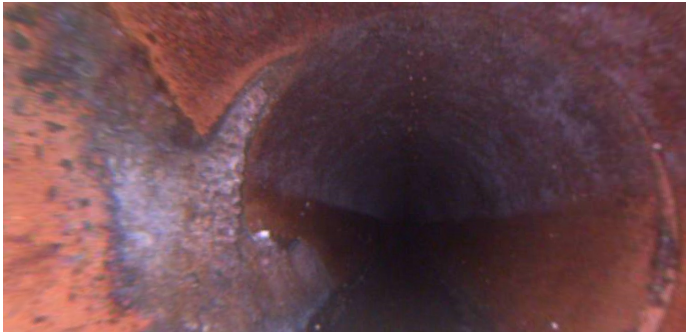
Code: **DAE**  
Description: **Deposits Attached Encrustation**

Distance (ft): **45.7**  
Structural Grade: **0**  
O&M Grade: **2**  
Clock Start/From: **8**  
Clock To: **11**  
1st Value:  
2nd Value:  
Value Percent: **5.000**  
Continuous Index:  
Within 8" of Joint: **YES**  
Remarks:

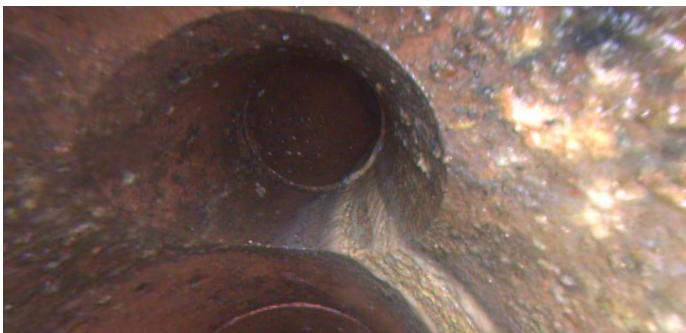
Code: **TF**  
Description: **Tap Factory**

Distance (ft): **132.8**  
Structural Grade: **0**  
O&M Grade: **0**  
Clock Start/From: **12**  
Clock To:  
1st Value: **4.000**  
2nd Value:  
Value Percent:  
Continuous Index:  
Within 8" of Joint:  
Remarks:

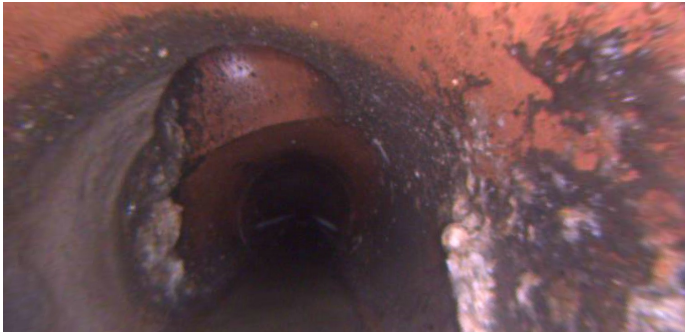
Code: **DAGS**  
Description: **Deposits Attached Grease**

Distance (ft): **208.4**  
Structural Grade: **0**  
O&M Grade: **2**  
Clock Start/From: **8**  
Clock To: **4**  
1st Value:  
2nd Value:  
Value Percent: **5.000**  
Continuous Index:  
Within 8" of Joint: **NO**  
Remarks:

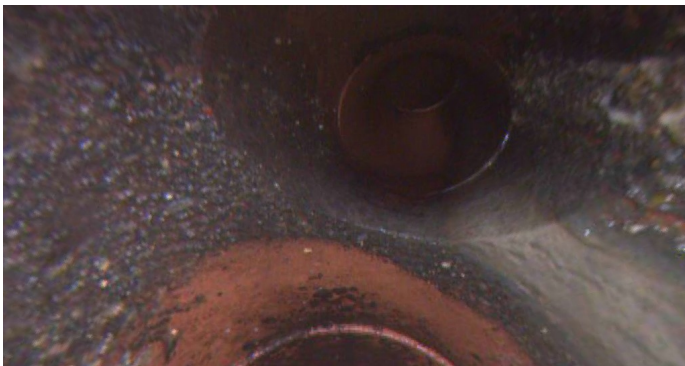
Code: **TF**  
Description: **Tap Factory**

Distance (ft): **209.4**  
Structural Grade: **0**  
O&M Grade: **0**  
Clock Start/From: **11**  
Clock To:  
1st Value: **4.000**  
2nd Value:  
Value Percent:  
Continuous Index:  
Within 8" of Joint:  
Remarks: **Photo taken from rear camera.**

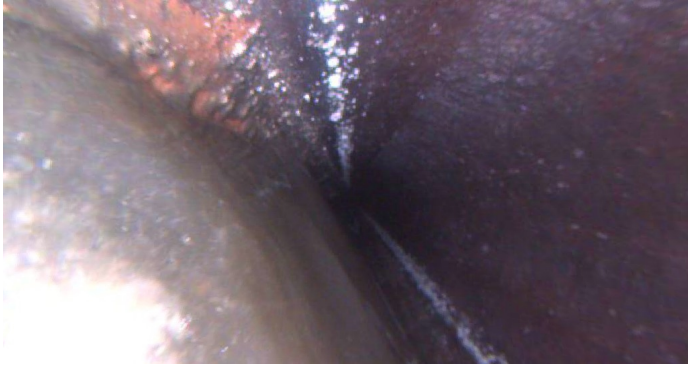
Code:	<b>MSA</b>
Description:	<b>Abandoned Survey</b>
Distance (ft):	<b>261.2</b>
Structural Grade:	<b>0</b>
O&M Grade:	<b>0</b>
Clock Start/From:	
Clock To:	
1st Value:	
2nd Value:	
Value Percent:	
Continuous Index:	
Within 8" of Joint:	<b>NO</b>
Remarks:	<b>Roll max</b>
