Profile/Photo Observation Report

Street:	N Hobart St.	Flow Control:	Not Controlled
City:	Hobart, IN	Year Renewed:	
Location:	Other	Tape/Media #:	
Purpose:	Not Known	Dia/Height:	10"
Use:	Sanitary	Material:	VCP
Drain Area:	NA	Lining:	
Category:	NA		
Comment:

Location Details:		Direction of Survey:	Downstream
US MH:	M-804-067	DS MH:	M-903-001
		Total Length Surveyed (ft):	37.8

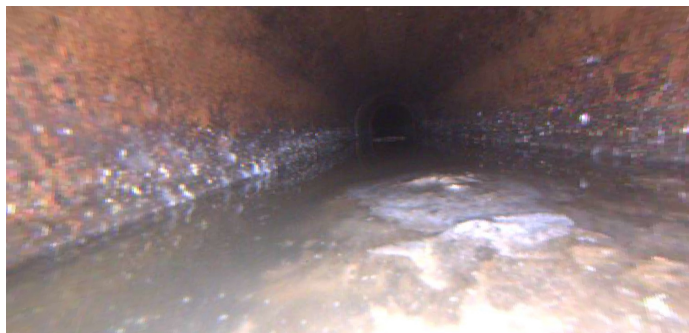
Code: **DSZ**
Description: **Deposits Settled Other**

Distance (ft): **.0**
Structural Grade: **0**
O&M Grade: **2**
Clock Start/From: **6**
Clock To:
1st Value:
2nd Value:
Value Percent: **5.000**
Continuous Index: **S01**
Within 8" of Joint: **NO**
Remarks: **debris/tissue**

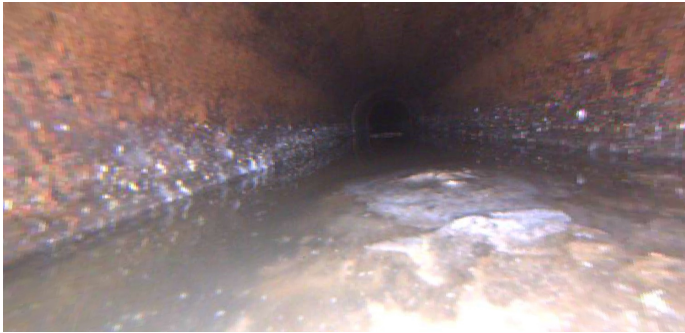
Code:	AMH
Description:	Manhole

Distance (ft):	.0
Structural Grade:	0
O&M Grade:	0
Clock Start/From:	
Clock To:	
1st Value:	
2nd Value:	
Value Percent:	
Continuous Index:	
Within 8" of Joint:	NO
Remarks:	M-804-067

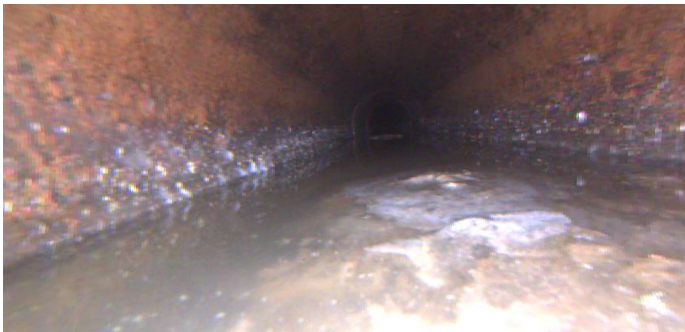
Code:	MWL
Description:	Water Level

Distance (ft):	.0
Structural Grade:	0
O&M Grade:	0
Clock Start/From:	
Clock To:	
1st Value:	
2nd Value:	
Value Percent:	15.000
Continuous Index:	
Within 8" of Joint:	NO
Remarks:

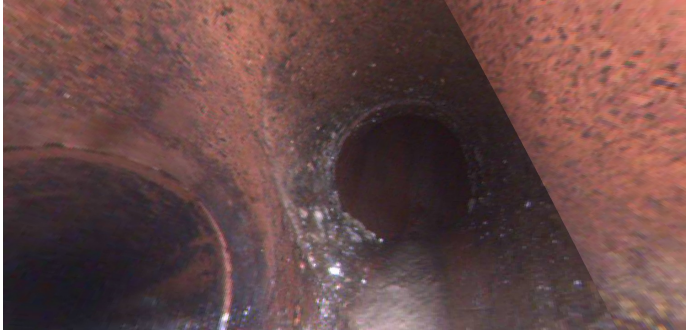
Code: **TF**
Description: **Tap Factory**

Distance (ft): **5.5**
Structural Grade: **0**
O&M Grade: **0**
Clock Start/From: **2**
Clock To:
1st Value: **4.000**
2nd Value:
Value Percent:
Continuous Index:
Within 8" of Joint: **YES**
Remarks:

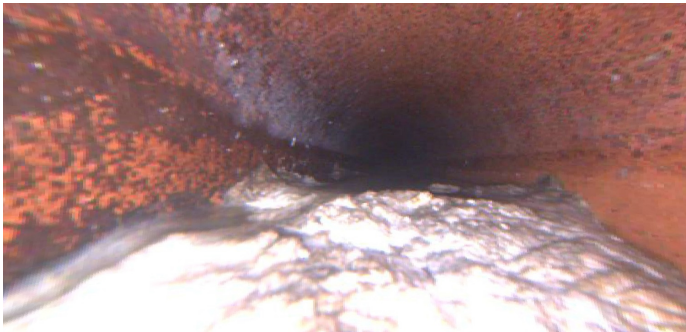
Code: **DSZ**
Description: **Deposits Settled Other**

Distance (ft): **37.1**
Structural Grade: **0**
O&M Grade: **4**
Clock Start/From: **4**
Clock To: **8**
1st Value:
2nd Value:
Value Percent: **25.000**
Continuous Index:
Within 8" of Joint: **NO**
Remarks: **unknown blockage**

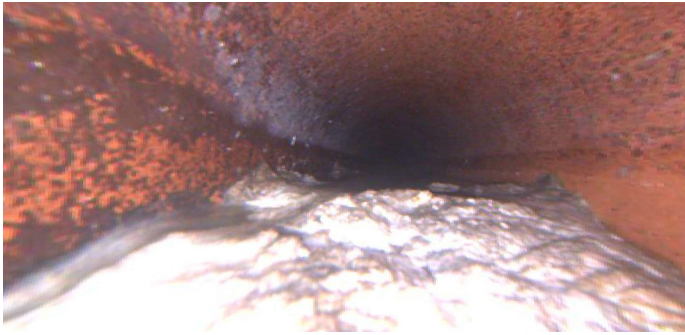
Code: **DSZ**
Description: **Deposits Settled Other**

Distance (ft): **37.1**
Structural Grade: **0**
O&M Grade: **2**
Clock Start/From: **6**
Clock To:
1st Value:
2nd Value:
Value Percent: **5.000**
Continuous Index: **F01**
Within 8" of Joint: **NO**
Remarks: **debris/tissue**

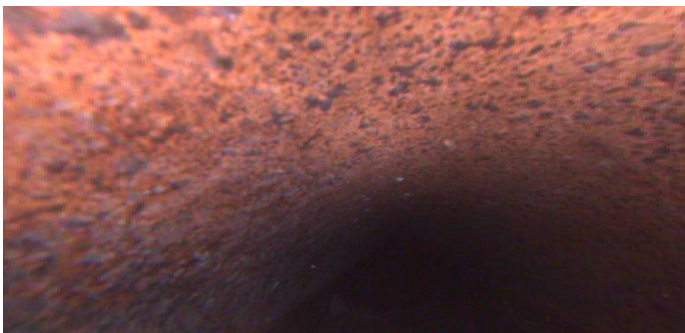
Code: **MSA**
Description: **Abandoned Survey**

Distance (ft): **37.8**
Structural Grade: **0**
O&M Grade: **0**
Clock Start/From:
Clock To:
1st Value:
2nd Value:
Value Percent:
Continuous Index:
Within 8" of Joint: **NO**
Remarks: **dsz**
