Profile/Photo Observation Report

Date:	01/09/2025	Weather:		Coding:	PACP 7.0
Pipe Length (ft):	209.0	Owner:	City of Hobart	Pre Clean:	Heavy Cleaning
P.O.#:	YES502259	Surveyor:	S. Bucklin	PSR:	P-804-068-069
Customer:	City of Hobart	Clean Date:	10/09/2022	Shape:	C

Street:	North Liberty Street	Flow Control:	Not Controlled
City:	Hobart, IN	Year Renewed:	
Location:	Yard	Tape/Media #:	
Purpose:	Sewer System Evaluation Survey (SS	Dia/Height:	10"
Use:	Sanitary Sewage Pipe	Material:	PVC
Drain Area:		Lining:	None
Category:	NA		
Comment:			
Location Details:		Direction of Survey:	Downstream
US MH:	M-804-068	DS MH:	M-804-069
		Total Length Surveyed (ft):	198.3

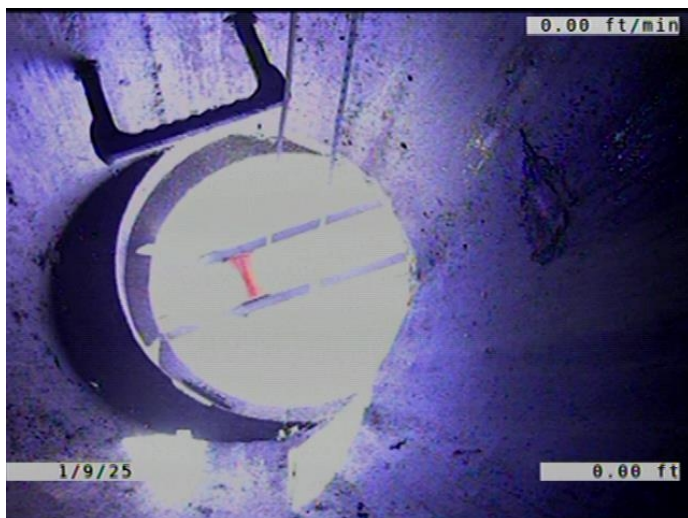
Code: **AMH**
Description: **Manhole**

Distance (ft): **.0**
Structural Grade: **0**
O&M Grade: **0**
Clock Start/From:
Clock To:
1st Value:
2nd Value:
Value Percent:
Continuous Index:
Within 8" of Joint: **NO**
Remarks: **M-804-068**

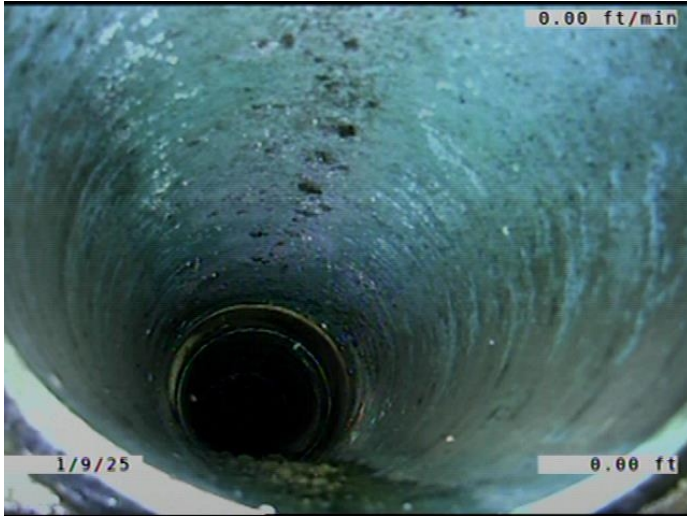
Code:	MWL
Description:	Miscellaneous Water Level
Distance (ft):	.0
Structural Grade:	0
O&M Grade:	0
Clock Start/From:	
Clock To:	
1st Value:	
2nd Value:	
Value Percent:	5.000
Continuous Index:	
Within 8" of Joint:	NO
Remarks:

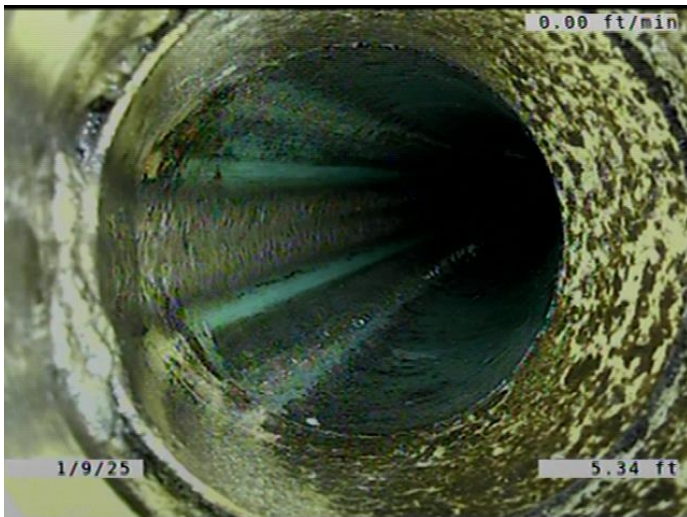
Code:	TF
Description:	Tap Factory
Distance (ft):	5.3
Structural Grade:	0
O&M Grade:	0
Clock Start/From:	9
Clock To:	
1st Value:	6.000
2nd Value:	
Value Percent:	
Continuous Index:	
Within 8" of Joint:	YES
Remarks:

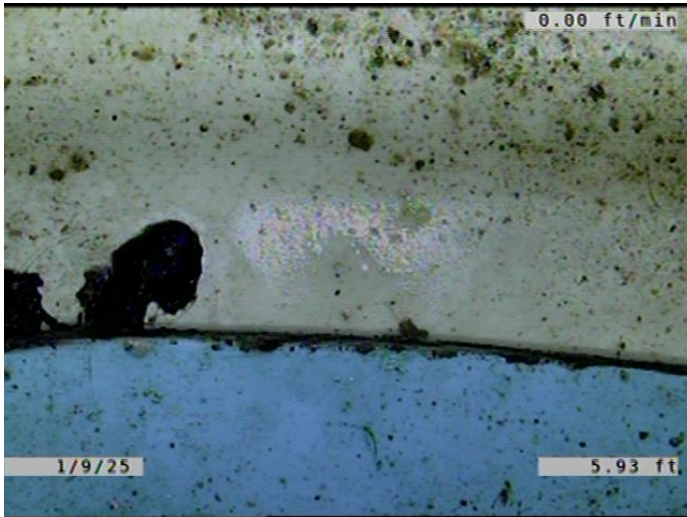
Code:	MGO
Description:	Miscellaneous General Observation
Distance (ft):	5.9
Structural Grade:	0
O&M Grade:	0
Clock Start/From:	
Clock To:	
1st Value:	
2nd Value:	
Value Percent:	
Continuous Index:	
Within 8" of Joint:	NO
Remarks:	JOINT/ PIPES NOT PUSHED ALL THE WAY TOGETHER WHEN INSTALLED

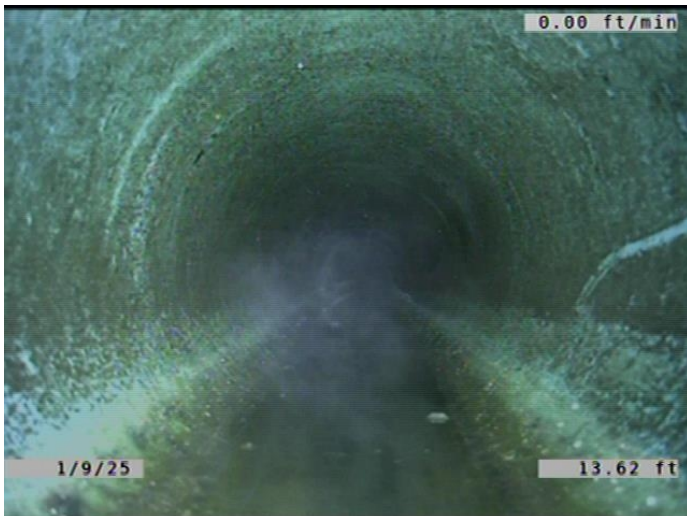
Code:	MWLS
Description:	Miscellaneous Water Level Sag
Distance (ft):	13.6
Structural Grade:	2
O&M Grade:	0
Clock Start/From:	
Clock To:	
1st Value:	
2nd Value:	
Value Percent:	10.000
Continuous Index:	S01
Within 8" of Joint:	NO
Remarks:

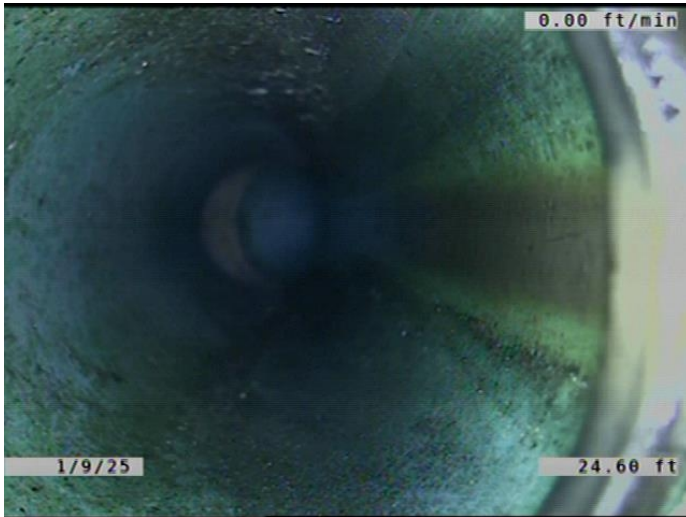
Code: **TS**
 Description: **Tap Saddle**

Distance (ft): **24.6**
 Structural Grade: **0**
 O&M Grade: **0**
 Clock Start/From: **2**
 Clock To:
 1st Value: **6.000**
 2nd Value:
 Value Percent:
 Continuous Index:
 Within 8" of Joint: **YES**
 Remarks:

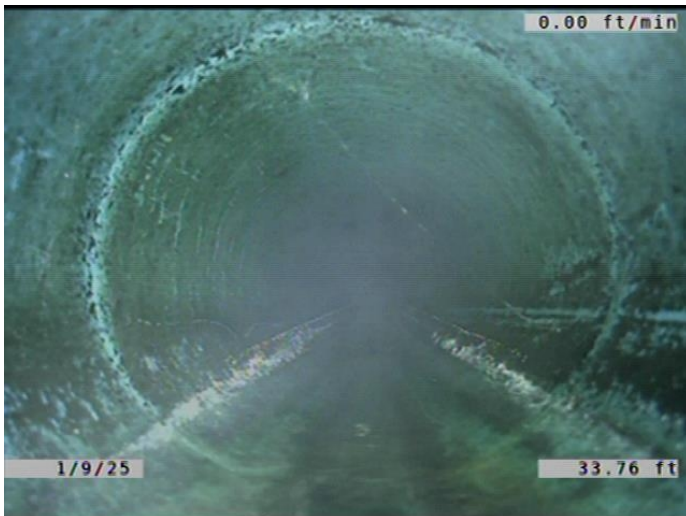
Code: **MWLS**
 Description: **Miscellaneous Water Level Sag**

Distance (ft): **33.8**
 Structural Grade: **2**
 O&M Grade: **0**
 Clock Start/From:
 Clock To:
 1st Value:
 2nd Value:
 Value Percent: **10.000**
 Continuous Index: **F01**
 Within 8" of Joint: **NO**
 Remarks:

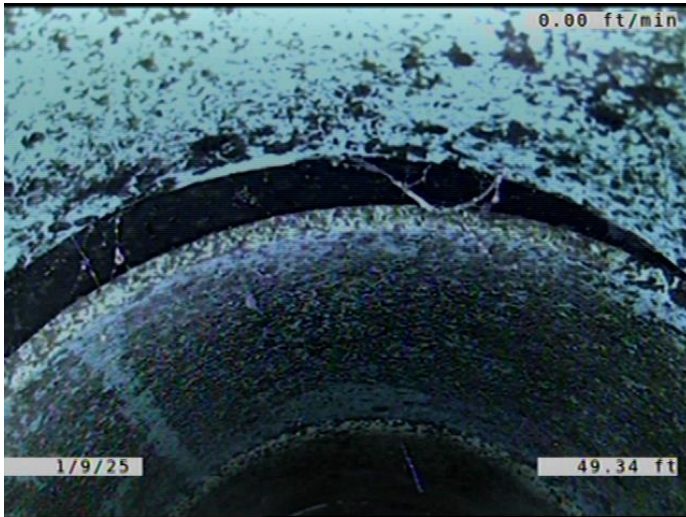
Code: **JOLD**
 Description: **Joint Offset Large Defective**

Distance (ft): **49.3**
 Structural Grade: **4**
 O&M Grade: **0**
 Clock Start/From:
 Clock To:
 1st Value:
 2nd Value:
 Value Percent:
 Continuous Index:
 Within 8" of Joint: **NO**
 Remarks:

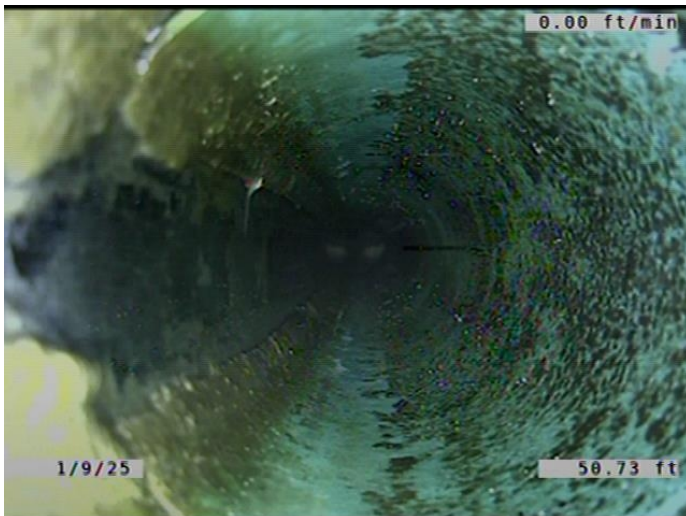
Code: **TF**
 Description: **Tap Factory**

Distance (ft): **50.7**
 Structural Grade: **0**
 O&M Grade: **0**
 Clock Start/From: **9**
 Clock To:
 1st Value: **6.000**
 2nd Value:
 Value Percent:
 Continuous Index:
 Within 8" of Joint: **YES**
 Remarks:

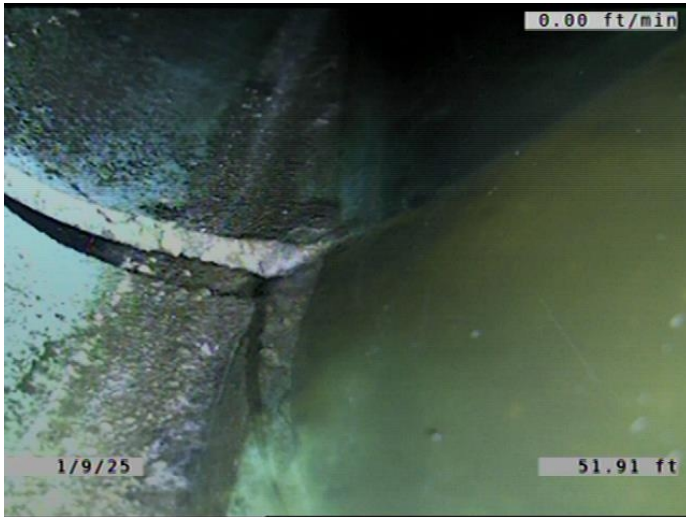
Code: **JOMD**
Description: **Joint Offset Medium Defective**

Distance (ft): **51.9**
Structural Grade: **3**
O&M Grade: **0**
Clock Start/From:
Clock To:
1st Value:
2nd Value:
Value Percent:
Continuous Index:
Within 8" of Joint: **NO**
Remarks:

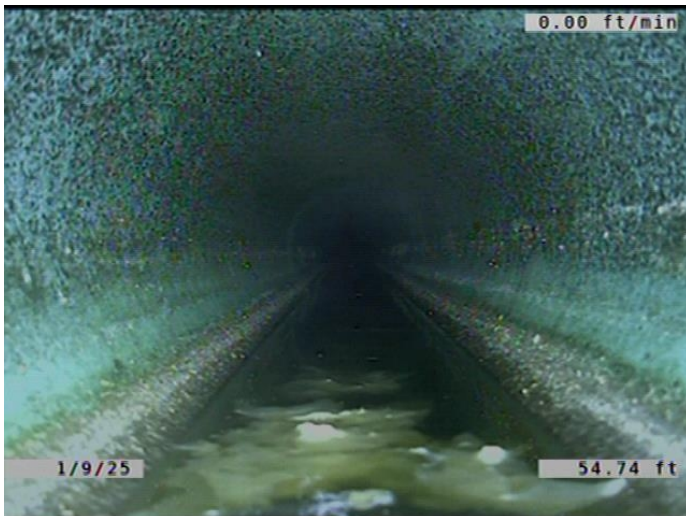
Code: **MWLS**
Description: **Miscellaneous Water Level Sag**

Distance (ft): **54.7**
Structural Grade: **4**
O&M Grade: **0**
Clock Start/From:
Clock To:
1st Value:
2nd Value:
Value Percent: **60.000**
Continuous Index: **S02**
Within 8" of Joint: **NO**
Remarks:

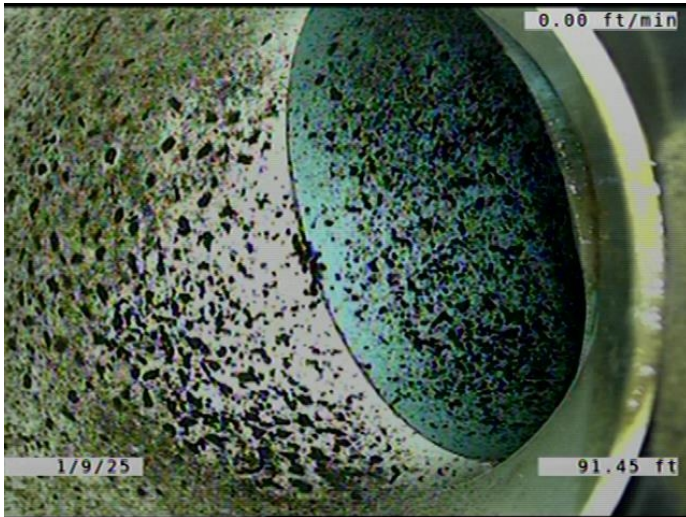
Code: **TSI**
Description: **Tap Saddle Intruding**

Distance (ft): **91.4**
Structural Grade: **0**
O&M Grade: **2**
Clock Start/From: **1**
Clock To:
1st Value: **6.000**
2nd Value: **1.000**
Value Percent:
Continuous Index:
Within 8" of Joint: **NO**
Remarks: **CONSTANTLY DRIPPING WATER.**

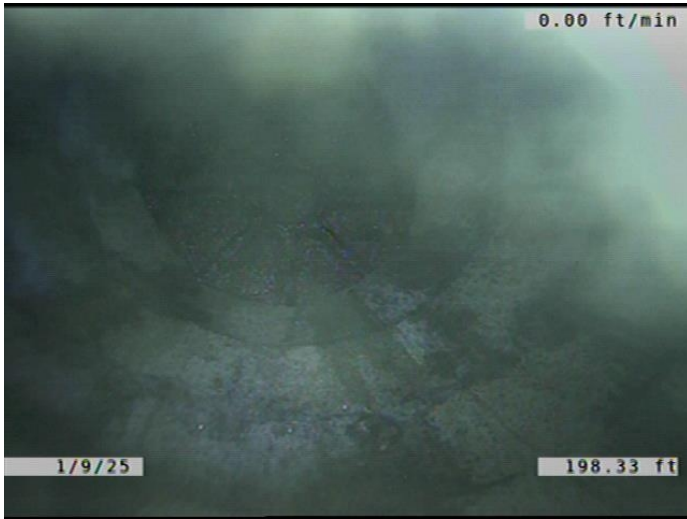
Code: **MWLS**
Description: **Miscellaneous Water Level Sag**

Distance (ft): **198.3**
Structural Grade: **4**
O&M Grade: **0**
Clock Start/From:
Clock To:
1st Value:
2nd Value:
Value Percent: **60.000**
Continuous Index: **F02**
Within 8" of Joint: **NO**
Remarks:

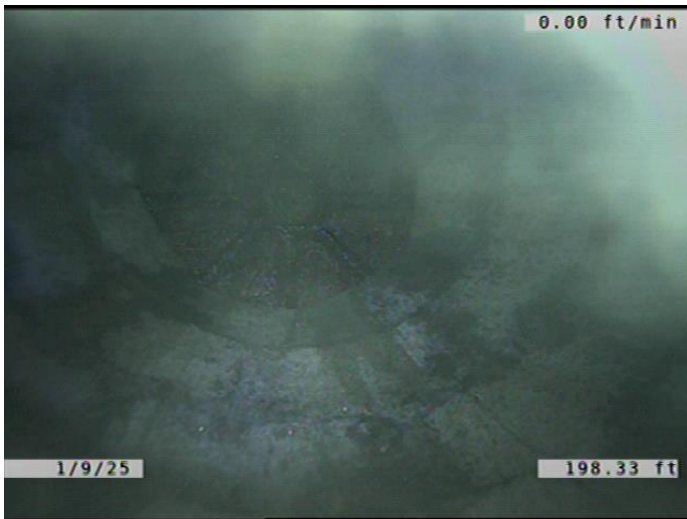
Code: **MCU**
Description: **Miscellaneous Camera Underwater**

Distance (ft): **198.3**
Structural Grade: **0**
O&M Grade: **4**
Clock Start/From:
Clock To:
1st Value:
2nd Value:
Value Percent:
Continuous Index: **F03**
Within 8" of Joint: **NO**
Remarks:

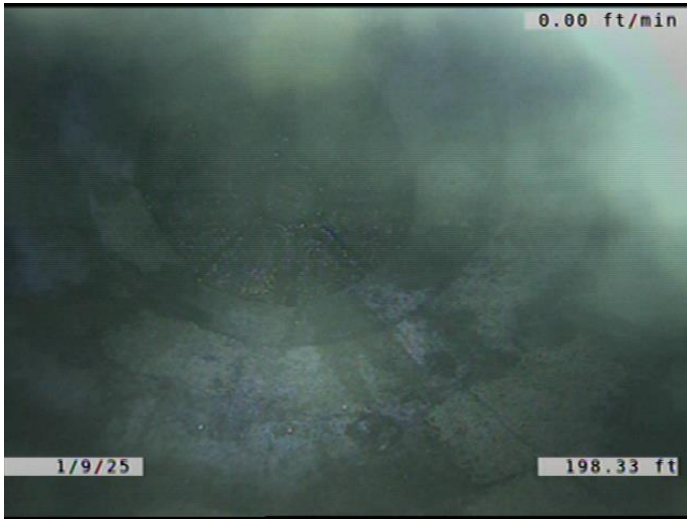
Code: **MGO**
Description: **Miscellaneous General Observation**

Distance (ft): **198.3**
Structural Grade: **0**
O&M Grade: **0**
Clock Start/From:
Clock To:
1st Value:
2nd Value:
Value Percent:
Continuous Index:
Within 8" of Joint: **NO**
Remarks: **CAMERA STILL UNDER WATER.
CAMERA MADE IT TO THE DOWNST**

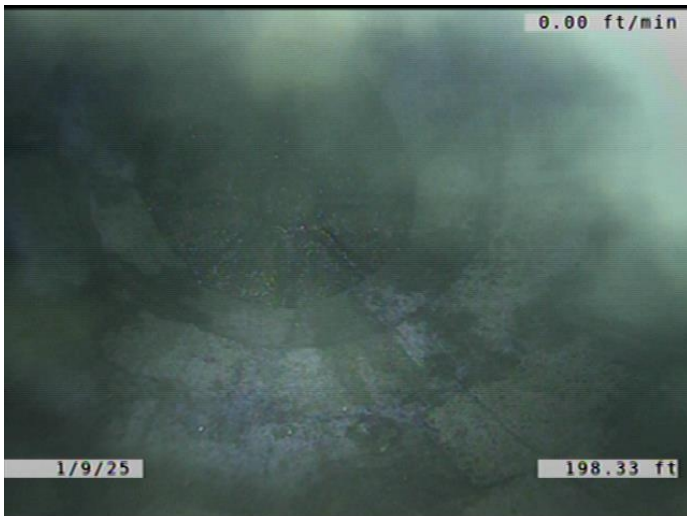
Code: **AMH**
Description: **Manhole**

Distance (ft): **198.3**
Structural Grade: **0**
O&M Grade: **0**
Clock Start/From:
Clock To:
1st Value:
2nd Value:
Value Percent:
Continuous Index:
Within 8" of Joint: **NO**
Remarks: **M-804-069**
