Profile/Photo Observation Report

Street:	North Liberty Street	Flow Control:	Not Controlled
City:	Hobart, IN	Year Renewed:	
Location:	Other	Tape/Media #:	
Purpose:	Sewer System Evaluation Survey (SS	Dia/Height:	10"
Use:	Sanitary Sewage Pipe	Material:	VCP
Drain Area:		Lining:	None
Category:	NA		
Comment:			
Location Details:	M-804-069 MANHOLE UNDER 229N	Direction of Survey:	Downstream
US MH:	M-804-069	DS MH:	M-804-070
		Total Length Surveyed (ft):	184.6

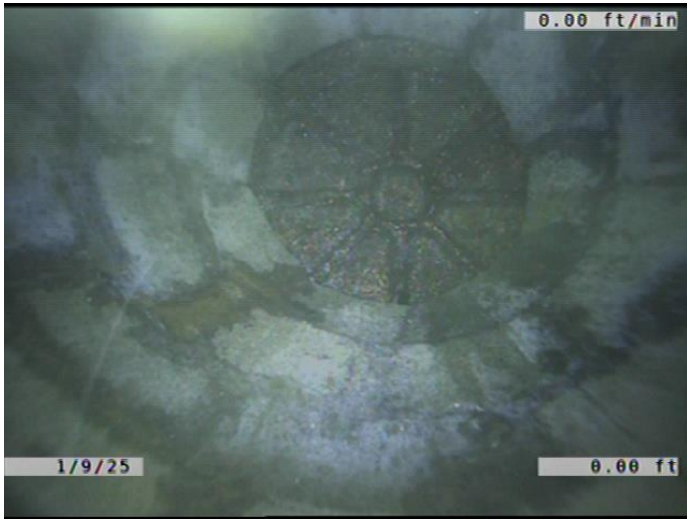
Code: **AMH**
Description: **Manhole**

Distance (ft): **.0**
Structural Grade: **0**
O&M Grade: **0**
Clock Start/From:
Clock To:
1st Value:
2nd Value:
Value Percent:
Continuous Index:
Within 8" of Joint: **NO**
Remarks: **M-804-069**

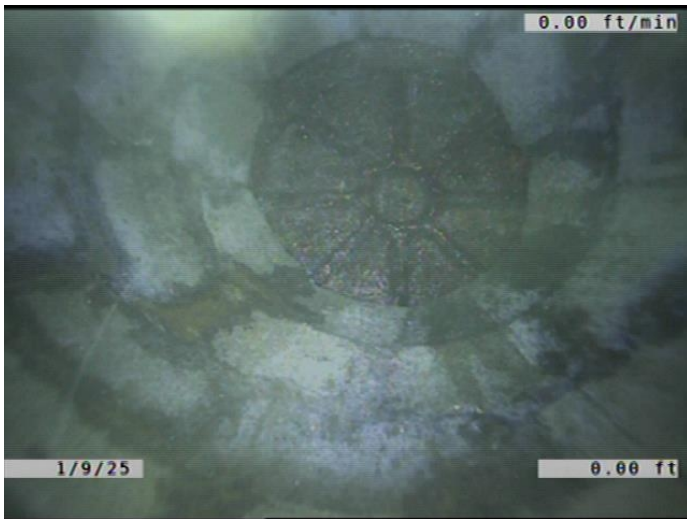
Code: **MWL**
Description: **Miscellaneous Water Level**

Distance (ft): **.0**
Structural Grade: **0**
O&M Grade: **0**
Clock Start/From:
Clock To:
1st Value:
2nd Value:
Value Percent: **55.000**
Continuous Index:
Within 8" of Joint: **NO**
Remarks:

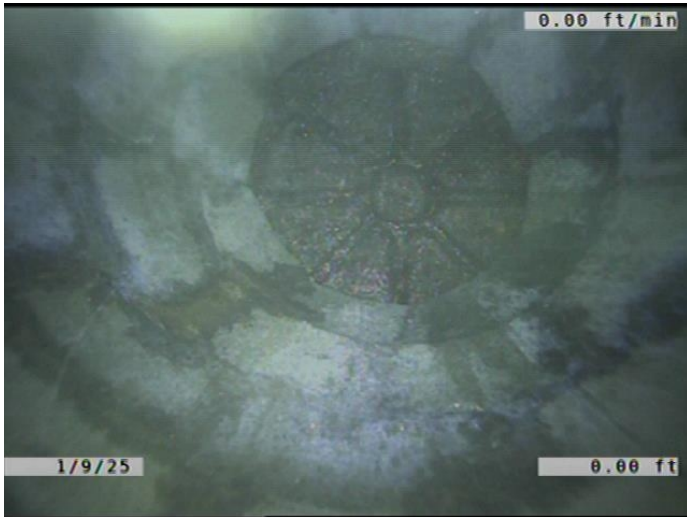
Code:	MCU
Description:	Miscellaneous Camera Underwater
Distance (ft):	.0
Structural Grade:	0
O&M Grade:	4
Clock Start/From:	
Clock To:	
1st Value:	
2nd Value:	
Value Percent:	
Continuous Index:	
Within 8" of Joint:	NO
Remarks:

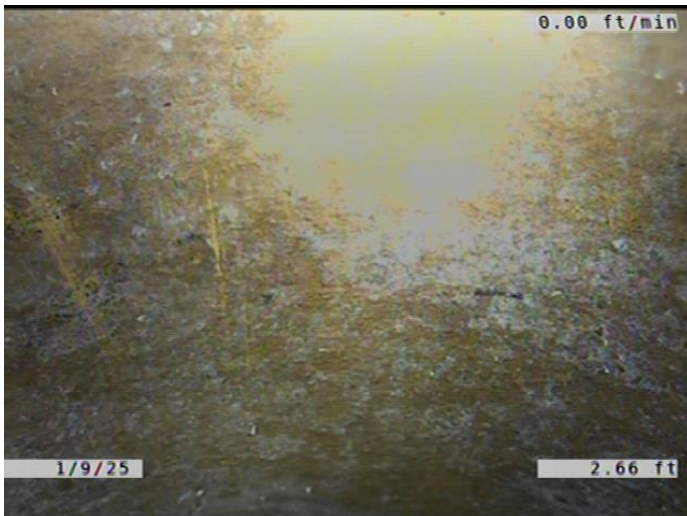
Code:	MWL
Description:	Miscellaneous Water Level
Distance (ft):	2.7
Structural Grade:	0
O&M Grade:	0
Clock Start/From:	
Clock To:	
1st Value:	
2nd Value:	
Value Percent:	45.000
Continuous Index:	
Within 8" of Joint:	NO
Remarks:

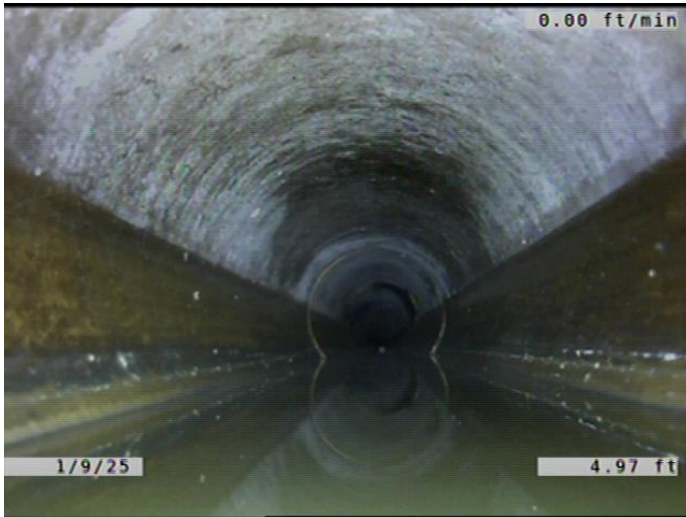
Code: **MWL**
Description: **Miscellaneous Water Level**

Distance (ft): **5.0**
Structural Grade: **0**
O&M Grade: **0**
Clock Start/From:
Clock To:
1st Value:
2nd Value:
Value Percent: **15.000**
Continuous Index:
Within 8" of Joint: **NO**
Remarks:

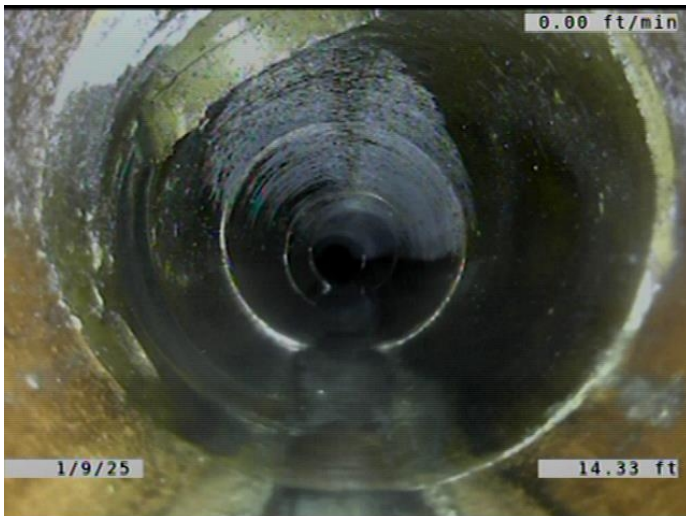
Code: **MWL**
Description: **Miscellaneous Water Level**

Distance (ft): **14.3**
Structural Grade: **0**
O&M Grade: **0**
Clock Start/From:
Clock To:
1st Value:
2nd Value:
Value Percent: **5.000**
Continuous Index:
Within 8" of Joint: **NO**
Remarks:

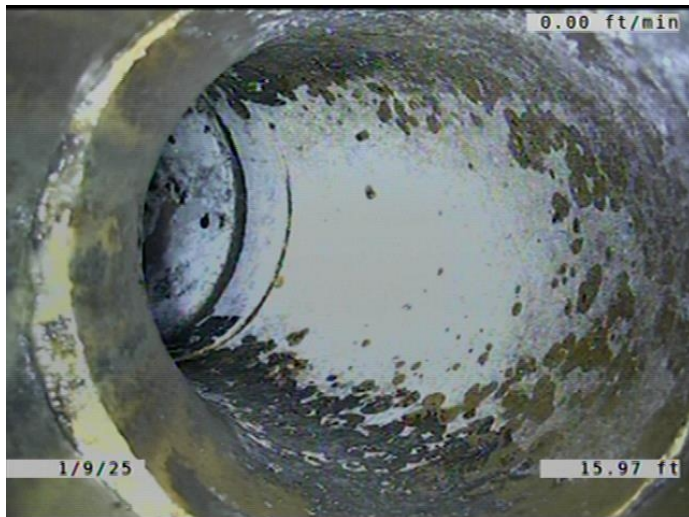
Code: **TF**
 Description: **Tap Factory**

Distance (ft): **16.0**
 Structural Grade: **0**
 O&M Grade: **0**
 Clock Start/From: **11**
 Clock To:
 1st Value: **6.000**
 2nd Value:
 Value Percent:
 Continuous Index:
 Within 8" of Joint: **YES**
 Remarks:

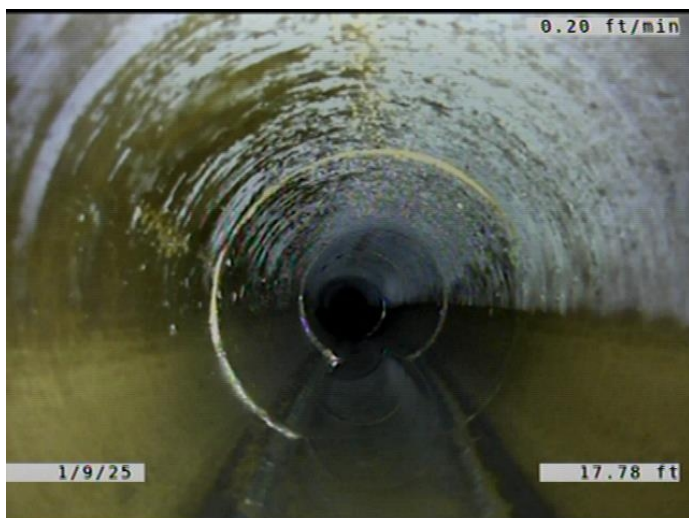
Code: **MWLS**
 Description: **Miscellaneous Water Level Sag**

Distance (ft): **17.7**
 Structural Grade: **2**
 O&M Grade: **0**
 Clock Start/From:
 Clock To:
 1st Value:
 2nd Value:
 Value Percent: **5.000**
 Continuous Index: **S01**
 Within 8" of Joint: **NO**
 Remarks:

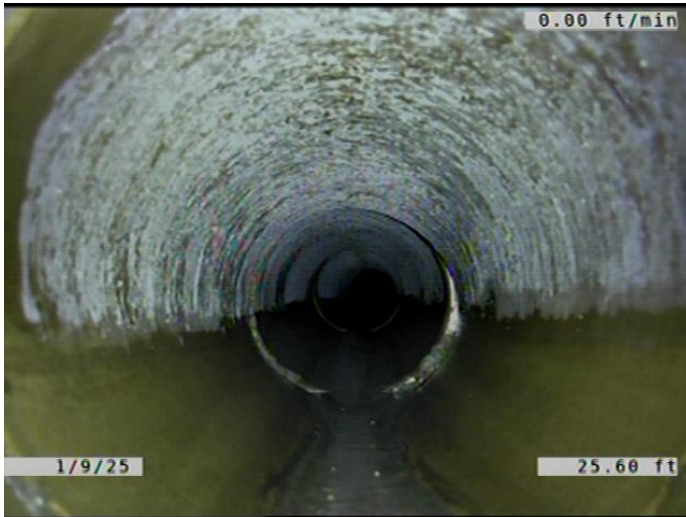
Code: **MWLS**
Description: **Miscellaneous Water Level Sag**

Distance (ft): **25.6**
Structural Grade: **2**
O&M Grade: **0**
Clock Start/From:
Clock To:
1st Value:
2nd Value:
Value Percent: **5.000**
Continuous Index: **F01**
Within 8" of Joint: **NO**
Remarks:

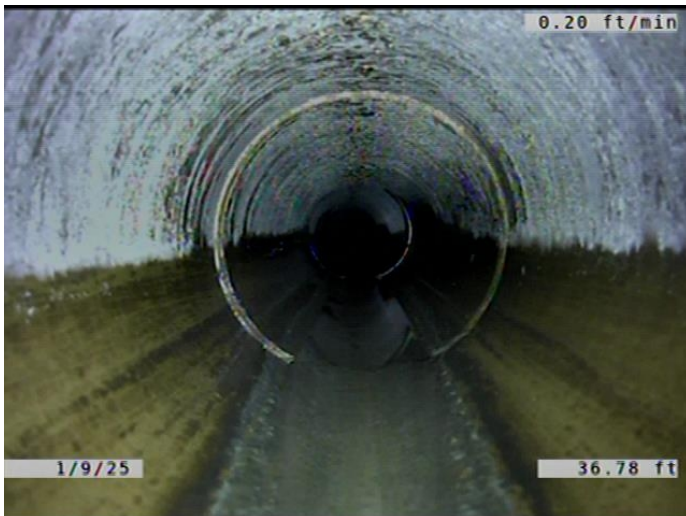
Code: **MWLS**
Description: **Miscellaneous Water Level Sag**

Distance (ft): **36.8**
Structural Grade: **2**
O&M Grade: **0**
Clock Start/From:
Clock To:
1st Value:
2nd Value:
Value Percent: **5.000**
Continuous Index: **S02**
Within 8" of Joint: **NO**
Remarks:

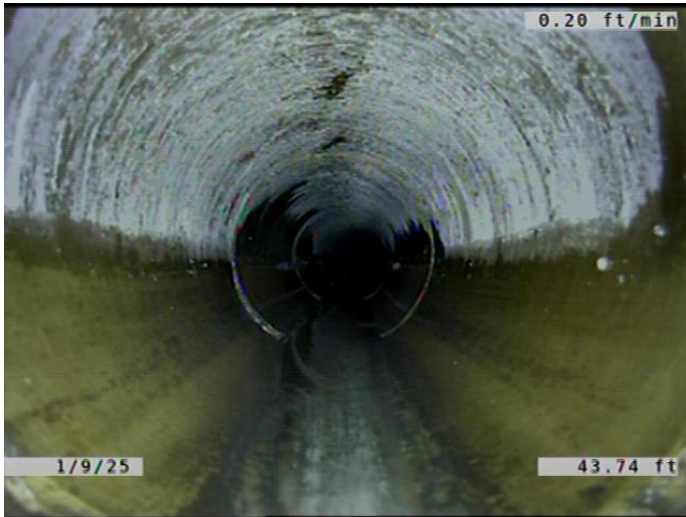
Code: **MWLS**
 Description: **Miscellaneous Water Level Sag**

Distance (ft): **43.7**
 Structural Grade: **2**
 O&M Grade: **0**
 Clock Start/From:
 Clock To:
 1st Value:
 2nd Value:
 Value Percent: **5.000**
 Continuous Index: **F02**
 Within 8" of Joint: **NO**
 Remarks:

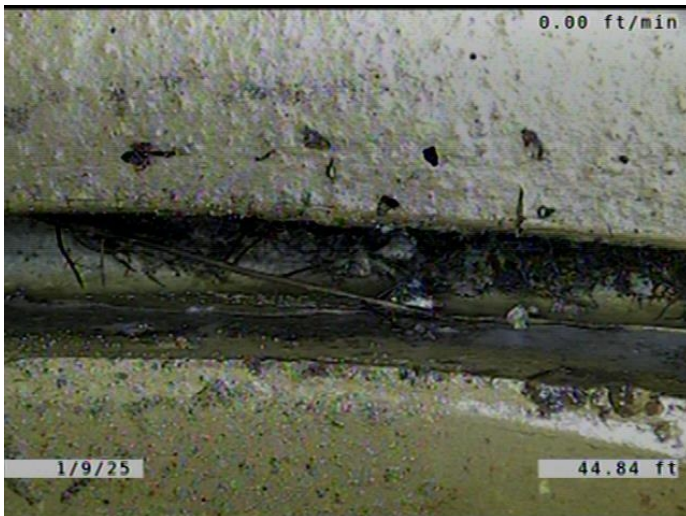
Code: **RFJ**
 Description: **Roots Fine Joint**

Distance (ft): **44.8**
 Structural Grade: **0**
 O&M Grade: **1**
 Clock Start/From: **12**
 Clock To: **4**
 1st Value:
 2nd Value:
 Value Percent:
 Continuous Index:
 Within 8" of Joint: **YES**
 Remarks:

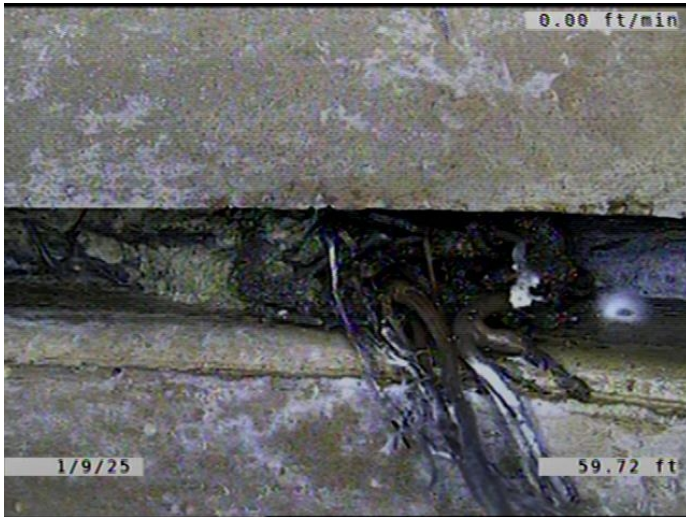
Code: **RFJ**
Description: **Roots Fine Joint**

Distance (ft): **59.7**
Structural Grade: **0**
O&M Grade: **1**
Clock Start/From: **12**
Clock To: **4**
1st Value:
2nd Value:
Value Percent:
Continuous Index:
Within 8" of Joint: **YES**
Remarks:

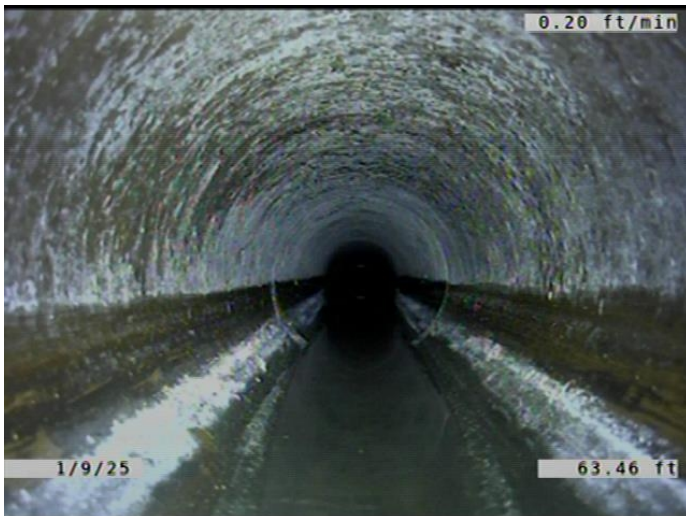
Code: **MWLS**
Description: **Miscellaneous Water Level Sag**

Distance (ft): **63.4**
Structural Grade: **3**
O&M Grade: **0**
Clock Start/From:
Clock To:
1st Value:
2nd Value:
Value Percent: **45.000**
Continuous Index: **S03**
Within 8" of Joint: **NO**
Remarks:

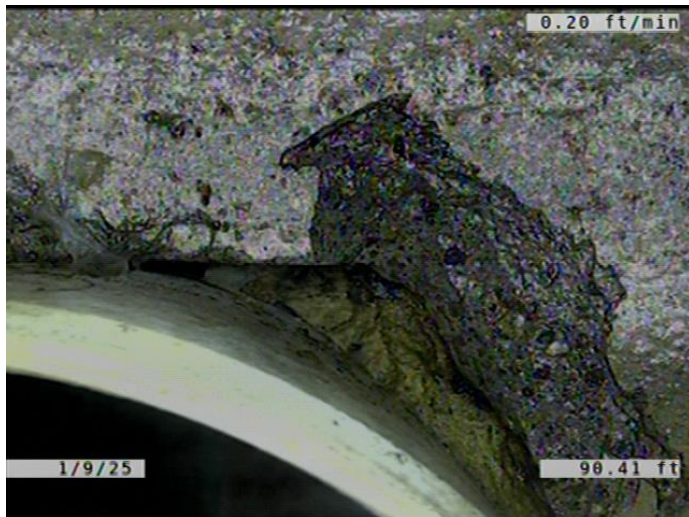
Code: **CM**
Description: **Crack Multiple**

Distance (ft): **90.4**
Structural Grade: **3**
O&M Grade: **0**
Clock Start/From: **10**
Clock To: **2**
1st Value:
2nd Value:
Value Percent:
Continuous Index:
Within 8" of Joint: **YES**
Remarks:

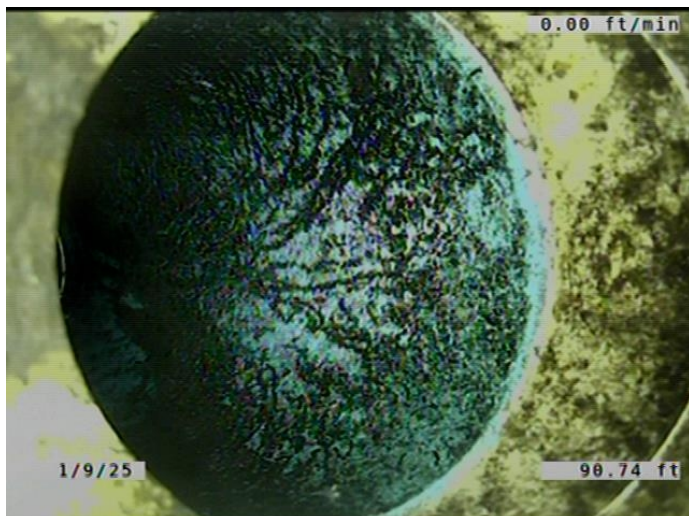
Code: **TBI**
Description: **Tap Break-in Intruding**

Distance (ft): **90.7**
Structural Grade: **0**
O&M Grade: **2**
Clock Start/From: **11**
Clock To:
1st Value: **6.000**
2nd Value: **3.000**
Value Percent:
Continuous Index:
Within 8" of Joint: **YES**
Remarks: **SERVICE IS PVC.**

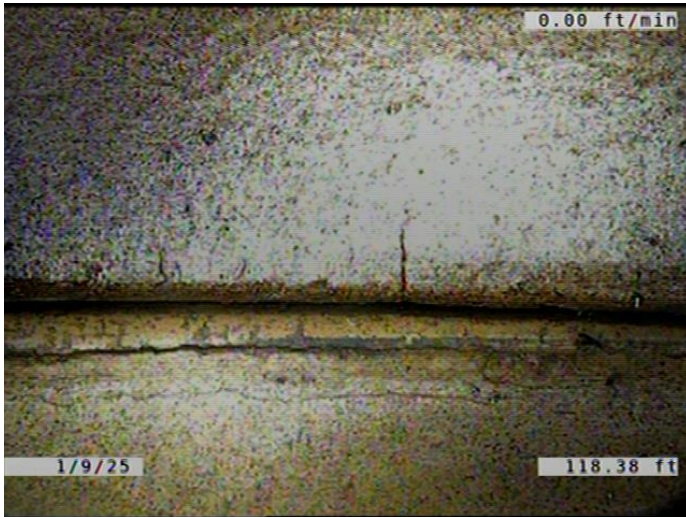
Code: **CL**
Description: **Crack Longitudinal**

Distance (ft): **118.4**
Structural Grade: **2**
O&M Grade: **0**
Clock Start/From: **12**
Clock To:
1st Value:
2nd Value:
Value Percent:
Continuous Index:
Within 8" of Joint: **YES**
Remarks:

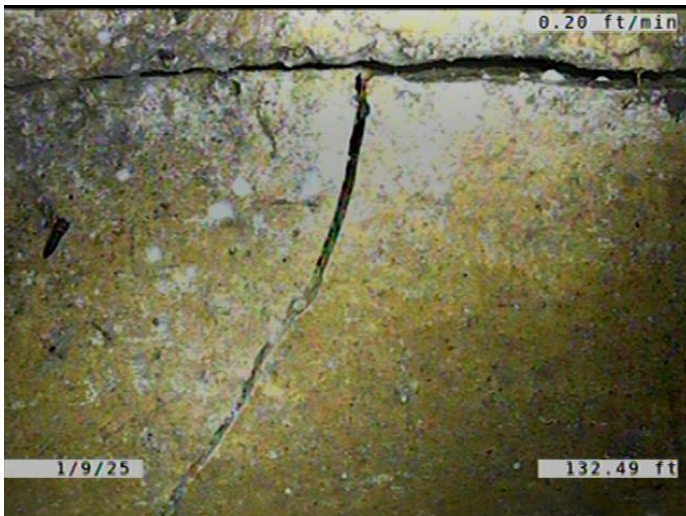
Code: **FS**
Description: **Fracture Spiral**

Distance (ft): **132.5**
Structural Grade: **3**
O&M Grade: **0**
Clock Start/From: **8**
Clock To: **11**
1st Value:
2nd Value:
Value Percent:
Continuous Index:
Within 8" of Joint: **YES**
Remarks:

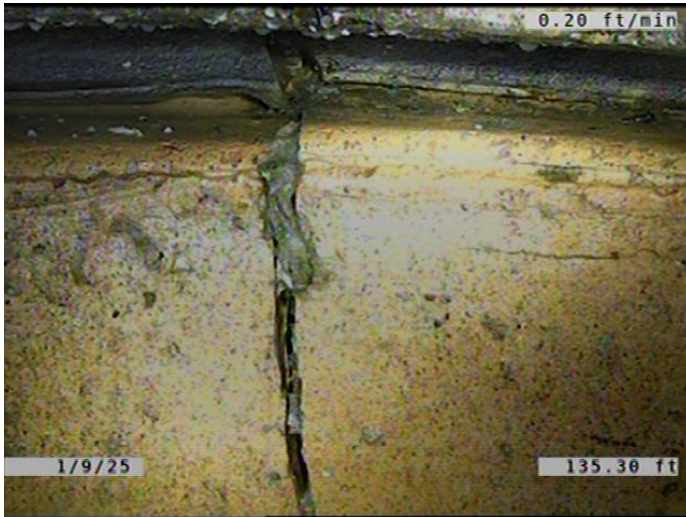
Code: **B**
Description: **Broken**

Distance (ft): **135.3**
Structural Grade: **4**
O&M Grade: **0**
Clock Start/From: **2**
Clock To: **4**
1st Value:
2nd Value:
Value Percent:
Continuous Index:
Within 8" of Joint: **YES**
Remarks:

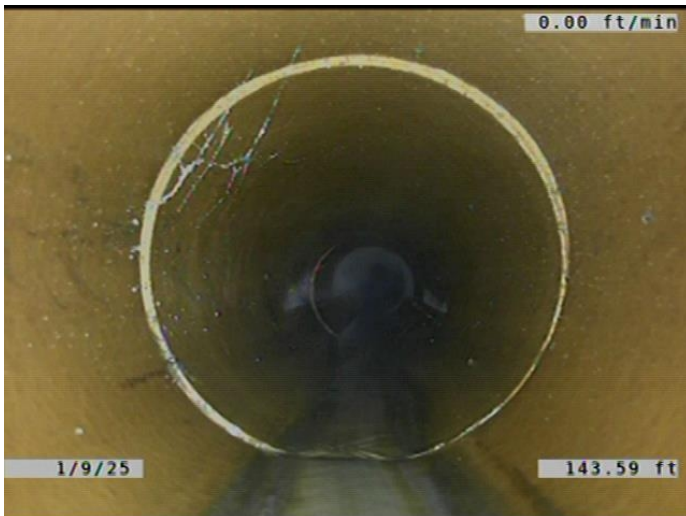
Code: **MWLS**
Description: **Miscellaneous Water Level Sag**

Distance (ft): **143.6**
Structural Grade: **3**
O&M Grade: **0**
Clock Start/From:
Clock To:
1st Value:
2nd Value:
Value Percent: **45.000**
Continuous Index: **F03**
Within 8" of Joint: **NO**
Remarks:

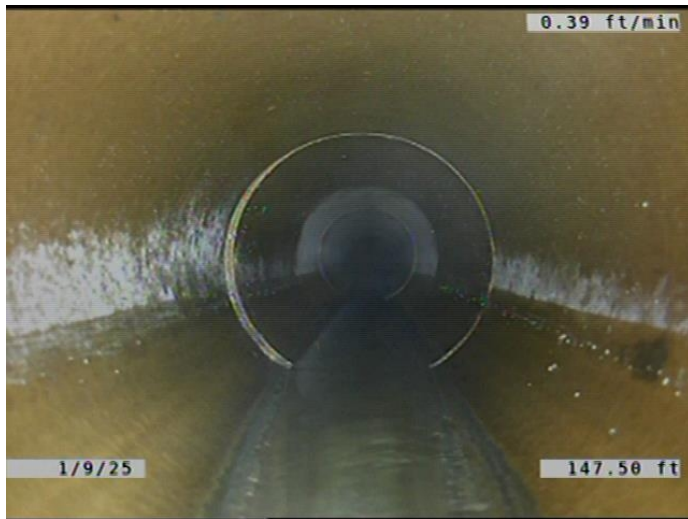
Code: **MWLS**
Description: **Miscellaneous Water Level Sag**

Distance (ft): **147.4**
Structural Grade: **2**
O&M Grade: **0**
Clock Start/From:
Clock To:
1st Value:
2nd Value:
Value Percent: **10.000**
Continuous Index: **S04**
Within 8" of Joint: **NO**
Remarks:

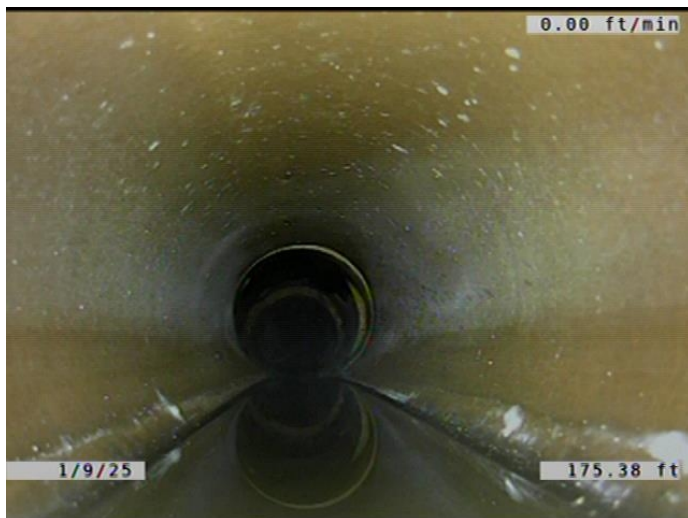
Code: **LL**
Description: **Line Left**

Distance (ft): **175.4**
Structural Grade: **0**
O&M Grade: **1**
Clock Start/From:
Clock To:
1st Value:
2nd Value:
Value Percent: **5.000**
Continuous Index:
Within 8" of Joint: **NO**
Remarks:

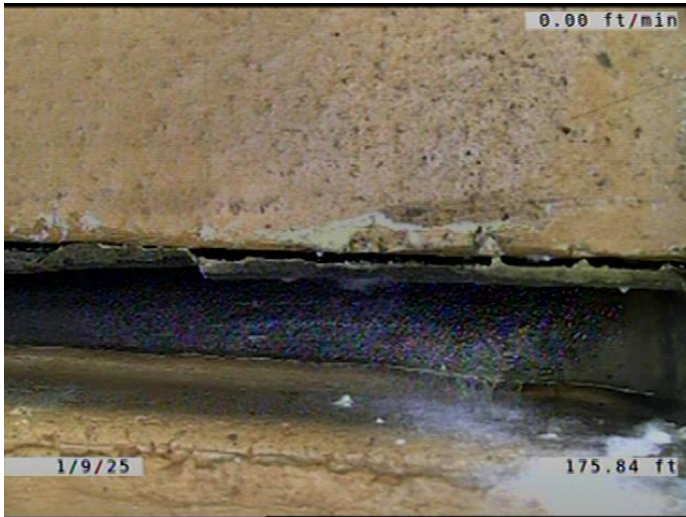
Code: **JAM**
Description: **Joint Angular Medium**

Distance (ft): **175.8**
Structural Grade: **3**
O&M Grade: **0**
Clock Start/From:
Clock To:
1st Value:
2nd Value:
Value Percent:
Continuous Index:
Within 8" of Joint: **NO**
Remarks:

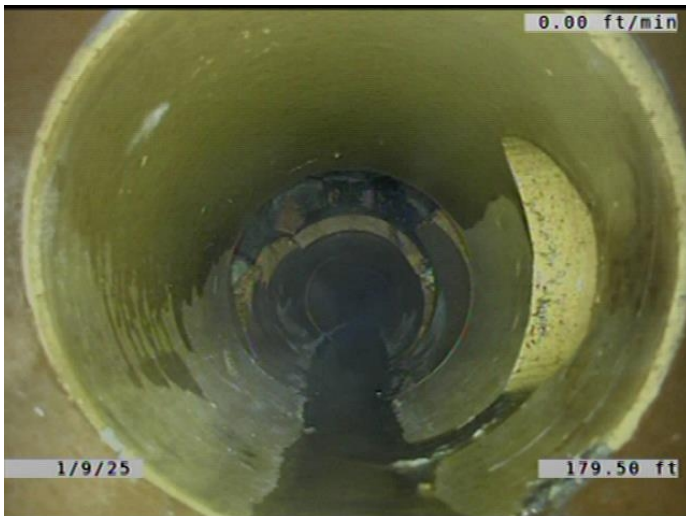
Code: **MWLS**
Description: **Miscellaneous Water Level Sag**

Distance (ft): **179.5**
Structural Grade: **2**
O&M Grade: **0**
Clock Start/From:
Clock To:
1st Value:
2nd Value:
Value Percent: **10.000**
Continuous Index: **F04**
Within 8" of Joint: **NO**
Remarks:

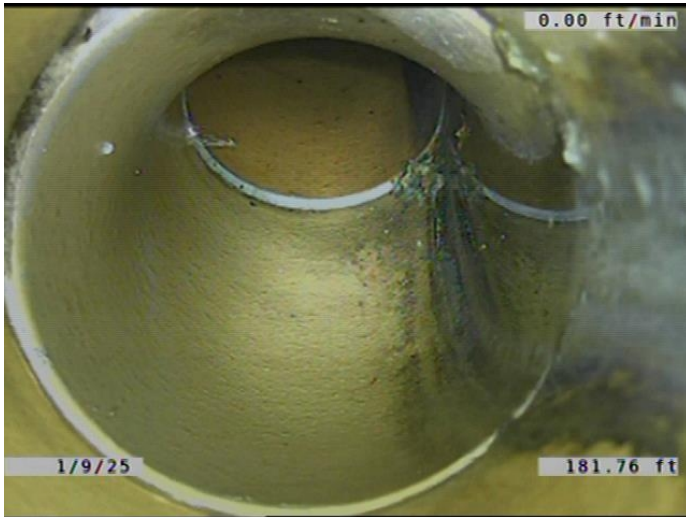
Code:	TF
Description:	Tap Factory
Distance (ft):	181.8
Structural Grade:	0
O&M Grade:	0
Clock Start/From:	3
Clock To:	
1st Value:	6.000
2nd Value:	
Value Percent:	
Continuous Index:	
Within 8" of Joint:	YES
Remarks:	ROOTS GROWING IN THE JOINTS OF THE SERVICE.

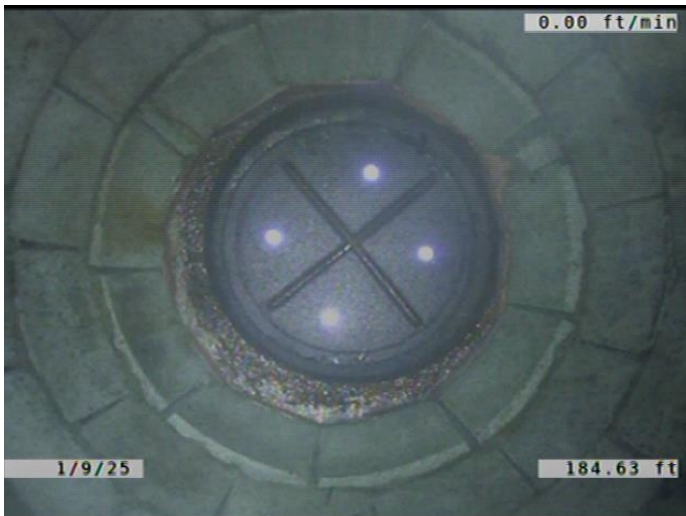
Code:	AMH
Description:	Manhole
Distance (ft):	184.6
Structural Grade:	0
O&M Grade:	0
Clock Start/From:	
Clock To:	
1st Value:	
2nd Value:	
Value Percent:	
Continuous Index:	
Within 8" of Joint:	NO
Remarks:	M-804-070
