## Profile/Photo Observation Report

Date:	<b>01/09/2025</b>	Weather:		Coding:	<b>PACP 7.0</b>
Pipe Length (ft):	<b>181.0</b>	Owner:	<b>City of Hobart</b>	Pre Clean:	<b>Heavy Cleaning</b>
P.O.#:	<b>YES502259</b>	Surveyor:	<b>S. Bucklin</b>	PSR:	<b>P-804-070-071</b>
Customer:	<b>City of Hobart</b>	Clean Date:	<b>12/01/2024</b>	Shape:	<b>C</b>

Street:	<b>North Liberty Street</b>	Flow Control:	<b>Not Controlled</b>
City:	<b>Hobart, IN</b>	Year Renewed:	
Location:	<b>Yard</b>	Tape/Media #:	
Purpose:	<b>Sewer System Evaluation Survey (SS</b>	Dia/Height:	<b>10"</b>
Use:	<b>Sanitary Sewage Pipe</b>	Material:	<b>VCP</b>
Drain Area:		Lining:	<b>None</b>
Category:	<b>NA</b>		
Comment:			
Location Details:		Direction of Survey:	<b>Downstream</b>
US MH:	<b>M-804-071</b>	DS MH:	<b>M-804-070</b>
		Total Length Surveyed (ft):	<b>192.1</b>

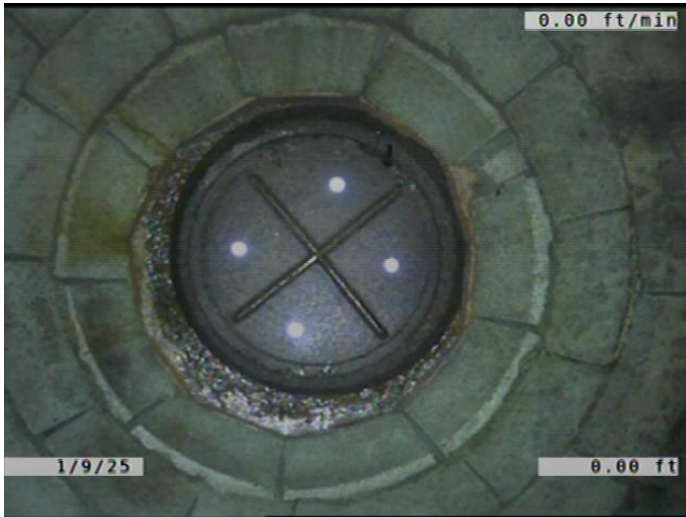
Code: **AMH**  
Description: **Manhole**

Distance (ft): **.0**  
Structural Grade: **0**  
O&M Grade: **0**  
Clock Start/From:  
Clock To:  
1st Value:  
2nd Value:  
Value Percent:  
Continuous Index:  
Within 8" of Joint: **NO**  
Remarks: **M-804-071**

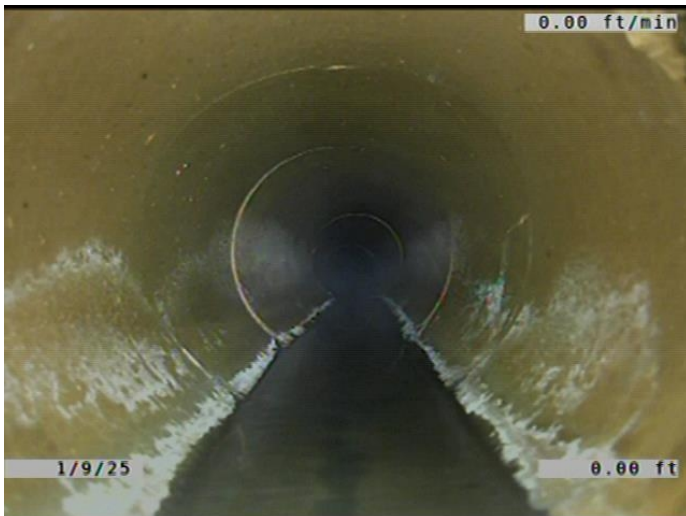
Code: **MWL**  
Description: **Miscellaneous Water Level**

Distance (ft): **.0**  
Structural Grade: **0**  
O&M Grade: **0**  
Clock Start/From:  
Clock To:  
1st Value:  
2nd Value:  
Value Percent: **10.000**  
Continuous Index:  
Within 8" of Joint: **NO**  
Remarks:

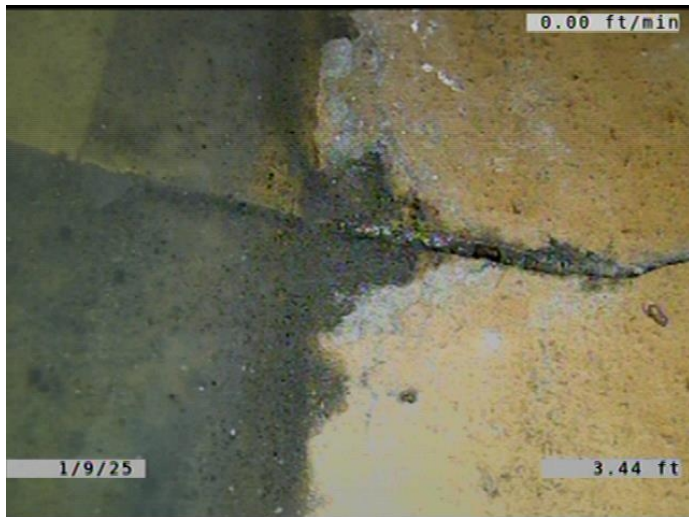
Code: **FM**  
Description: **Fracture Multiple**

Distance (ft): **3.4**  
Structural Grade: **4**  
O&M Grade: **0**  
Clock Start/From: **12**  
Clock To: **12**  
1st Value:  
2nd Value:  
Value Percent:  
Continuous Index:  
Within 8" of Joint: **YES**  
Remarks:

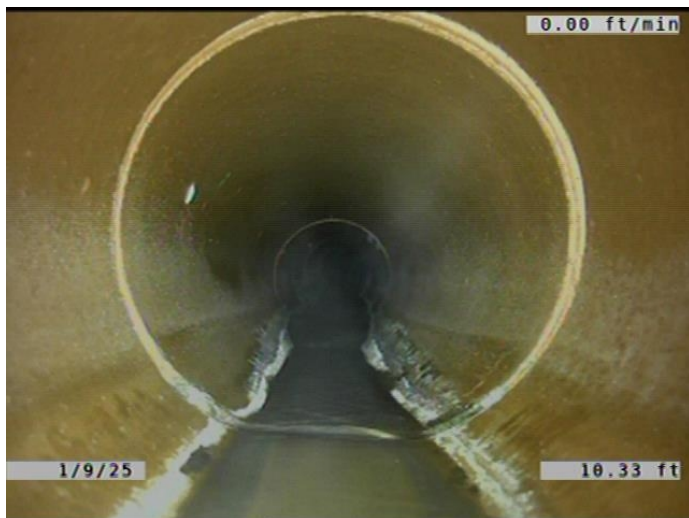
Code: **LD**  
Description: **Line Down**

Distance (ft): **10.3**  
Structural Grade: **0**  
O&M Grade: **1**  
Clock Start/From:  
Clock To:  
1st Value:  
2nd Value:  
Value Percent: **5.000**  
Continuous Index:  
Within 8" of Joint: **NO**  
Remarks:

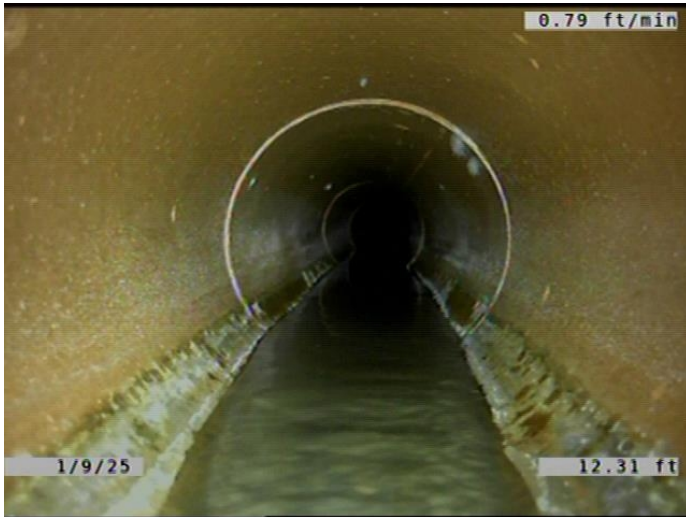
Code: **MWLS**  
Description: **Miscellaneous Water Level Sag**

Distance (ft): **12.3**  
Structural Grade: **2**  
O&M Grade: **0**  
Clock Start/From:  
Clock To:  
1st Value:  
2nd Value:  
Value Percent: **20.000**  
Continuous Index: **S01**  
Within 8" of Joint: **NO**  
Remarks:

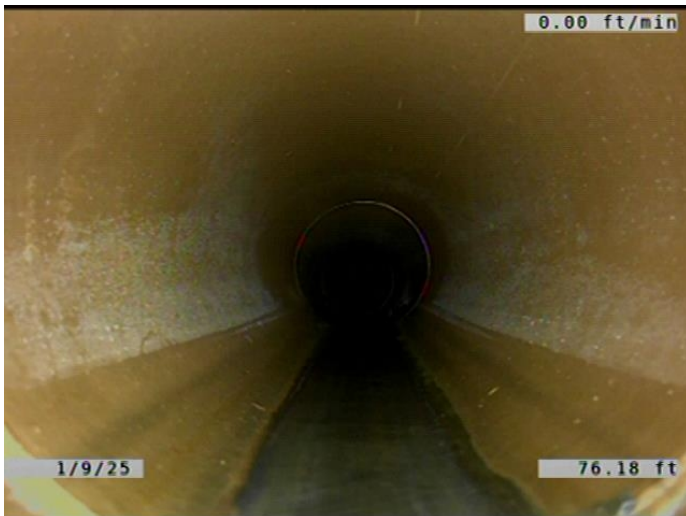
Code: **MWLS**  
Description: **Miscellaneous Water Level Sag**

Distance (ft): **76.2**  
Structural Grade: **2**  
O&M Grade: **0**  
Clock Start/From:  
Clock To:  
1st Value:  
2nd Value:  
Value Percent: **20.000**  
Continuous Index: **F01**  
Within 8" of Joint: **NO**  
Remarks:

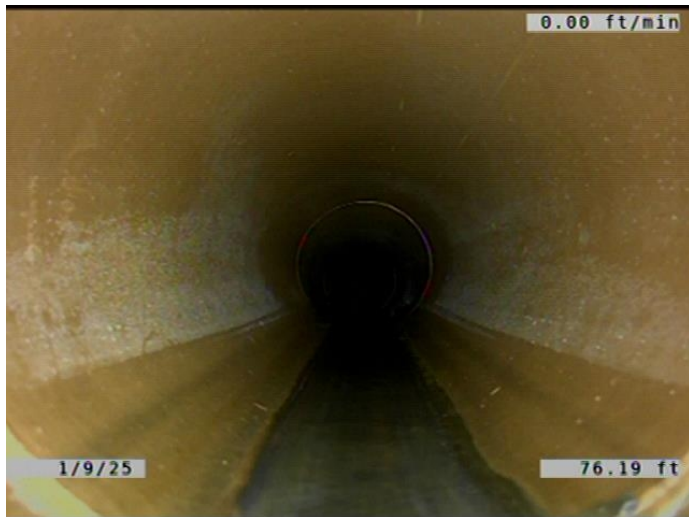
Code: **LD**  
Description: **Line Down**

Distance (ft): **76.2**  
Structural Grade: **0**  
O&M Grade: **1**  
Clock Start/From:  
Clock To:  
1st Value:  
2nd Value:  
Value Percent: **5.000**  
Continuous Index:  
Within 8" of Joint: **NO**  
Remarks:

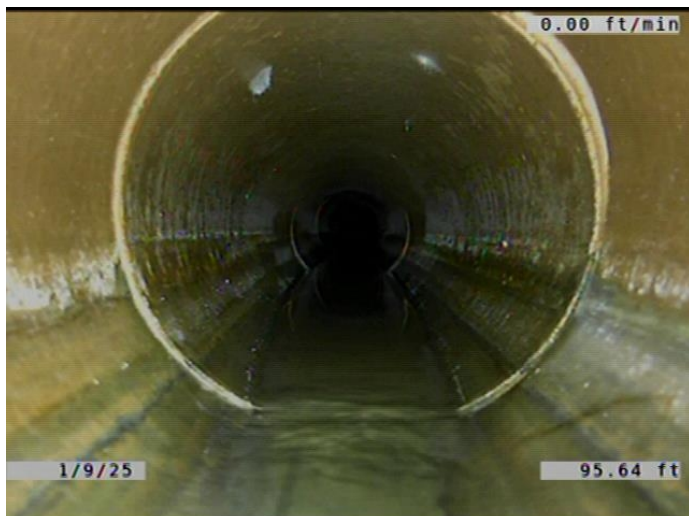
Code: **MWLS**  
Description: **Miscellaneous Water Level Sag**

Distance (ft): **95.6**  
Structural Grade: **2**  
O&M Grade: **0**  
Clock Start/From:  
Clock To:  
1st Value:  
2nd Value:  
Value Percent: **10.000**  
Continuous Index: **S02**  
Within 8" of Joint: **NO**  
Remarks:

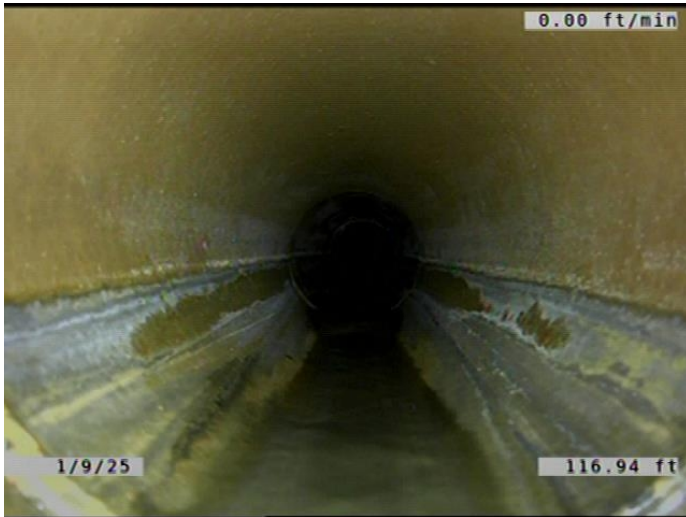
Code: **MWLS**  
Description: **Miscellaneous Water Level Sag**

Distance (ft): **116.9**  
Structural Grade: **2**  
O&M Grade: **0**  
Clock Start/From:  
Clock To:  
1st Value:  
2nd Value:  
Value Percent: **10.000**  
Continuous Index: **F02**  
Within 8" of Joint: **NO**  
Remarks:

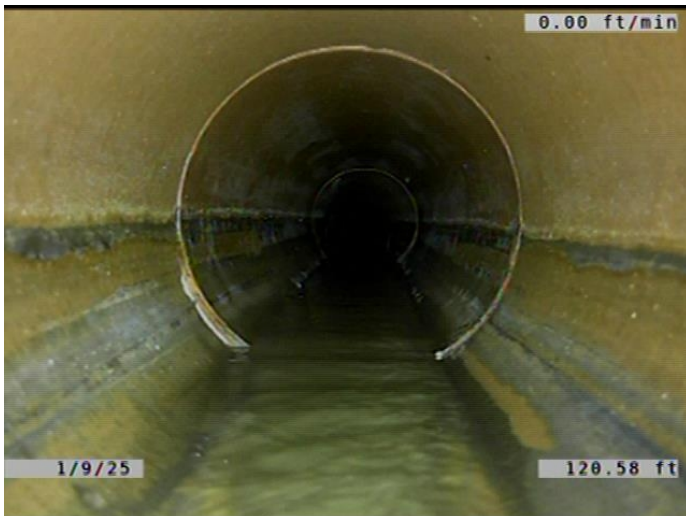
Code: **MWLS**  
Description: **Miscellaneous Water Level Sag**

Distance (ft): **120.6**  
Structural Grade: **2**  
O&M Grade: **0**  
Clock Start/From:  
Clock To:  
1st Value:  
2nd Value:  
Value Percent: **25.000**  
Continuous Index: **S03**  
Within 8" of Joint: **NO**  
Remarks:

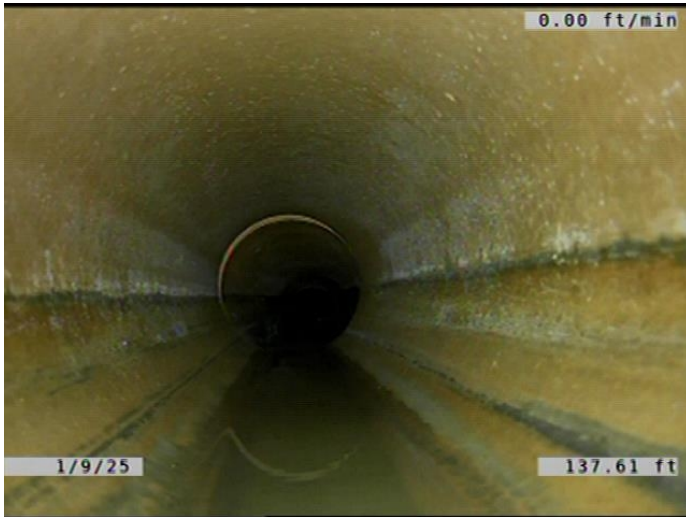
Code: **MWLS**  
Description: **Miscellaneous Water Level Sag**

Distance (ft): **137.6**  
Structural Grade: **2**  
O&M Grade: **0**  
Clock Start/From:  
Clock To:  
1st Value:  
2nd Value:  
Value Percent: **25.000**  
Continuous Index: **F03**  
Within 8" of Joint: **NO**  
Remarks:

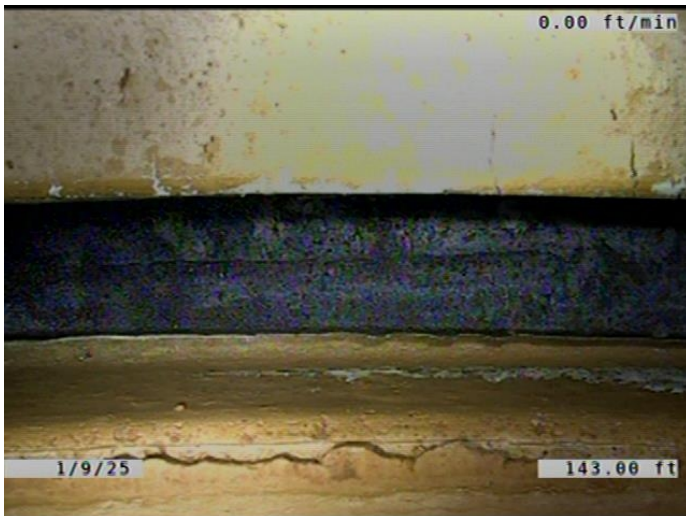
Code: **JAM**  
Description: **Joint Angular Medium**

Distance (ft): **143.0**  
Structural Grade: **3**  
O&M Grade: **0**  
Clock Start/From:  
Clock To:  
1st Value:  
2nd Value:  
Value Percent:  
Continuous Index:  
Within 8" of Joint: **NO**  
Remarks:

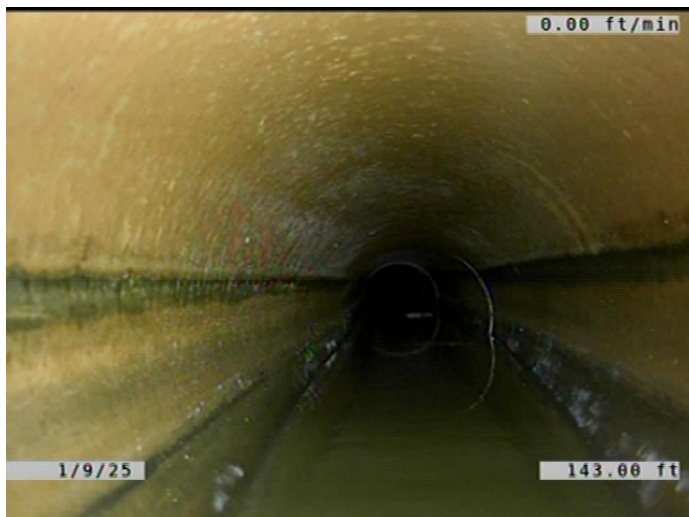
Code: **MWLS**  
 Description: **Miscellaneous Water Level Sag**

Distance (ft): **143.0**  
 Structural Grade: **3**  
 O&M Grade: **0**  
 Clock Start/From:  
 Clock To:  
 1st Value:  
 2nd Value:  
 Value Percent: **35.000**  
 Continuous Index: **S04**  
 Within 8" of Joint: **NO**  
 Remarks:

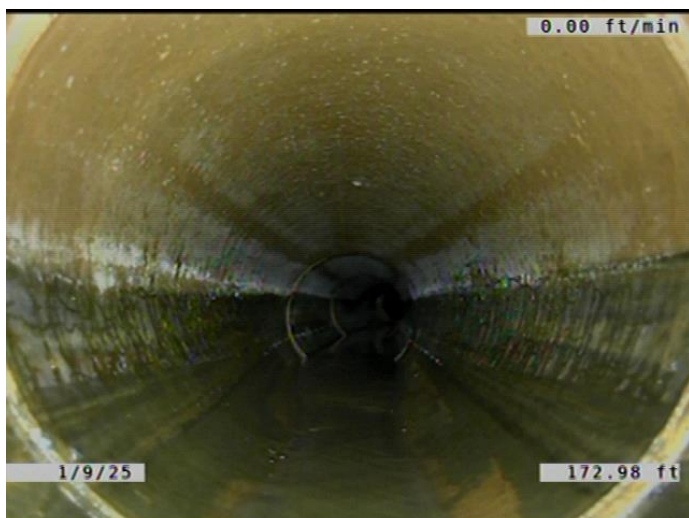
Code: **MWLS**  
 Description: **Miscellaneous Water Level Sag**

Distance (ft): **173.0**  
 Structural Grade: **3**  
 O&M Grade: **0**  
 Clock Start/From:  
 Clock To:  
 1st Value:  
 2nd Value:  
 Value Percent: **35.000**  
 Continuous Index: **F04**  
 Within 8" of Joint: **NO**  
 Remarks:

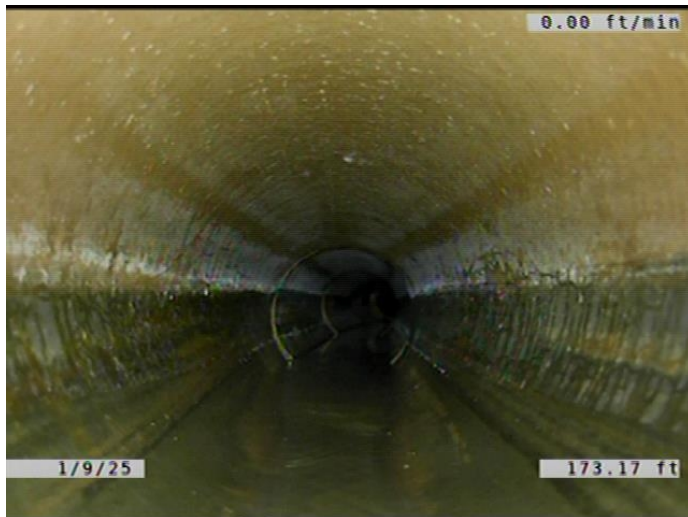
Code: **LD**  
Description: **Line Down**

Distance (ft): **173.2**  
Structural Grade: **0**  
O&M Grade: **1**  
Clock Start/From:  
Clock To:  
1st Value:  
2nd Value:  
Value Percent: **5.000**  
Continuous Index:  
Within 8" of Joint: **NO**  
Remarks:

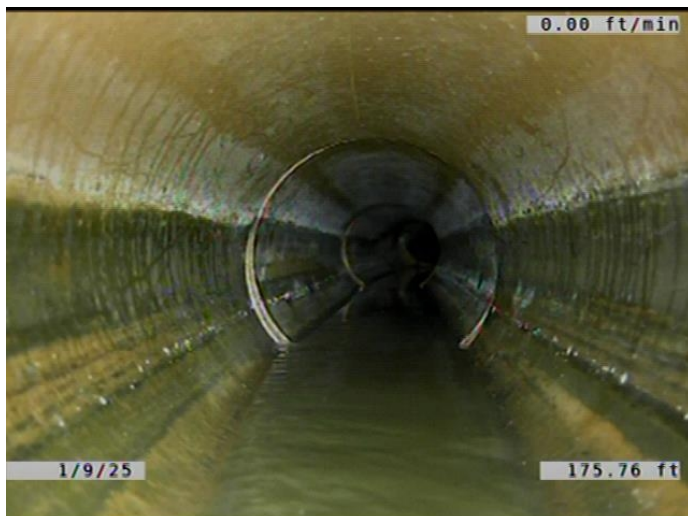
Code: **MWLS**  
Description: **Miscellaneous Water Level Sag**

Distance (ft): **175.8**  
Structural Grade: **2**  
O&M Grade: **0**  
Clock Start/From:  
Clock To:  
1st Value:  
2nd Value:  
Value Percent: **10.000**  
Continuous Index: **S05**  
Within 8" of Joint: **NO**  
Remarks:

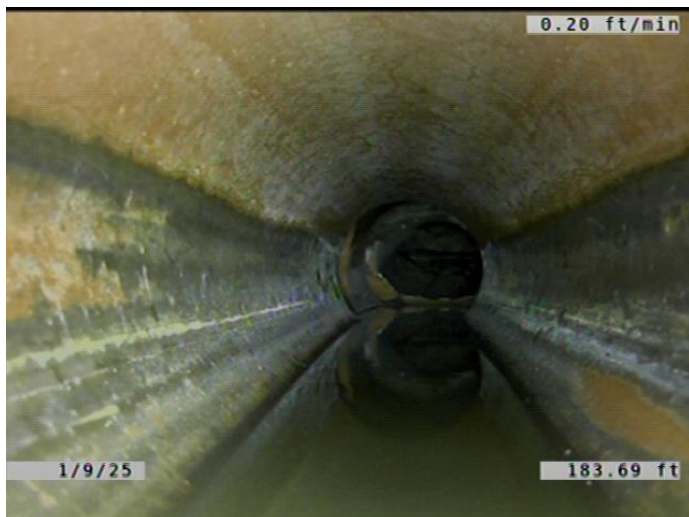
Code: **LR**  
 Description: **Line Right**

Distance (ft): **183.7**  
 Structural Grade: **0**  
 O&M Grade: **1**  
 Clock Start/From:  
 Clock To:  
 1st Value:  
 2nd Value:  
 Value Percent: **5.000**  
 Continuous Index:  
 Within 8" of Joint: **NO**  
 Remarks:

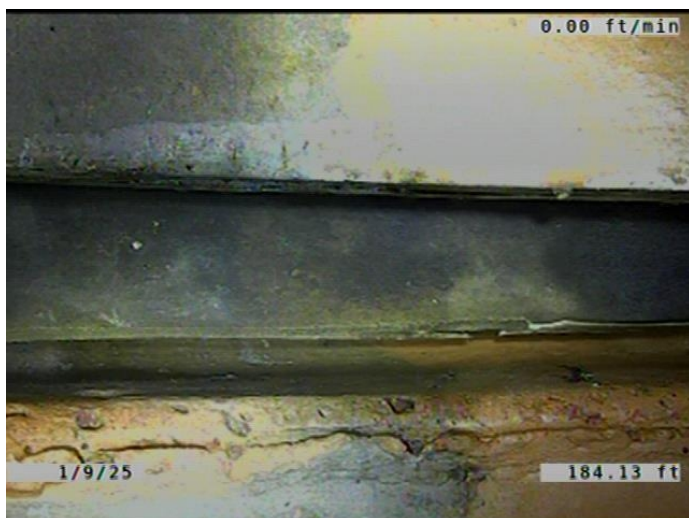
Code: **JAM**  
 Description: **Joint Angular Medium**

Distance (ft): **184.1**  
 Structural Grade: **3**  
 O&M Grade: **0**  
 Clock Start/From:  
 Clock To:  
 1st Value:  
 2nd Value:  
 Value Percent:  
 Continuous Index:  
 Within 8" of Joint: **NO**  
 Remarks:

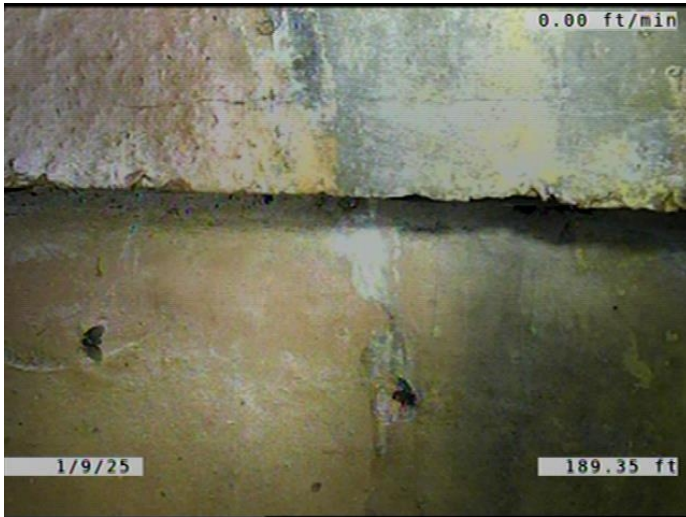
Code: **MSC**  
 Description: **Miscellaneous Shape/Size Change**

Distance (ft): **189.4**  
 Structural Grade: **0**  
 O&M Grade: **0**  
 Clock Start/From:  
 Clock To:  
 1st Value: **12.000**  
 2nd Value:  
 Value Percent:  
 Continuous Index:  
 Within 8" of Joint: **NO**  
 Remarks:

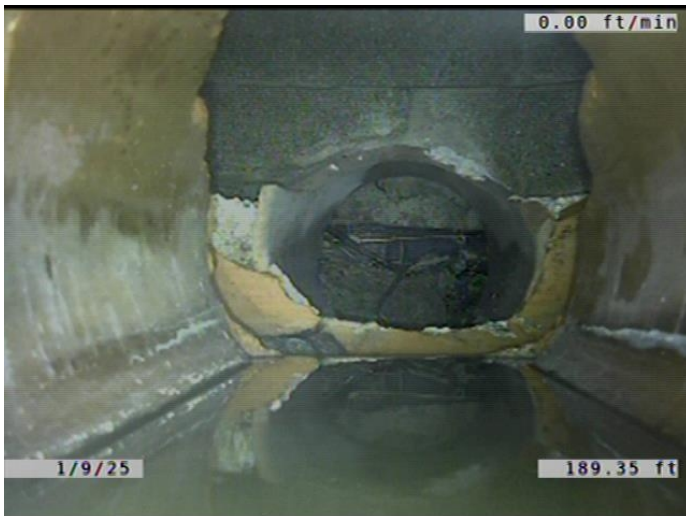
Code: **MWLS**  
 Description: **Miscellaneous Water Level Sag**

Distance (ft): **189.4**  
 Structural Grade: **2**  
 O&M Grade: **0**  
 Clock Start/From:  
 Clock To:  
 1st Value:  
 2nd Value:  
 Value Percent: **10.000**  
 Continuous Index: **F05**  
 Within 8" of Joint: **NO**  
 Remarks:

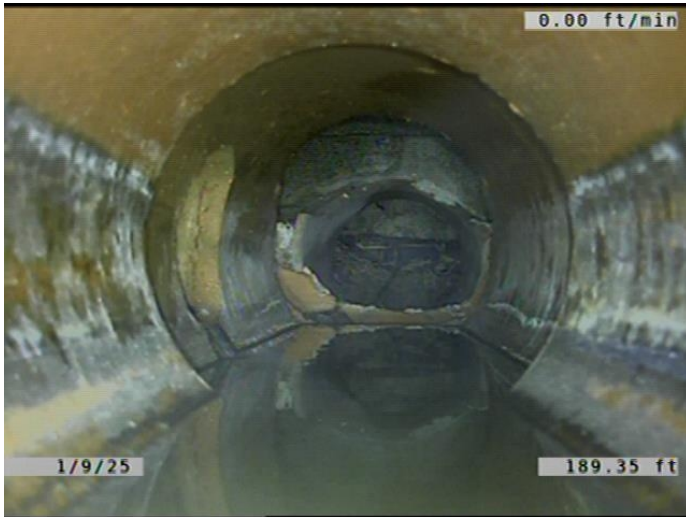
Code: **MGO**  
Description: **Miscellaneous General Observation**

Distance (ft): **189.4**  
Structural Grade: **0**  
O&M Grade: **0**  
Clock Start/From:  
Clock To:  
1st Value:  
2nd Value:  
Value Percent:  
Continuous Index:  
Within 8" of Joint: **NO**  
Remarks: **10" VCP TO 12" VCP.**

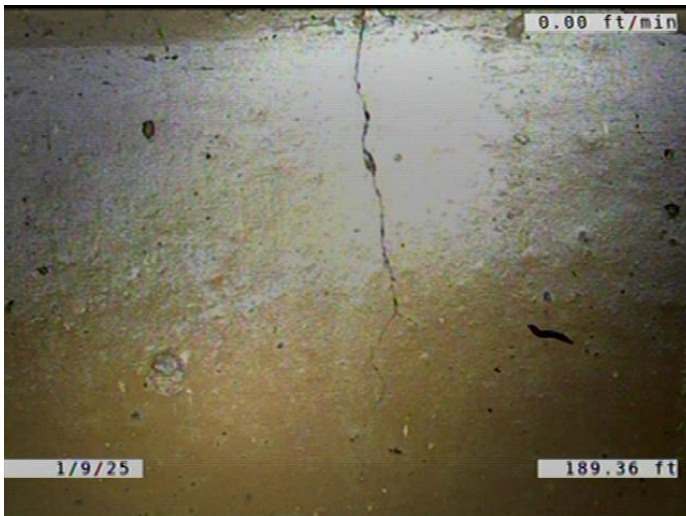
Code: **CM**  
Description: **Crack Multiple**

Distance (ft): **189.4**  
Structural Grade: **3**  
O&M Grade: **0**  
Clock Start/From: **12**  
Clock To: **1**  
1st Value:  
2nd Value:  
Value Percent:  
Continuous Index:  
Within 8" of Joint: **YES**  
Remarks:

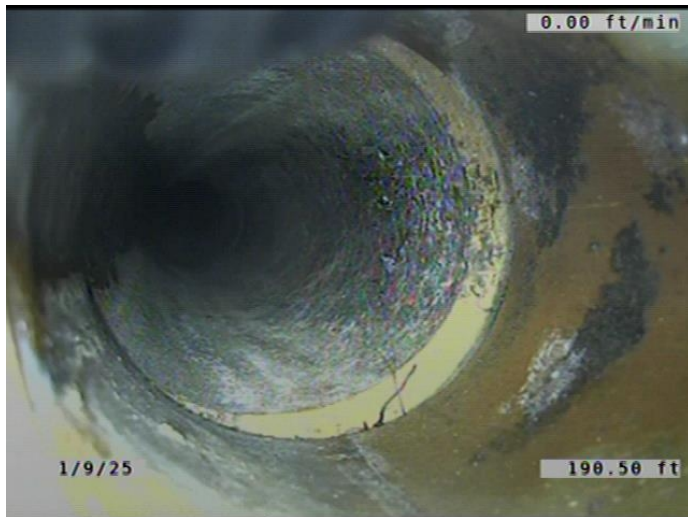
Code:	<b>TF</b>
Description:	<b>Tap Factory</b>
Distance (ft):	<b>190.5</b>
Structural Grade:	<b>0</b>
O&M Grade:	<b>0</b>
Clock Start/From:	<b>9</b>
Clock To:	
1st Value:	<b>6.000</b>
2nd Value:	
Value Percent:	
Continuous Index:	
Within 8" of Joint:	<b>YES</b>
Remarks:	<b>ROOTS GROWING IN THE JOINTS OF THE SERVICE.</b>

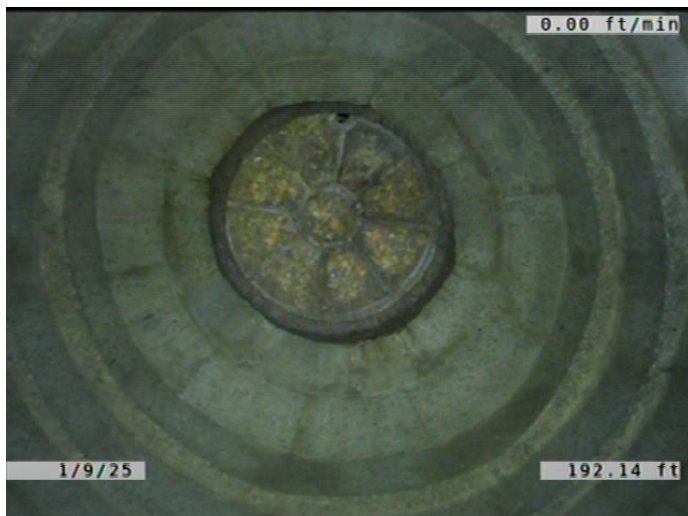
Code:	<b>AMH</b>
Description:	<b>Manhole</b>
Distance (ft):	<b>192.1</b>
Structural Grade:	<b>0</b>
O&M Grade:	<b>0</b>
Clock Start/From:	
Clock To:	
1st Value:	
2nd Value:	
Value Percent:	
Continuous Index:	
Within 8" of Joint:	<b>NO</b>
Remarks:	<b>M-804-070</b>
