Profile/Photo Observation Report

Date:	03/28/2018	Weather:		Coding:	PACP 6.0
Pipe Length (ft):	303.5	Owner:	NA	Pre Clean:	Not Known
P.O.#:		Surveyor:	Selasie Honu	PSR:	P-804-072-073
Customer:		Clean Date:	01/01/1900	Shape:	C

Street:	HIGH ST	Flow Control:	Not Controlled
City:	Hobart, IN	Year Renewed:	
Location:	Other	Tape/Media #:	
Purpose:	Not Known	Dia/Height:	10"
Use:	Sanitary	Material:	VCP
Drain Area:	NA	Lining:	
Category:	NA		
Comment:

Location Details:		Direction of Survey:	Downstream
US MH:	M-804-073	DS MH:	M-804-072
		Total Length Surveyed (ft):	302.1

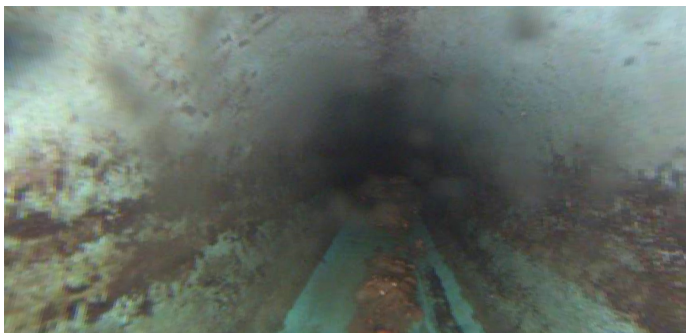
Code: **AMH**
Description: **Manhole**

Distance (ft): **.0**
Structural Grade: **0**
O&M Grade: **0**
Clock Start/From:
Clock To:
1st Value:
2nd Value:
Value Percent:
Continuous Index:
Within 8" of Joint: **NO**
Remarks: **M-804-073**

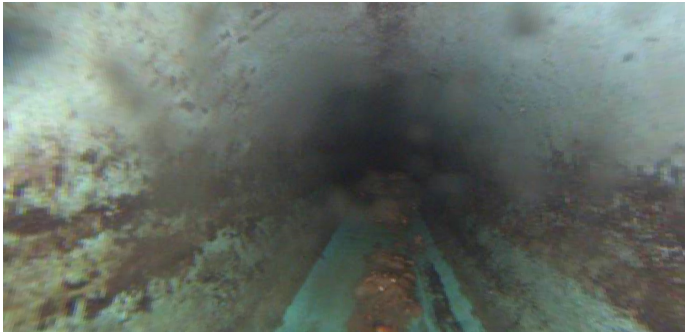
Code:	MWL
Description:	Water Level

Distance (ft):	.0
Structural Grade:	0
O&M Grade:	0
Clock Start/From:	
Clock To:	
1st Value:	
2nd Value:	
Value Percent:	5.000
Continuous Index:	
Within 8" of Joint:	NO
Remarks:

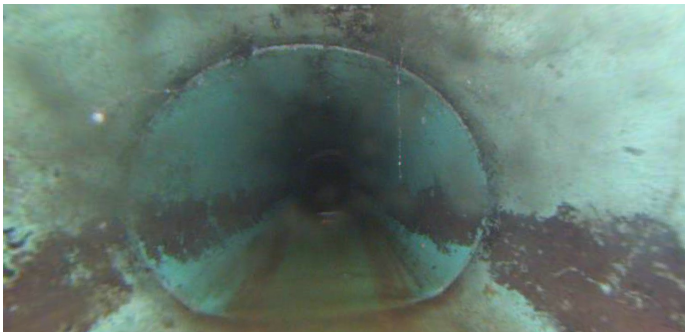
Code:	D
Description:	Deformed

Distance (ft):	13.1
Structural Grade:	4
O&M Grade:	0
Clock Start/From:	
Clock To:	
1st Value:	
2nd Value:	
Value Percent:	5.000
Continuous Index:	
Within 8" of Joint:	NO
Remarks:

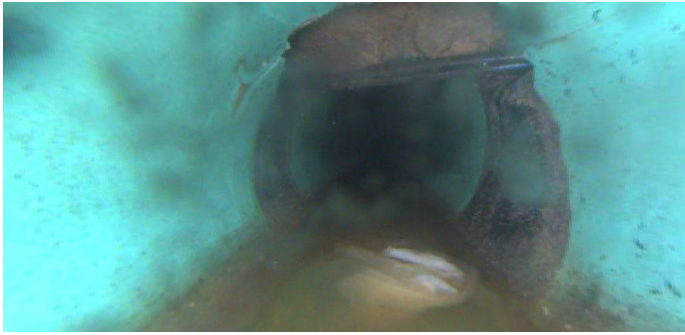
Code: **OBI**
Description: **Obstacle Intruding Thru Wall**

Distance (ft): **16.1**
Structural Grade: **0**
O&M Grade: **2**
Clock Start/From: **10**
Clock To: **2**
1st Value:
2nd Value:
Value Percent: **5.000**
Continuous Index:
Within 8" of Joint: **NO**
Remarks:

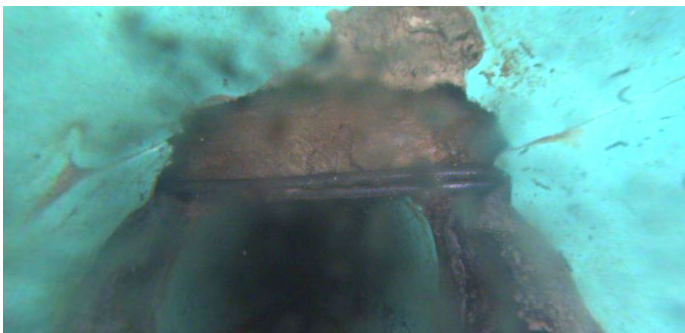
Code: **HVV**
Description: **Hole Void Visible**

Distance (ft): **16.3**
Structural Grade: **5**
O&M Grade: **0**
Clock Start/From: **10**
Clock To: **2**
1st Value:
2nd Value:
Value Percent:
Continuous Index:
Within 8" of Joint:
Remarks:

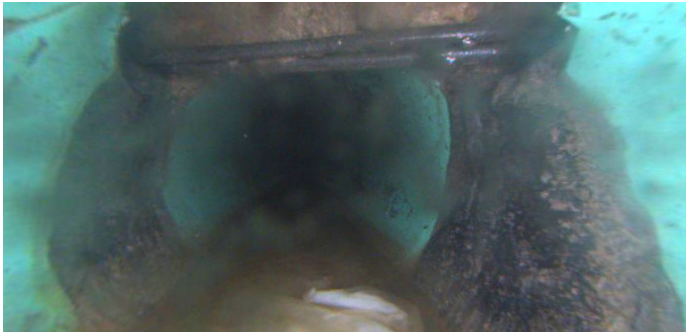
Code: **IW**
Description: **Infil Weeper**

Distance (ft): **16.3**
Structural Grade: **0**
O&M Grade: **2**
Clock Start/From: **7**
Clock To: **10**
1st Value:
2nd Value:
Value Percent:
Continuous Index:
Within 8" of Joint:
Remarks:

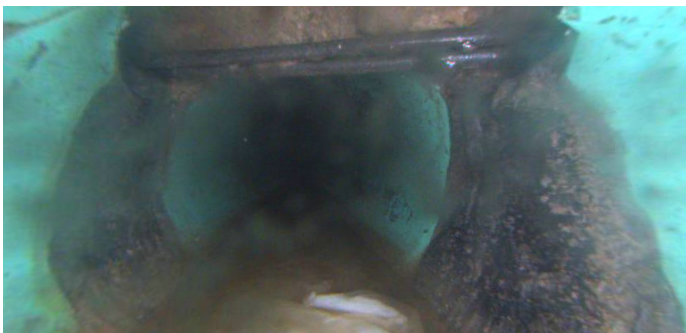
Code: **IW**
Description: **Infil Weeper**

Distance (ft): **16.3**
Structural Grade: **0**
O&M Grade: **2**
Clock Start/From: **2**
Clock To: **5**
1st Value:
2nd Value:
Value Percent:
Continuous Index:
Within 8" of Joint:
Remarks:

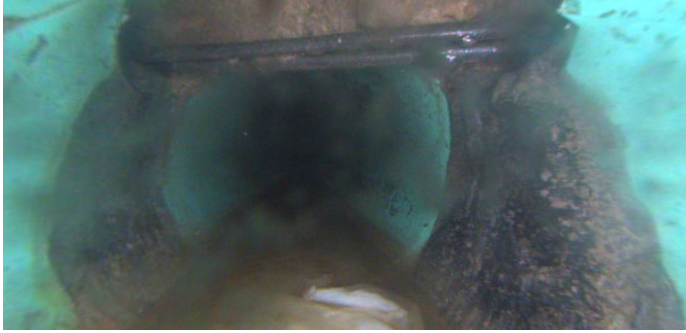
Code: **DAE**
Description: **Deposits Attached Encrustation**

Distance (ft): **16.3**
Structural Grade: **0**
O&M Grade: **2**
Clock Start/From: **8**
Clock To: **4**
1st Value:
2nd Value:
Value Percent: **5.000**
Continuous Index:
Within 8" of Joint: **NO**
Remarks:

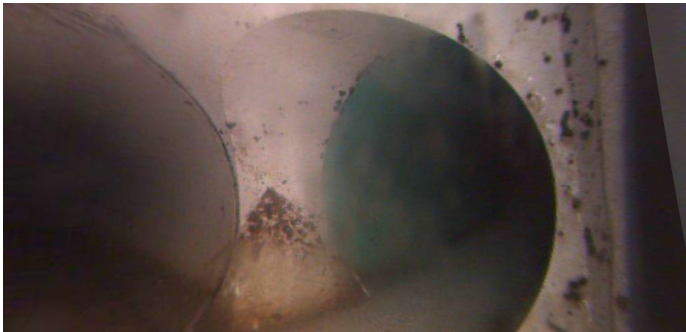
Code: **TFA**
Description: **Tap Factory Active**

Distance (ft): **96.1**
Structural Grade: **0**
O&M Grade: **0**
Clock Start/From: **9**
Clock To:
1st Value: **4.000**
2nd Value:
Value Percent:
Continuous Index:
Within 8" of Joint:
Remarks:

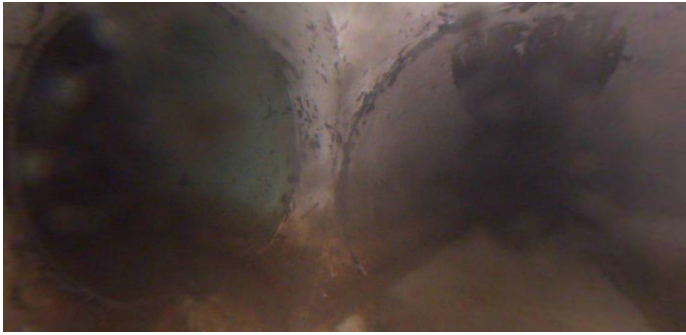
Code: **TFA**
Description: **Tap Factory Active**

Distance (ft): **225.2**
Structural Grade: **0**
O&M Grade: **0**
Clock Start/From: **9**
Clock To:
1st Value: **4.000**
2nd Value:
Value Percent:
Continuous Index:
Within 8" of Joint:
Remarks:

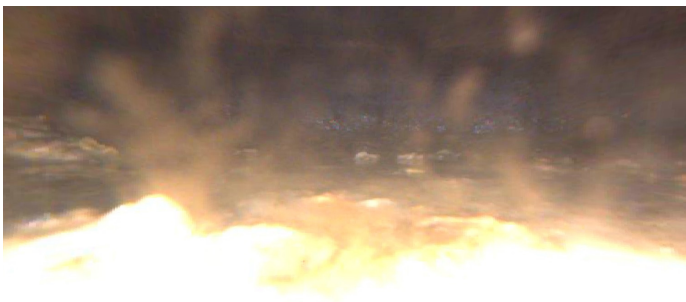
Code: **AMH**
Description: **Manhole**

Distance (ft): **302.1**
Structural Grade: **0**
O&M Grade: **0**
Clock Start/From:
Clock To:
1st Value:
2nd Value:
Value Percent:
Continuous Index:
Within 8" of Joint: **NO**
Remarks: **M-804-072**
