Profile/Photo Observation Report

Date:	10/19/2021	Weather:		Coding:	PACP 6.0
Pipe Length (ft):		Owner:	Hobart, IN	Pre Clean:	Not Known
P.O.#:	887_1	Surveyor:	M. Pielacha	PSR:	P-804-UNK-074
Customer:	Hobart, IN	Clean Date:		Shape:	C

Street:	North Indiana Street	Flow Control:	
City:	Hobart, IN	Year Renewed:	
Location:	Light Highway	Tape/Media #:	887
Purpose:	Routine Assessment	Dia/Height:	10"
Use:	Sanitary	Material:	CP
Drain Area:		Lining:	
Category:	NA		
Comment:			
Location Details:		Direction of Survey:	Upstream
US MH:	M-804-74	DS MH:	M-804-74
		Total Length Surveyed (ft):	186.3

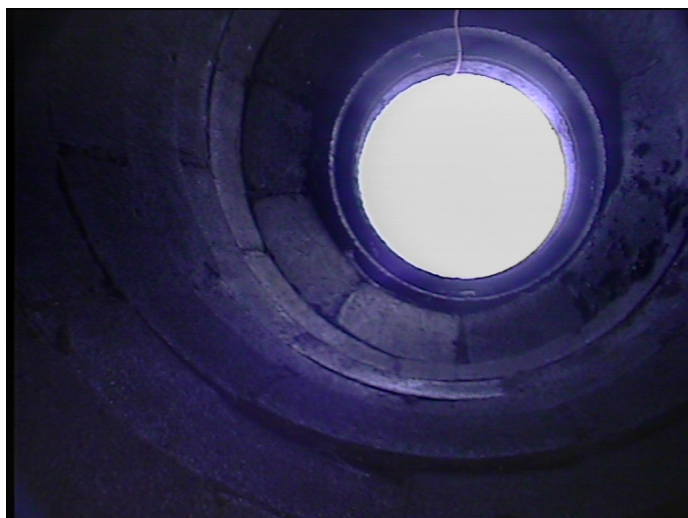
Code: **AMH**
 Description: **Manhole**

Distance (ft): **.0**
 Structural Grade: **0**
 O&M Grade: **0**
 Clock Start/From:
 Clock To:
 1st Value:
 2nd Value:
 Value Percent:
 Continuous Index:
 Within 8" of Joint: **NO**
 Remarks: **M-804-74**

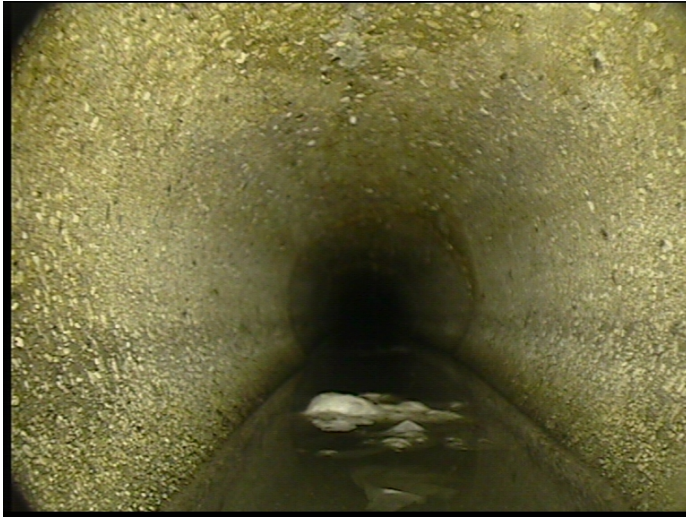
Code: **MWL**
Description: **Water Level**

Distance (ft): **.0**
Structural Grade: **0**
O&M Grade: **0**
Clock Start/From:
Clock To:
1st Value:
2nd Value:
Value Percent: **5.000**
Continuous Index:
Within 8" of Joint: **NO**
Remarks:

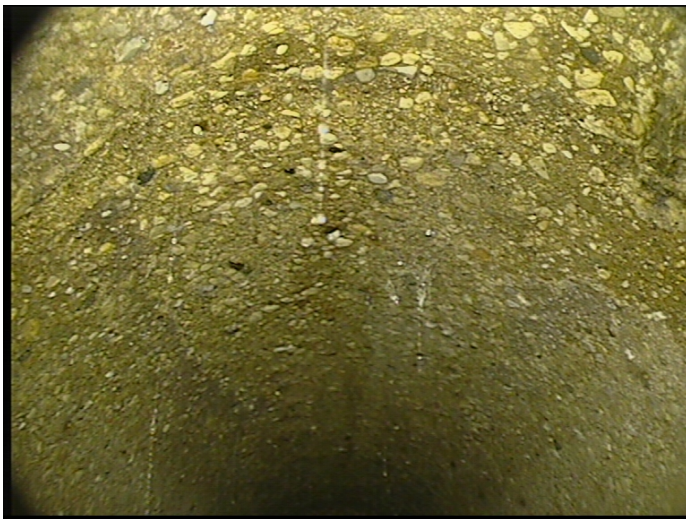
Code: **SAV**
Description: **Surface Aggregate Visible**

Distance (ft): **5.7**
Structural Grade: **3**
O&M Grade: **0**
Clock Start/From: **8**
Clock To: **4**
1st Value:
2nd Value:
Value Percent:
Continuous Index: **S01**
Within 8" of Joint: **YES**
Remarks:

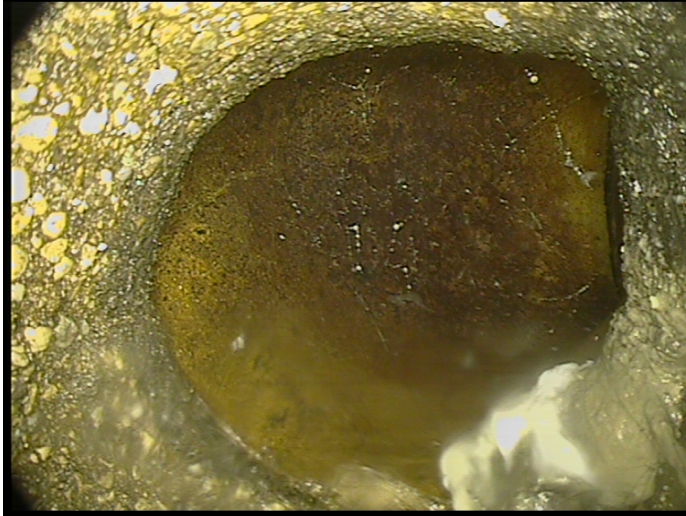
Code: **TB**
Description: **Tap Break-in**

Distance (ft): **14.9**
Structural Grade: **0**
O&M Grade: **0**
Clock Start/From: **12**
Clock To:
1st Value: **4.000**
2nd Value:
Value Percent:
Continuous Index:
Within 8" of Joint: **NO**
Remarks:

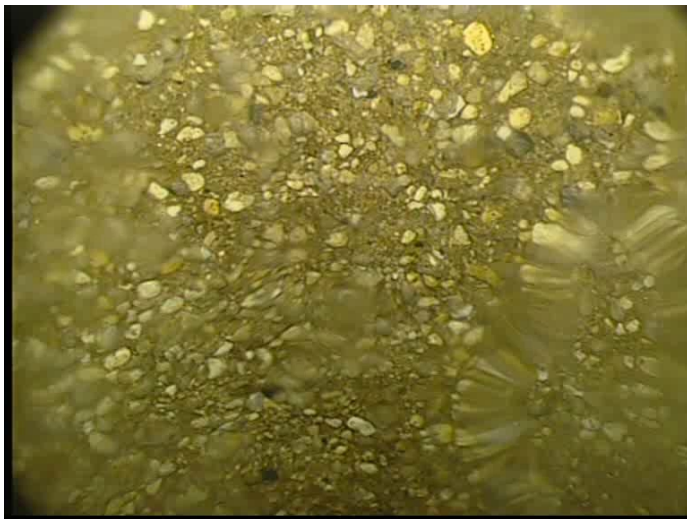
Code:	SAV
Description:	Surface Aggregate Visible
Distance (ft):	30.4
Structural Grade:	3
O&M Grade:	0
Clock Start/From:	9
Clock To:	3
1st Value:	
2nd Value:	
Value Percent:	
Continuous Index:	
Within 8" of Joint:	NO
Remarks:

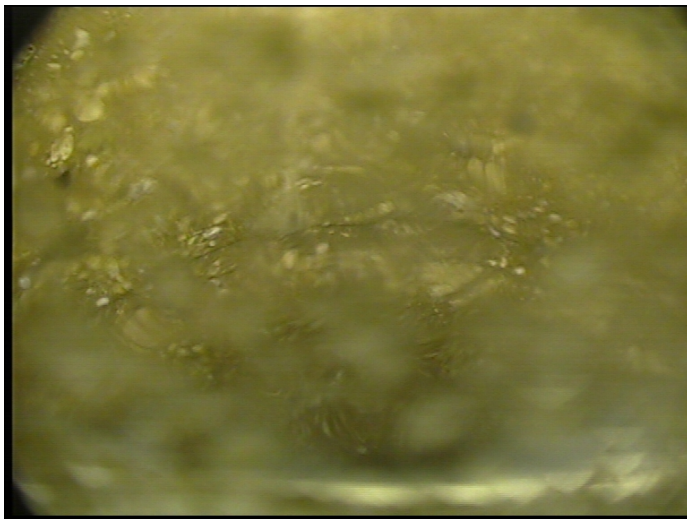
Code: **MWL**
Description: **Water Level**

Distance (ft): **34.0**
Structural Grade: **0**
O&M Grade: **0**
Clock Start/From:
Clock To:
1st Value:
2nd Value:
Value Percent: **50.000**
Continuous Index:
Within 8" of Joint: **NO**
Remarks:

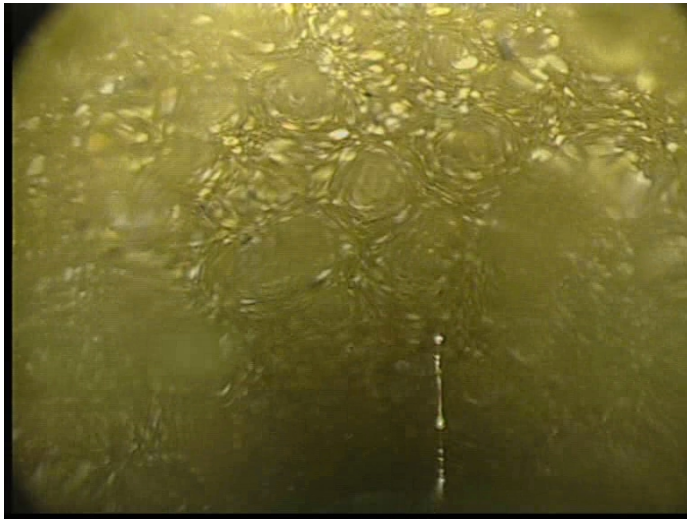
Code: **SAV**
Description: **Surface Aggregate Visible**

Distance (ft): **43.3**
Structural Grade: **3**
O&M Grade: **0**
Clock Start/From: **8**
Clock To: **4**
1st Value:
2nd Value:
Value Percent:
Continuous Index: **S03**
Within 8" of Joint: **NO**
Remarks:

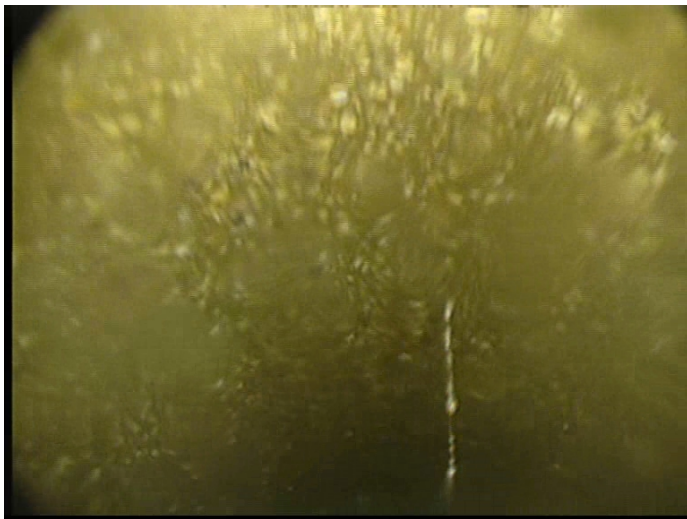
Code: **MCU**
Description: **Camera Underwater**

Distance (ft): **43.4**
Structural Grade: **0**
O&M Grade: **4**
Clock Start/From:
Clock To:
1st Value:
2nd Value:
Value Percent:
Continuous Index: **F02**
Within 8" of Joint: **NO**
Remarks:

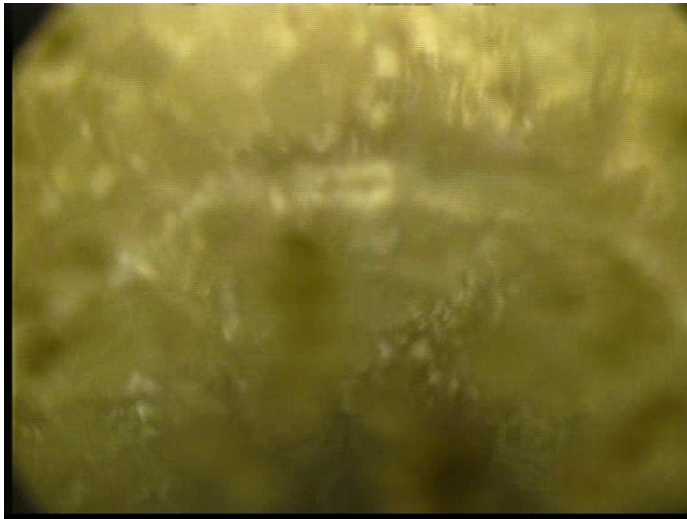
Code: **MCU**
Description: **Camera Underwater**

Distance (ft): **54.5**
Structural Grade: **0**
O&M Grade: **4**
Clock Start/From:
Clock To:
1st Value:
2nd Value:
Value Percent:
Continuous Index: **F04**
Within 8" of Joint: **NO**
Remarks:

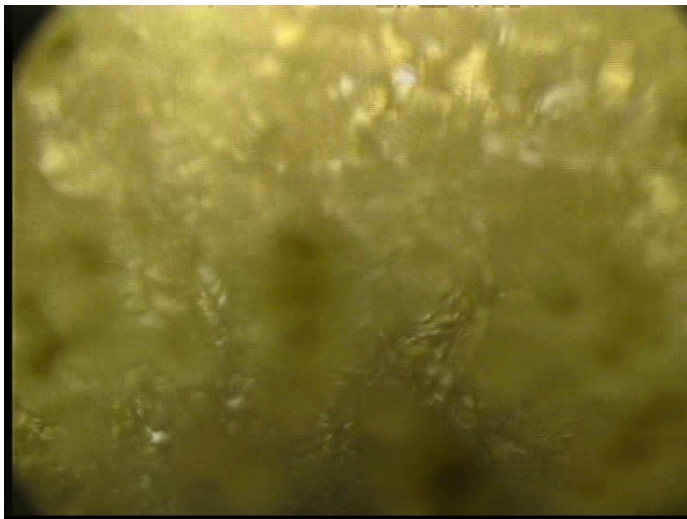
Code: **SAV**
Description: **Surface Aggregate Visible**

Distance (ft): **55.2**
Structural Grade: **3**
O&M Grade: **0**
Clock Start/From: **8**
Clock To: **4**
1st Value:
2nd Value:
Value Percent:
Continuous Index: **S05**
Within 8" of Joint: **NO**
Remarks:

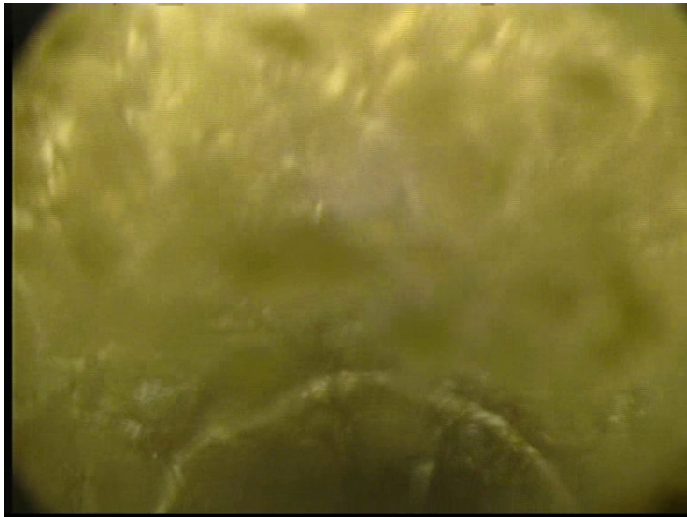
Code:	MGO
Description:	General Observation
Distance (ft):	62.6
Structural Grade:	0
O&M Grade:	0
Clock Start/From:	
Clock To:	
1st Value:	
2nd Value:	
Value Percent:	
Continuous Index:	
Within 8" of Joint:	NO
Remarks:	Camera obscured by grime

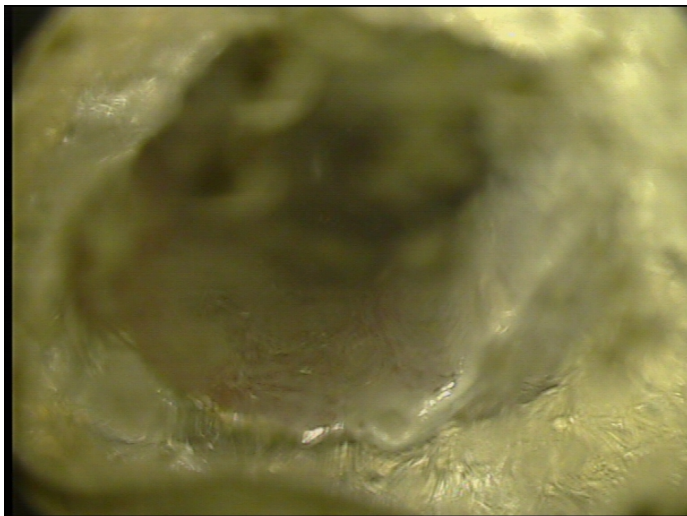
Code:	TBA
Description:	Tap Break-in Active
Distance (ft):	74.9
Structural Grade:	0
O&M Grade:	0
Clock Start/From:	10
Clock To:	
1st Value:	4.000
2nd Value:	
Value Percent:	
Continuous Index:	
Within 8" of Joint:	NO
Remarks:

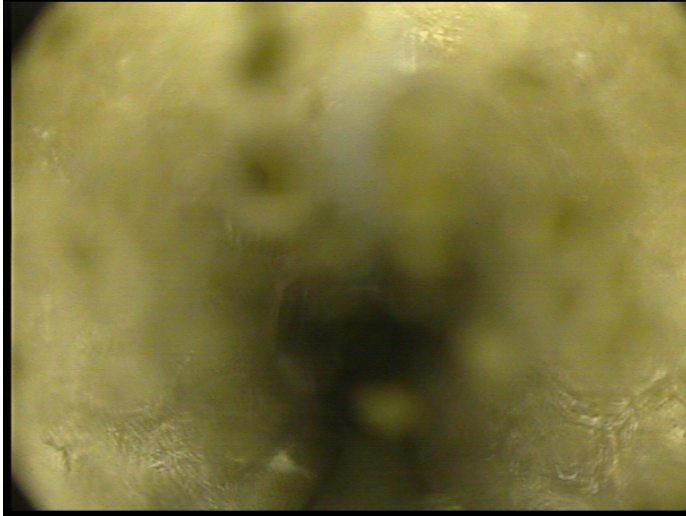
Code: **MWL**
Description: **Water Level**

Distance (ft): **99.1**
Structural Grade: **0**
O&M Grade: **0**
Clock Start/From:
Clock To:
1st Value:
2nd Value:
Value Percent: **5.000**
Continuous Index:
Within 8" of Joint: **NO**
Remarks:

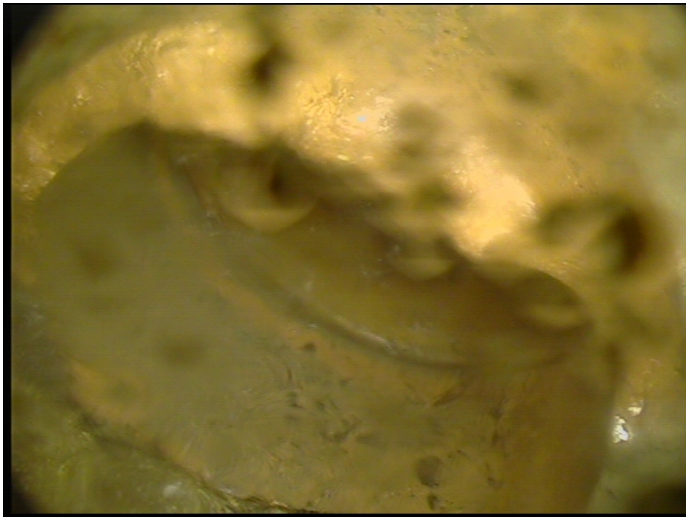
Code: **TB**
Description: **Tap Break-in**

Distance (ft): **141.9**
Structural Grade: **0**
O&M Grade: **0**
Clock Start/From: **3**
Clock To:
1st Value: **4.000**
2nd Value:
Value Percent:
Continuous Index:
Within 8" of Joint: **NO**
Remarks:

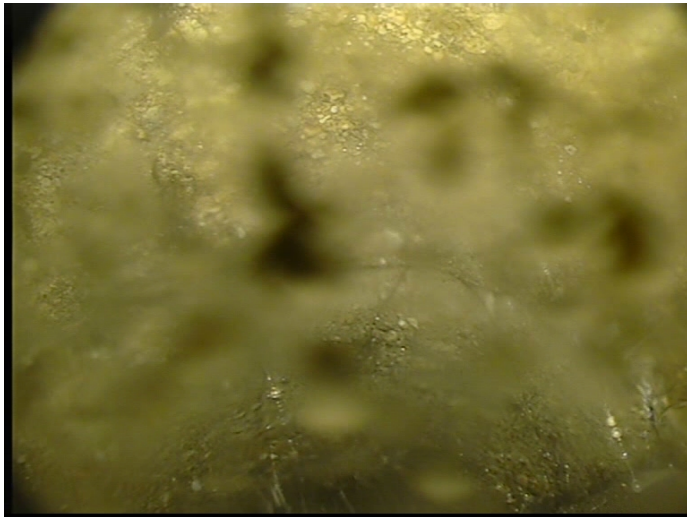
Code:	SAV
Description:	Surface Aggregate Visible
Distance (ft):	185.9
Structural Grade:	3
O&M Grade:	0
Clock Start/From:	8
Clock To:	4
1st Value:	
2nd Value:	
Value Percent:	
Continuous Index:	F05
Within 8" of Joint:	NO
Remarks:

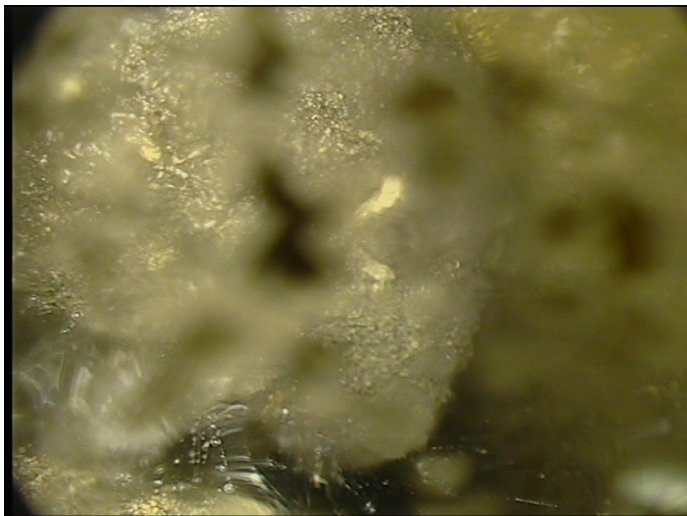
Code:	RMJ
Description:	Roots Medium Joint
Distance (ft):	186.0
Structural Grade:	0
O&M Grade:	3
Clock Start/From:	8
Clock To:	4
1st Value:	
2nd Value:	
Value Percent:	30.000
Continuous Index:	
Within 8" of Joint:	YES
Remarks:

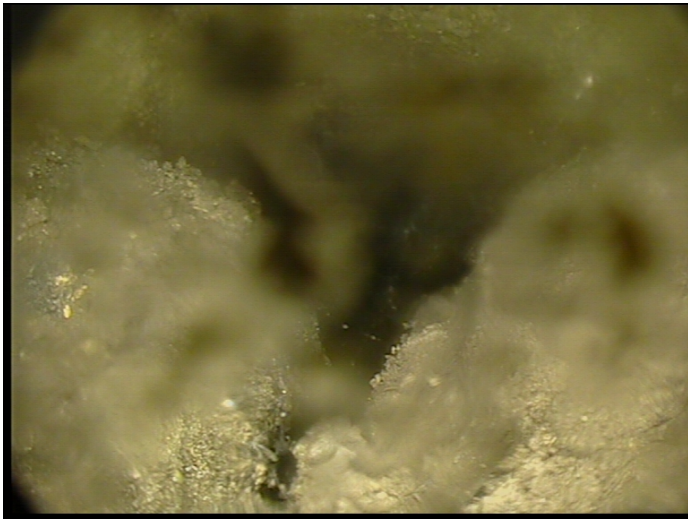
Code:	MSA
Description:	Abandoned Survey
Distance (ft):	186.0
Structural Grade:	0
O&M Grade:	0
Clock Start/From:	
Clock To:	
1st Value:	
2nd Value:	
Value Percent:	
Continuous Index:	
Within 8" of Joint:	NO
Remarks:	Large Roots
