Profile/Photo Observation Report

Profile/Photo Observation Report								
Date: Pipe Length (f	10/19/2021 it):	Weather: Owner:	Hobart,	IN	G	PACP 6.0 Not Known		
P.O.#:	888_1	Surveyor:	M. Piela	icha	PSR:	P-804-UNK-074		
Customer:	Hobart, IN	Clean Date:			Shape:	С		
Street: Off Indiana Street		Flow Control:		Not Controlled	Not Controlled			
City:	Hobart, IN		Year Rene	ewed:				
Location:	ocation: Yard		Tape/Media #:		888	888		
Purpose:	Reversal		Dia/Heigh	nt:	10"			
Use:	Sanitary		Material:		СР			
Drain Area:			Lining:					
Category:	NA							
Comment:								
Location Deta	ils:		Direction	of Survey:	Downstream			
US MH:	M-804-74	DS MH:	M-804-74		Total Length Surveyed (ft):	.1		
O&M Index:	4.00	O&M Quick:		4100	O&M Rating:	4.00		
Structural Index	O.00	— Structural Qu	uick:	0000	Structural Rating:	0.00		
Overall Index:	4.00	Overall Quicl	k:	4100	Overall Rating:	4.00

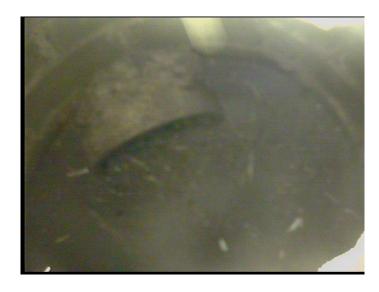
Code: MWL
Description: Water Level

Distance (ft): .0
Structural Grade: 0
O&M Grade: 0

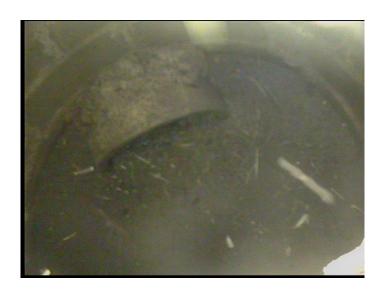
Code: **DSF**

Description: Deposits Settled Fine

Distance (ft): .0
Structural Grade: 0
O&M Grade: 4
Clock Start/From: 4
Clock To: 8
1st Value:
2nd Value:

Value Percent: **30.000**

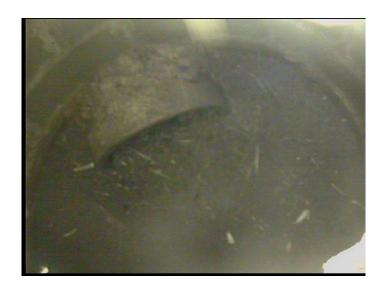
Code: MSA

Description: Abandoned Survey

Remarks: deep sdiment
