## Profile/Photo Observation Report

Date:	<b>10/11/2021</b>	Weather:		Coding:	<b>PACP 7.0</b>
Pipe Length (ft):	<b>84.8</b>	Owner:	<b>City of Hobart</b>	Pre Clean:	<b>Heavy Cleaning</b>
P.O.#:	<b>YES502259</b>	Surveyor:	<b>S. Bucklin</b>	PSR:	<b>P-804-016-077</b>
Customer:	<b>City of Hobart</b>	Clean Date:	<b>10/09/2021</b>	Shape:	<b>C</b>

Street:	<b>East Home Avenue</b>	Flow Control:	<b>Not Controlled</b>
City:	<b>Hobart, IN</b>	Year Renewed:	
Location:	<b>Local rural streets with light traffic, t</b>	Tape/Media #:	
Purpose:	<b>Routine Assessment</b>	Dia/Height:	<b>12"</b>
Use:	<b>Sanitary Sewage Pipe</b>	Material:	<b>VCP</b>
Drain Area:		Lining:	
Category:	<b>NA</b>		
Comment:			
Location Details:		Direction of Survey:	<b>Downstream</b>
US MH:	<b>M-804-077</b>	DS MH:	<b>M-804-016</b>
		Total Length Surveyed (ft):	<b>84.8</b>

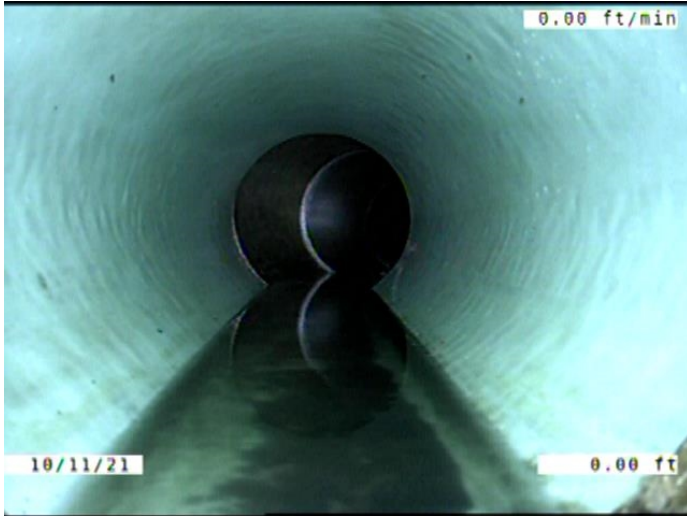
Code:	<b>MWL</b>
Description:	<b>Miscellaneous Water Level</b>
Distance (ft):	<b>.0</b>
Structural Grade:	<b>0</b>
O&M Grade:	<b>0</b>
Clock Start/From:	
Clock To:	
1st Value:	
2nd Value:	
Value Percent:	<b>5.000</b>
Continuous Index:	
Within 8" of Joint:	<b>NO</b>
Remarks:

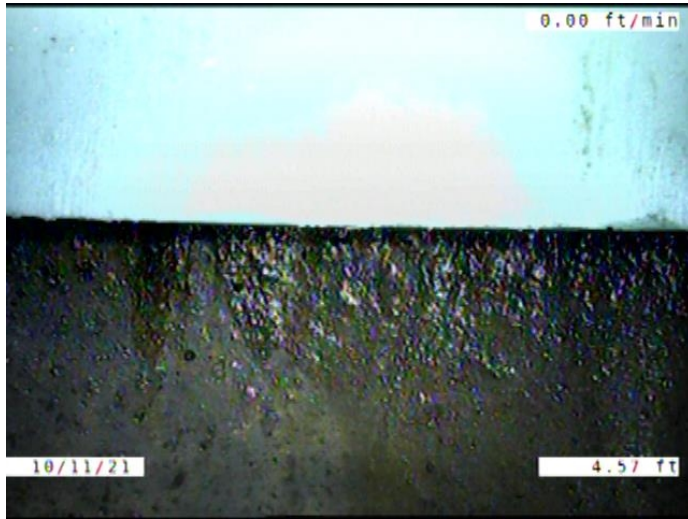
Code: **MMC**  
Description: **Miscellaneous Material Change**

Distance (ft): **4.6**  
Structural Grade: **0**  
O&M Grade: **0**  
Clock Start/From:  
Clock To:  
1st Value:  
2nd Value:  
Value Percent:  
Continuous Index:  
Within 8" of Joint: **NO**  
Remarks: **PVC to VCP**

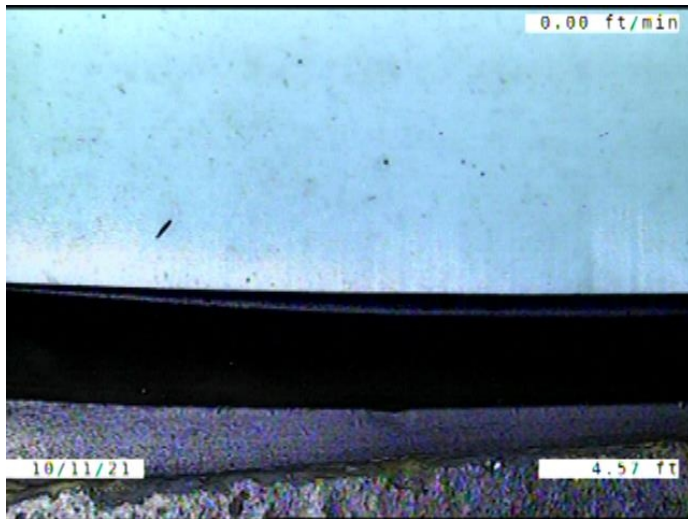
Code: **JAM**  
Description: **Joint Angular Medium**

Distance (ft): **4.6**  
Structural Grade: **3**  
O&M Grade: **0**  
Clock Start/From:  
Clock To:  
1st Value:  
2nd Value:  
Value Percent:  
Continuous Index:  
Within 8" of Joint: **NO**  
Remarks:

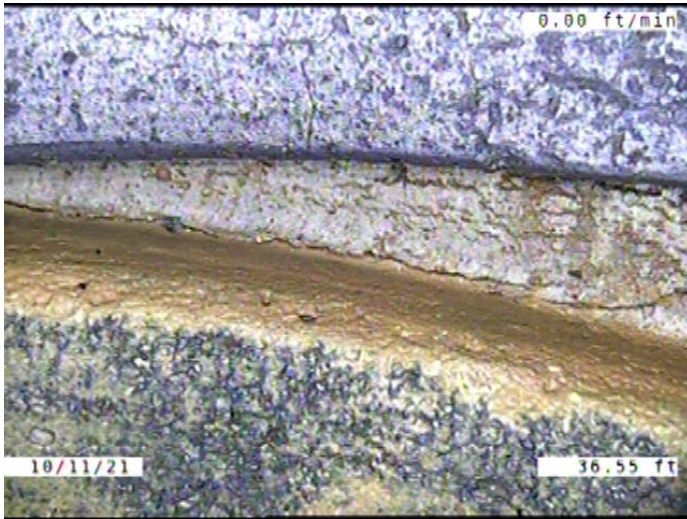
Code: **JAM**  
 Description: **Joint Angular Medium**

Distance (ft): **36.5**  
 Structural Grade: **3**  
 O&M Grade: **0**  
 Clock Start/From:  
 Clock To:  
 1st Value:  
 2nd Value:  
 Value Percent:  
 Continuous Index:  
 Within 8" of Joint: **NO**  
 Remarks:

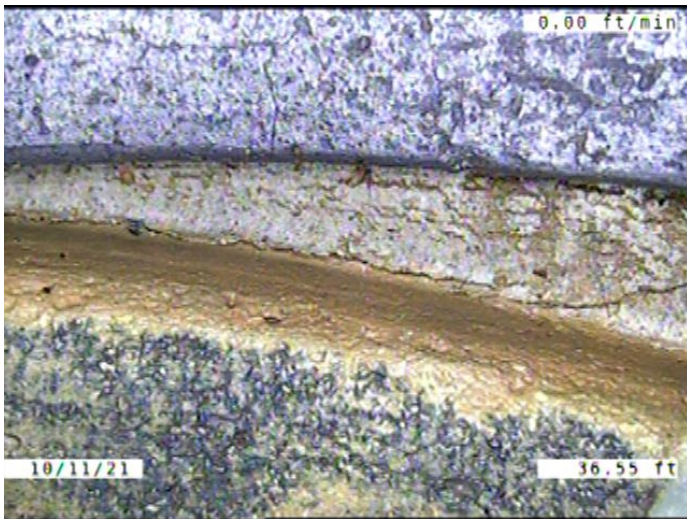
Code: **CM**  
 Description: **Crack Multiple**

Distance (ft): **36.5**  
 Structural Grade: **3**  
 O&M Grade: **0**  
 Clock Start/From: **12**  
 Clock To: **3**  
 1st Value:  
 2nd Value:  
 Value Percent:  
 Continuous Index:  
 Within 8" of Joint: **YES**  
 Remarks:

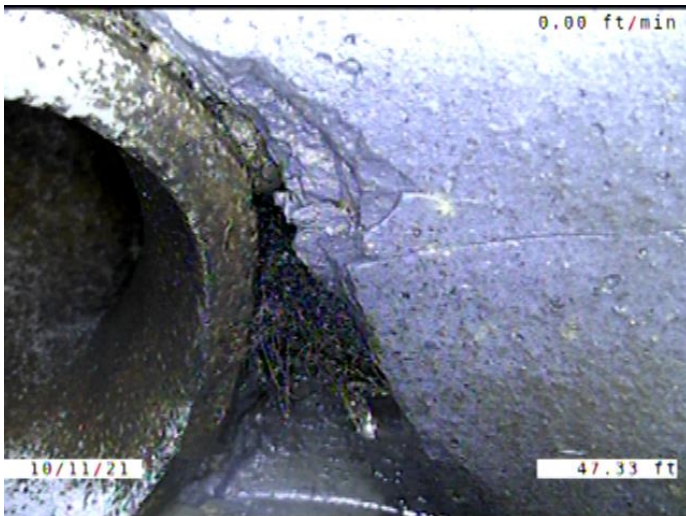
Code: **SSS**  
Description: **Surface Damage Surface Spalling**

Distance (ft): **47.3**  
Structural Grade: **2**  
O&M Grade: **0**  
Clock Start/From: **9**  
Clock To: **3**  
1st Value:  
2nd Value:  
Value Percent:  
Continuous Index:  
Within 8" of Joint: **YES**  
Remarks:

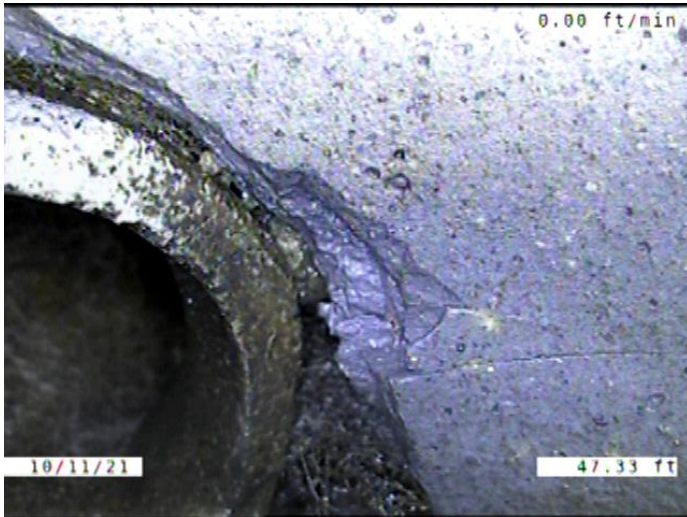
Code:	<b>RFB</b>
Description:	<b>Roots Fine Barrel</b>
Distance (ft):	<b>47.3</b>
Structural Grade:	<b>0</b>
O&M Grade:	<b>2</b>
Clock Start/From:	<b>11</b>
Clock To:	<b>1</b>
1st Value:	
2nd Value:	
Value Percent:	
Continuous Index:	
Within 8" of Joint:	<b>NO</b>
Remarks:	<b>CAP LOOKS TO BE WOOD AND ROTTING AWAY</b>

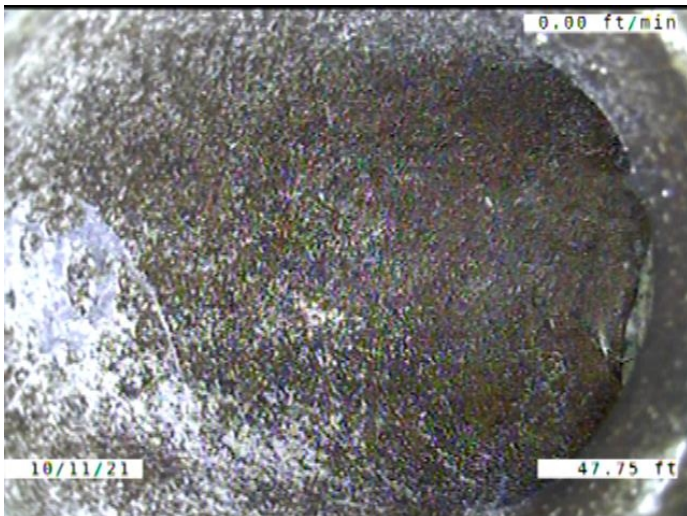
Code:	<b>TB</b>
Description:	<b>Tap Break-in/Hammer</b>
Distance (ft):	<b>47.8</b>
Structural Grade:	<b>0</b>
O&M Grade:	<b>0</b>
Clock Start/From:	<b>12</b>
Clock To:	
1st Value:	<b>4.000</b>
2nd Value:	
Value Percent:	
Continuous Index:	
Within 8" of Joint:	<b>YES</b>
Remarks:

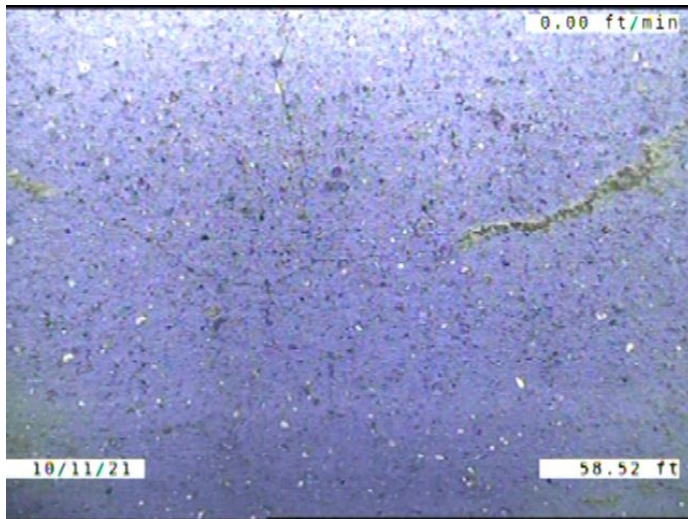
Code: **CM**  
Description: **Crack Multiple**

Distance (ft): **58.5**  
Structural Grade: **3**  
O&M Grade: **0**  
Clock Start/From: **10**  
Clock To: **2**  
1st Value:  
2nd Value:  
Value Percent:  
Continuous Index:  
Within 8" of Joint: **YES**  
Remarks: **CAP MISSING SOIL VISIBLE**

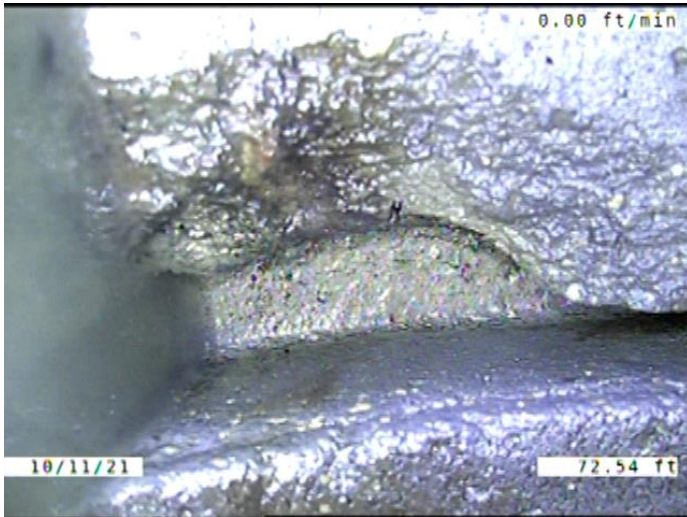
Code: **SMW**  
Description: **Surface Damage Missing Wall**

Distance (ft): **72.5**  
Structural Grade: **5**  
O&M Grade: **0**  
Clock Start/From: **8**  
Clock To: **9**  
1st Value:  
2nd Value:  
Value Percent:  
Continuous Index:  
Within 8" of Joint: **YES**  
Remarks:

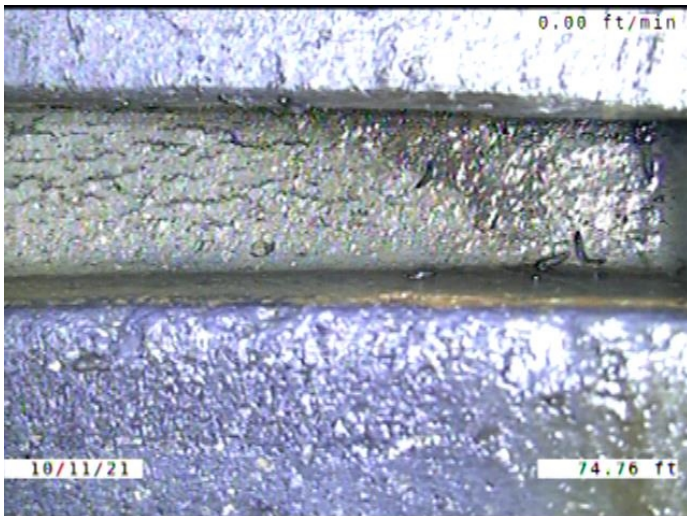
Code: **JAM**  
Description: **Joint Angular Medium**

Distance (ft): **74.8**  
Structural Grade: **3**  
O&M Grade: **0**  
Clock Start/From:  
Clock To:  
1st Value:  
2nd Value:  
Value Percent:  
Continuous Index:  
Within 8" of Joint: **NO**  
Remarks:
