## Profile/Photo Observation Report

Date:	<b>10/11/2021</b>	Weather:		Coding:	<b>PACP 7.0</b>
Pipe Length (ft):	<b>84.8</b>	Owner:	<b>City of Hobart</b>	Pre Clean:	<b>Heavy Cleaning</b>
P.O.#:	<b>YES502259</b>	Surveyor:	<b>S. Bucklin</b>	PSR:	<b>P-804-016-077</b>
Customer:	<b>City of Hobart</b>	Clean Date:	<b>10/09/2021</b>	Shape:	<b>C</b>

Street:	<b>East Home Avenue</b>	Flow Control:	<b>Not Controlled</b>
City:	<b>Hobart, IN</b>	Year Renewed:	
Location:	<b>Local rural streets with light traffic, t</b>	Tape/Media #:	
Purpose:	<b>Routine Assessment</b>	Dia/Height:	<b>12"</b>
Use:	<b>Sanitary Sewage Pipe</b>	Material:	<b>VCP</b>
Drain Area:		Lining:	
Category:	<b>NA</b>		
Comment:			
Location Details:		Direction of Survey:	<b>Downstream</b>
US MH:	<b>M-804-077</b>	DS MH:	<b>M-804-016</b>
		Total Length Surveyed (ft):	<b>84.8</b>

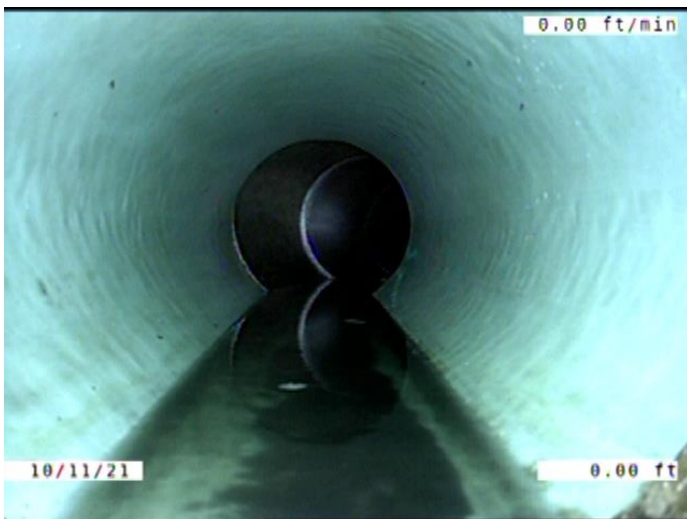
Code:	<b>DSF</b>
Description:	<b>Deposits Settled Fine</b>
Distance (ft):	<b>.0</b>
Structural Grade:	<b>0</b>
O&M Grade:	<b>2</b>
Clock Start/From:	<b>5</b>
Clock To:	<b>7</b>
1st Value:	
2nd Value:	
Value Percent:	<b>5.000</b>
Continuous Index:	<b>S01</b>
Within 8" of Joint:	<b>YES</b>
Remarks:

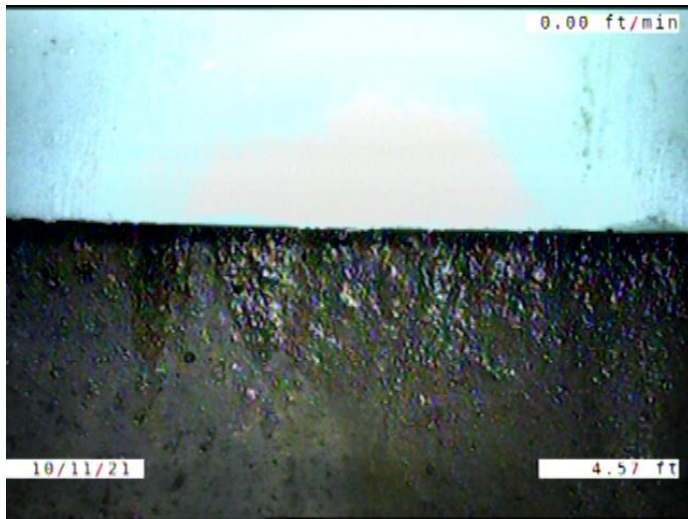
Code: **MMC**  
 Description: **Miscellaneous Material Change**

Distance (ft): **4.6**  
 Structural Grade: **0**  
 O&M Grade: **0**  
 Clock Start/From:  
 Clock To:  
 1st Value:  
 2nd Value:  
 Value Percent:  
 Continuous Index:  
 Within 8" of Joint: **NO**  
 Remarks: **PVC to VCP**

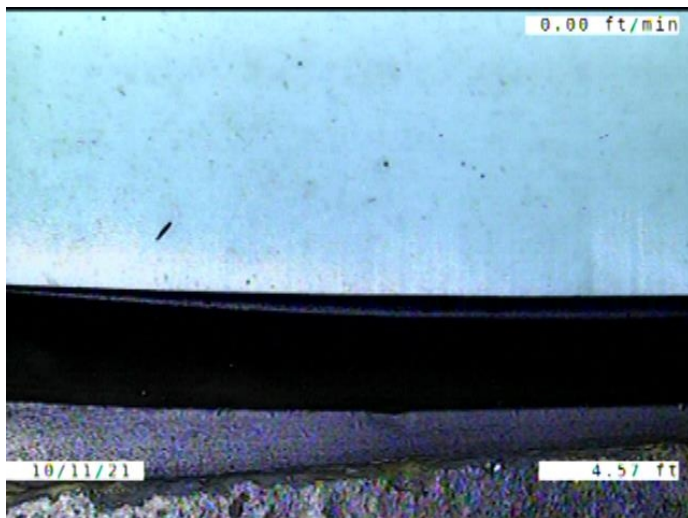
Code: **JAM**  
 Description: **Joint Angular Medium**

Distance (ft): **4.6**  
 Structural Grade: **3**  
 O&M Grade: **0**  
 Clock Start/From:  
 Clock To:  
 1st Value:  
 2nd Value:  
 Value Percent:  
 Continuous Index:  
 Within 8" of Joint: **NO**  
 Remarks:

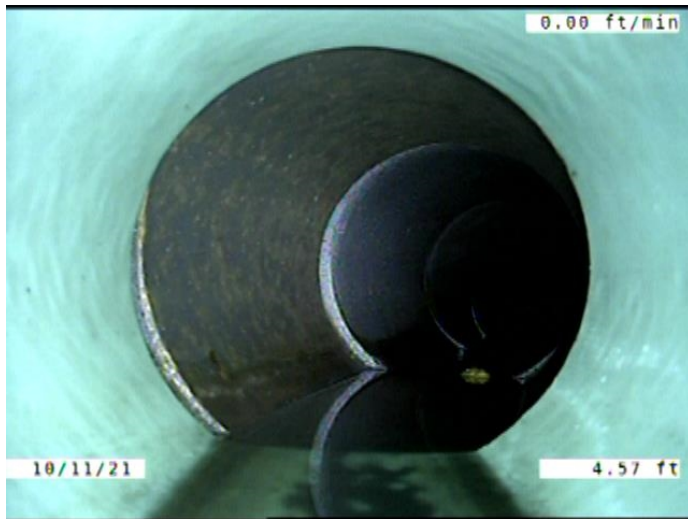
Code: **LR**  
Description: **Line Right**

Distance (ft): **4.6**  
Structural Grade: **0**  
O&M Grade: **1**  
Clock Start/From:  
Clock To:  
1st Value:  
2nd Value:  
Value Percent: **10.000**  
Continuous Index:  
Within 8" of Joint: **NO**  
Remarks:

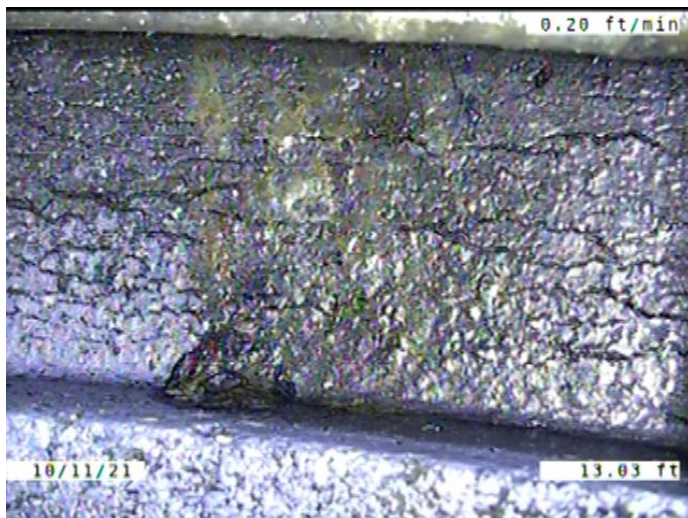
Code: **JAM**  
Description: **Joint Angular Medium**

Distance (ft): **13.0**  
Structural Grade: **3**  
O&M Grade: **0**  
Clock Start/From:  
Clock To:  
1st Value:  
2nd Value:  
Value Percent:  
Continuous Index:  
Within 8" of Joint: **NO**  
Remarks:

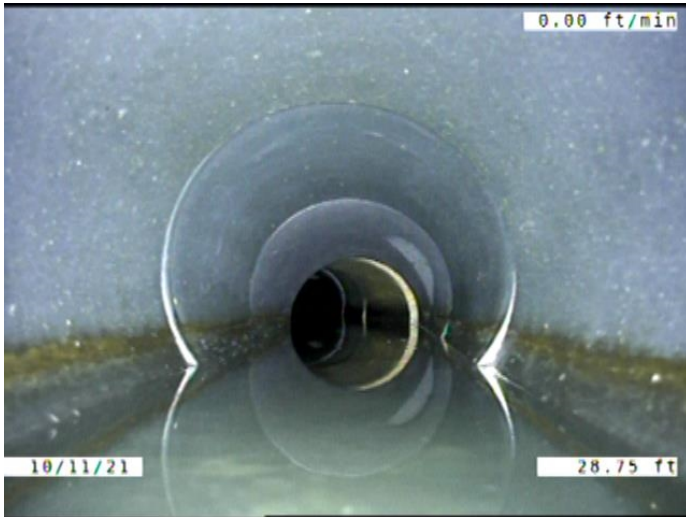
Code: **MWLS**  
 Description: **Miscellaneous Water Level Sag**

Distance (ft): **28.7**  
 Structural Grade: **2**  
 O&M Grade: **0**  
 Clock Start/From:  
 Clock To:  
 1st Value:  
 2nd Value:  
 Value Percent: **30.000**  
 Continuous Index: **S02**  
 Within 8" of Joint: **NO**  
 Remarks:

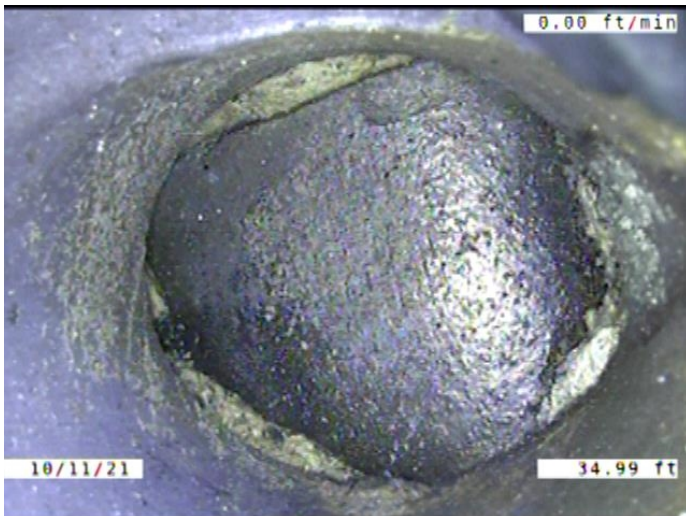
Code: **TFD**  
 Description: **Tap Factory Defective**

Distance (ft): **35.0**  
 Structural Grade: **0**  
 O&M Grade: **3**  
 Clock Start/From: **2**  
 Clock To:  
 1st Value: **4.000**  
 2nd Value:  
 Value Percent:  
 Continuous Index:  
 Within 8" of Joint: **YES**  
 Remarks: **Defective**

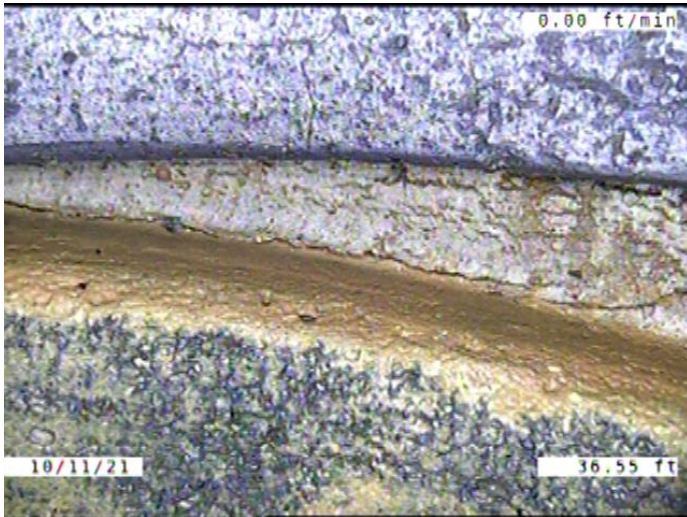
Code: **JAM**  
 Description: **Joint Angular Medium**

Distance (ft): **36.5**  
 Structural Grade: **3**  
 O&M Grade: **0**  
 Clock Start/From:  
 Clock To:  
 1st Value:  
 2nd Value:  
 Value Percent:  
 Continuous Index:  
 Within 8" of Joint: **NO**  
 Remarks:

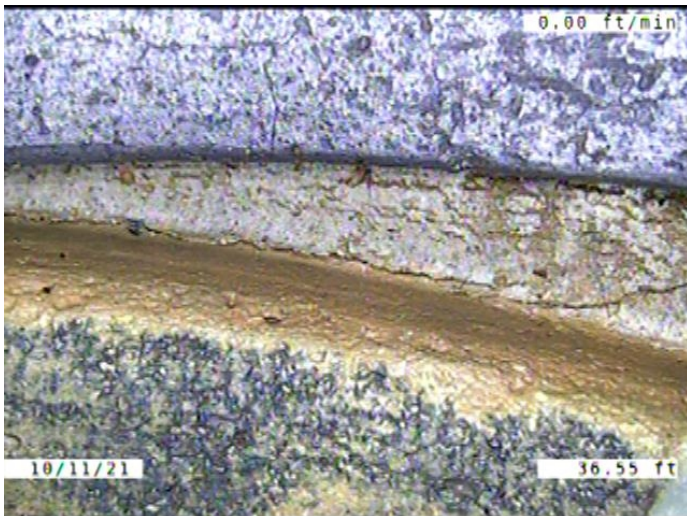
Code: **CM**  
 Description: **Crack Multiple**

Distance (ft): **36.5**  
 Structural Grade: **3**  
 O&M Grade: **0**  
 Clock Start/From: **12**  
 Clock To: **3**  
 1st Value:  
 2nd Value:  
 Value Percent:  
 Continuous Index:  
 Within 8" of Joint: **YES**  
 Remarks:

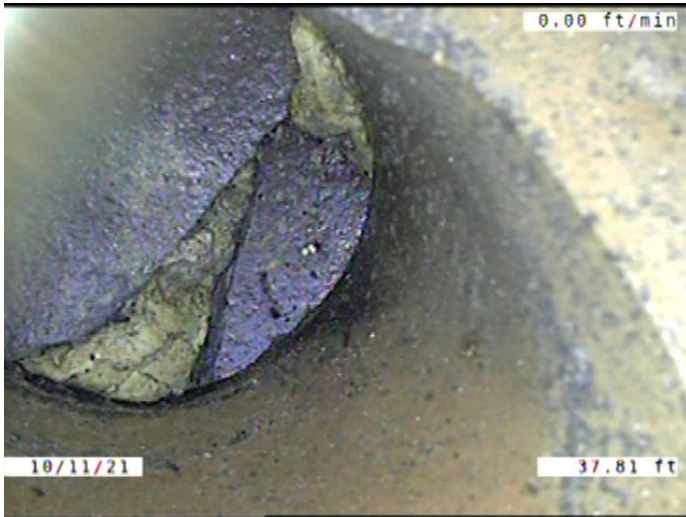
Code: **TFD**  
 Description: **Tap Factory Defective**

Distance (ft): **37.8**  
 Structural Grade: **0**  
 O&M Grade: **3**  
 Clock Start/From: **11**  
 Clock To:  
 1st Value: **4.000**  
 2nd Value:  
 Value Percent:  
 Continuous Index:  
 Within 8" of Joint: **YES**  
 Remarks: **Defective**

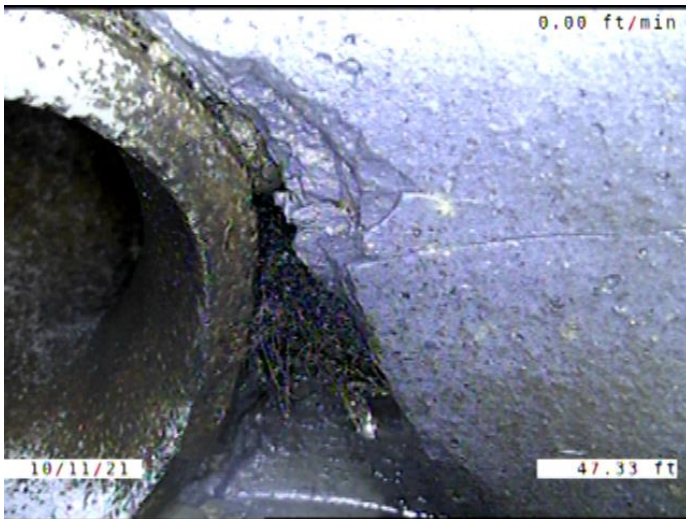
Code: **SSS**  
 Description: **Surface Damage Surface Spalling**

Distance (ft): **47.3**  
 Structural Grade: **2**  
 O&M Grade: **0**  
 Clock Start/From: **9**  
 Clock To: **3**  
 1st Value:  
 2nd Value:  
 Value Percent:  
 Continuous Index:  
 Within 8" of Joint: **YES**  
 Remarks:

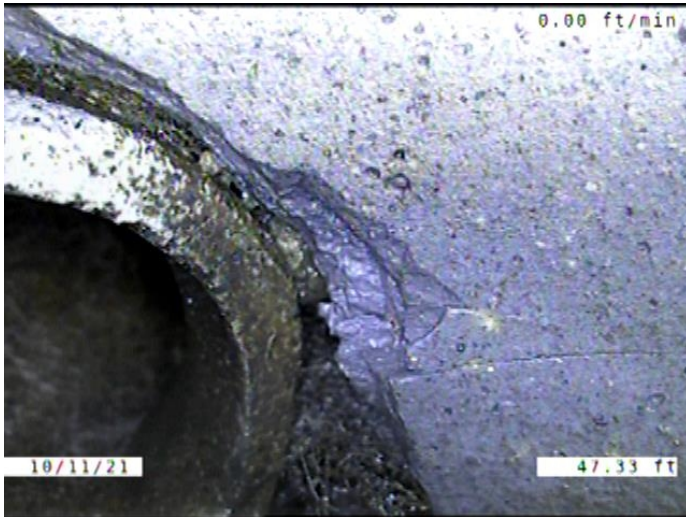
Code: **RFB**  
 Description: **Roots Fine Barrel**

Distance (ft): **47.3**  
 Structural Grade: **0**  
 O&M Grade: **2**  
 Clock Start/From: **11**  
 Clock To: **1**  
 1st Value:  
 2nd Value:  
 Value Percent:  
 Continuous Index:  
 Within 8" of Joint: **NO**  
 Remarks: **CAP LOOKS TO BE WOOD AND ROTTING AWAY**

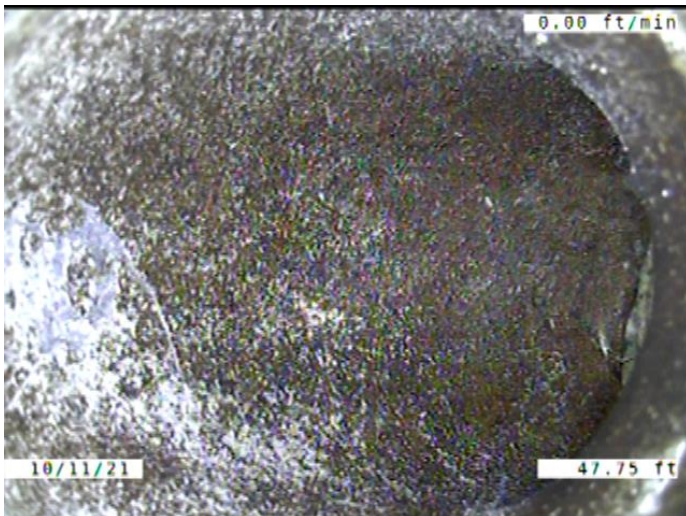
Code: **TB**  
 Description: **Tap Break-in/Hammer**

Distance (ft): **47.8**  
 Structural Grade: **0**  
 O&M Grade: **0**  
 Clock Start/From: **12**  
 Clock To:  
 1st Value: **4.000**  
 2nd Value:  
 Value Percent:  
 Continuous Index:  
 Within 8" of Joint: **YES**  
 Remarks:

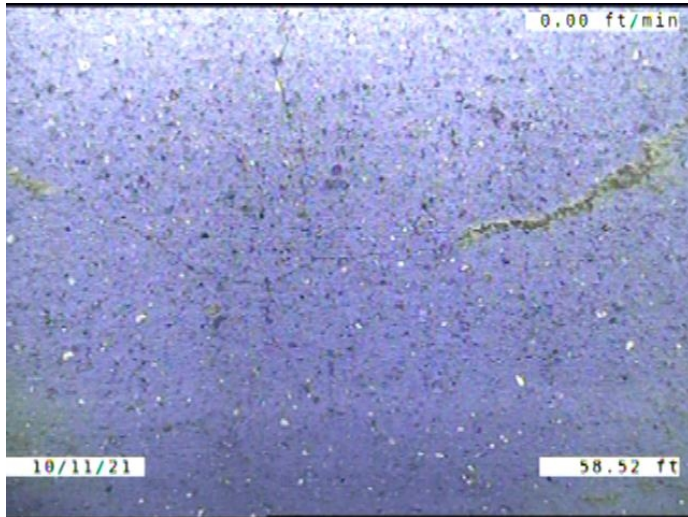
Code: **CM**  
 Description: **Crack Multiple**

Distance (ft): **58.5**  
 Structural Grade: **3**  
 O&M Grade: **0**  
 Clock Start/From: **10**  
 Clock To: **2**  
 1st Value:  
 2nd Value:  
 Value Percent:  
 Continuous Index:  
 Within 8" of Joint: **YES**  
 Remarks: **CAP MISSING SOIL VISIBLE**

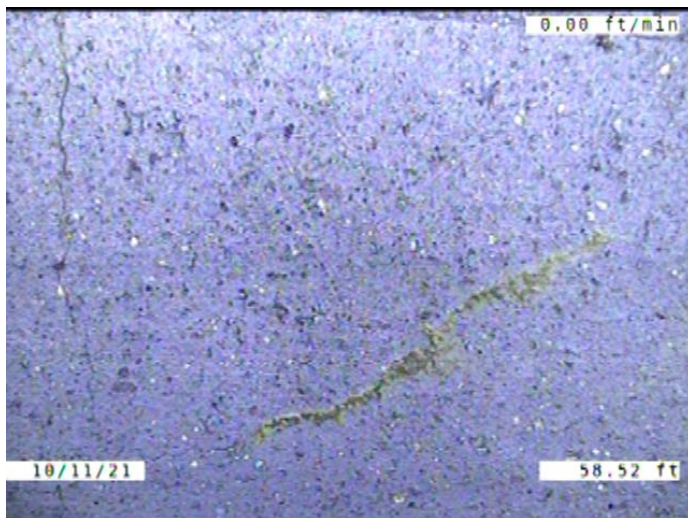
Code: **ISB**  
 Description: **Infiltration Stain Barrel**

Distance (ft): **58.5**  
 Structural Grade: **0**  
 O&M Grade: **1**  
 Clock Start/From: **11**  
 Clock To: **1**  
 1st Value:  
 2nd Value:  
 Value Percent:  
 Continuous Index:  
 Within 8" of Joint: **YES**  
 Remarks:

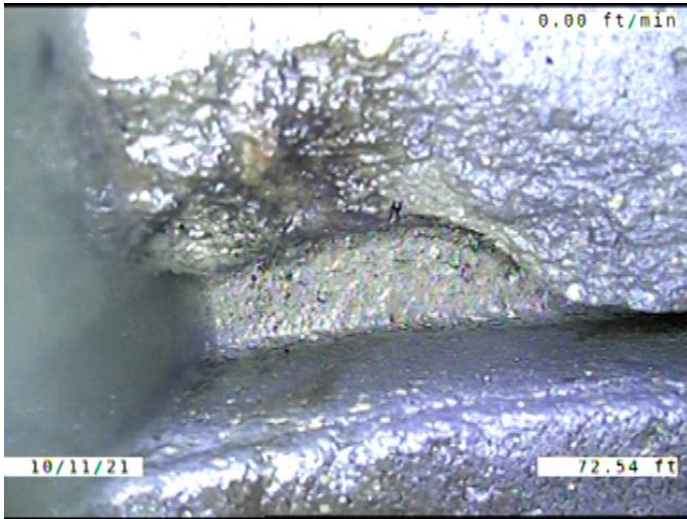
Code: **SMW**  
Description: **Surface Damage Missing Wall**

Distance (ft): **72.5**  
Structural Grade: **5**  
O&M Grade: **0**  
Clock Start/From: **8**  
Clock To: **9**  
1st Value:  
2nd Value:  
Value Percent:  
Continuous Index:  
Within 8" of Joint: **YES**  
Remarks:

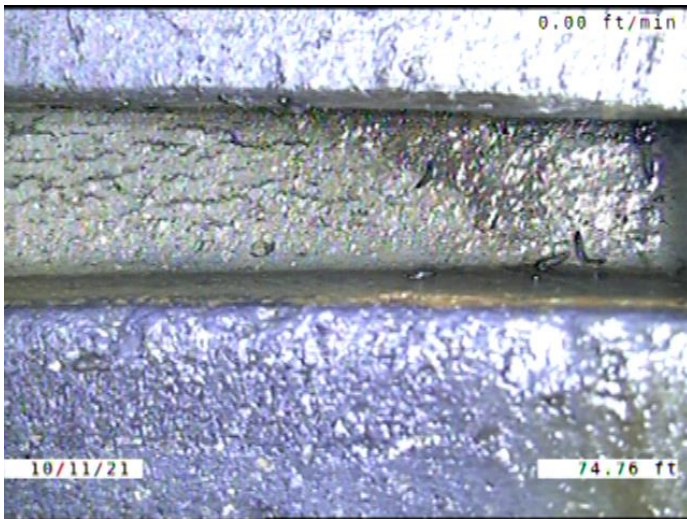
Code: **JAM**  
Description: **Joint Angular Medium**

Distance (ft): **74.8**  
Structural Grade: **3**  
O&M Grade: **0**  
Clock Start/From:  
Clock To:  
1st Value:  
2nd Value:  
Value Percent:  
Continuous Index:  
Within 8" of Joint: **NO**  
Remarks:

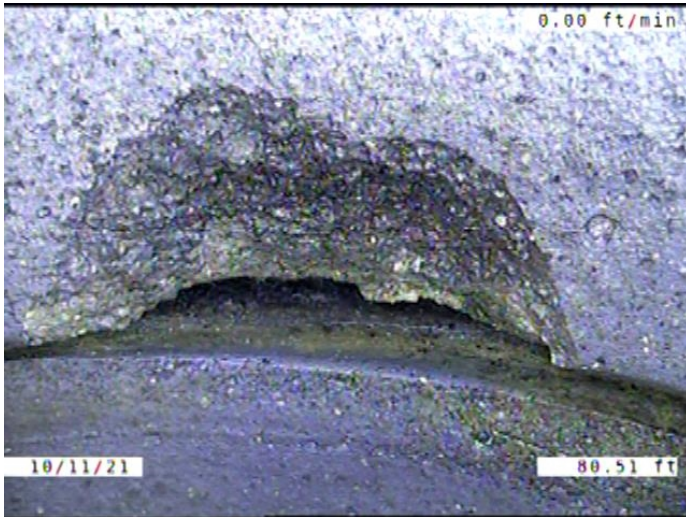
Code: **SSS**  
 Description: **Surface Damage Surface Spalling**

Distance (ft): **80.5**  
 Structural Grade: **2**  
 O&M Grade: **0**  
 Clock Start/From: **1**  
 Clock To: **2**  
 1st Value:  
 2nd Value:  
 Value Percent:  
 Continuous Index:  
 Within 8" of Joint: **YES**  
 Remarks:

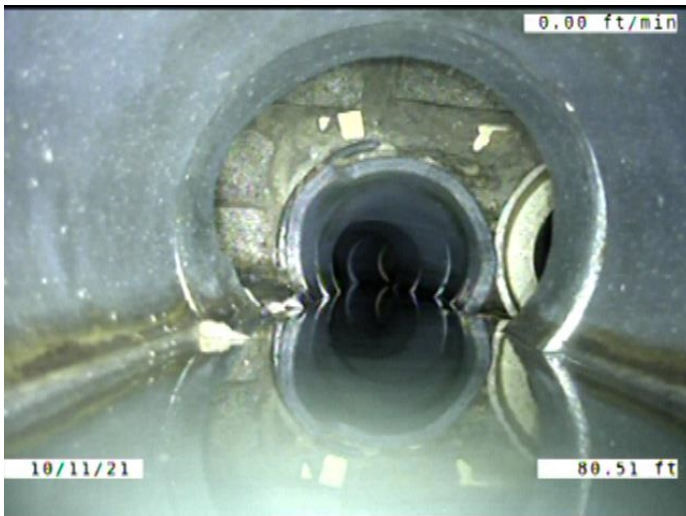
Code: **MWLS**  
 Description: **Miscellaneous Water Level Sag**

Distance (ft): **80.5**  
 Structural Grade: **2**  
 O&M Grade: **0**  
 Clock Start/From:  
 Clock To:  
 1st Value:  
 2nd Value:  
 Value Percent: **30.000**  
 Continuous Index: **F02**  
 Within 8" of Joint: **NO**  
 Remarks: **CAP LOOKS TO BE WOOD AND ROTTING AWAY**

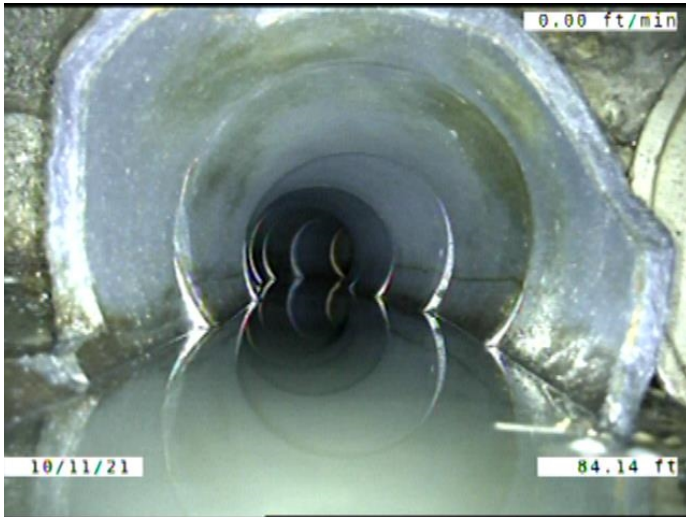
Code: **DSF**  
 Description: **Deposits Settled Fine**

Distance (ft): **84.1**  
 Structural Grade: **0**  
 O&M Grade: **2**  
 Clock Start/From: **5**  
 Clock To: **7**  
 1st Value:  
 2nd Value:  
 Value Percent: **5.000**  
 Continuous Index: **F01**  
 Within 8" of Joint: **YES**  
 Remarks:
