Profile/Photo Observation Report

Date:	10/11/2021	Weather:		Coding:	PACP 7.0
Pipe Length (ft):	35.0	Owner:	City of Hobart	Pre Clean:	Heavy Cleaning
P.O.#:	YES502259	Surveyor:	S. Bucklin	PSR:	P-804-077-018
Customer:	City of Hobart	Clean Date:	10/09/2021	Shape:	C

Street:	East Home Avenue	Flow Control:	Not Controlled
City:	Hobart, IN	Year Renewed:	
Location:	Local rural streets with light traffic, t	Tape/Media #:	
Purpose:	Routine Assessment	Dia/Height:	12"
Use:	Sanitary Sewage Pipe	Material:	VCP
Drain Area:		Lining:	
Category:	NA		
Comment:			
Location Details:		Direction of Survey:	Upstream
US MH:	M-804-018	DS MH:	M-804-077
		Total Length Surveyed (ft):	34.0

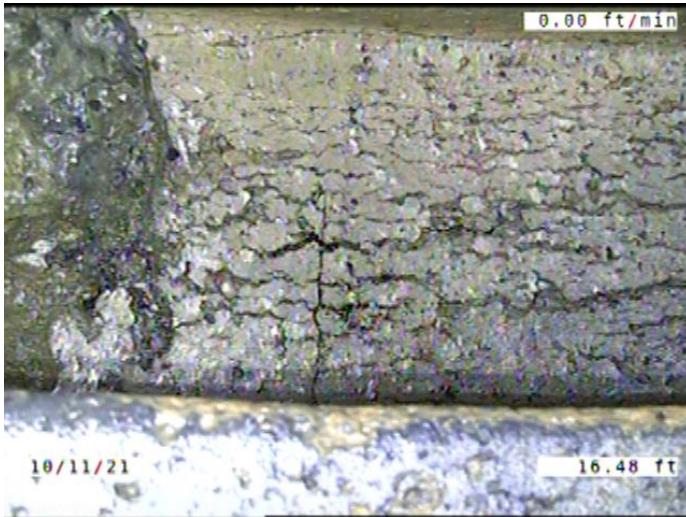
Code: **JAL**
 Description: **Joint Angular Large**

Distance (ft): **16.5**
 Structural Grade: **4**
 O&M Grade: **0**
 Clock Start/From:
 Clock To:
 1st Value:
 2nd Value:
 Value Percent:
 Continuous Index:
 Within 8" of Joint: **NO**
 Remarks:

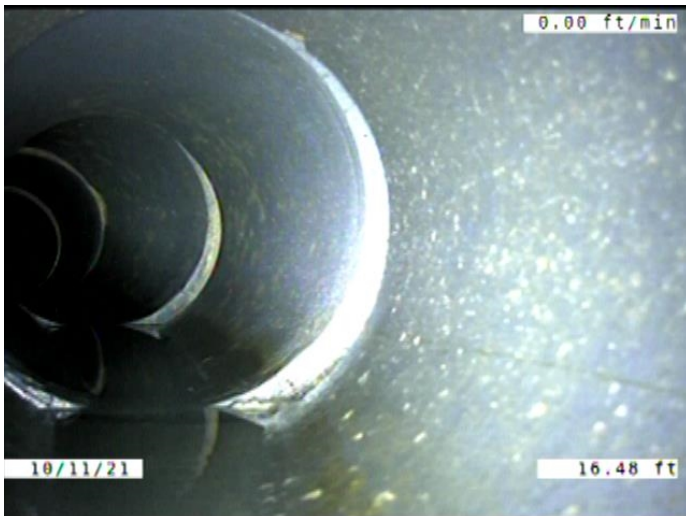
Code: **LL**
 Description: **Line Left**

Distance (ft): **16.5**
 Structural Grade: **0**
 O&M Grade: **1**
 Clock Start/From:
 Clock To:
 1st Value:
 2nd Value:
 Value Percent: **5.000**
 Continuous Index:
 Within 8" of Joint: **NO**
 Remarks:

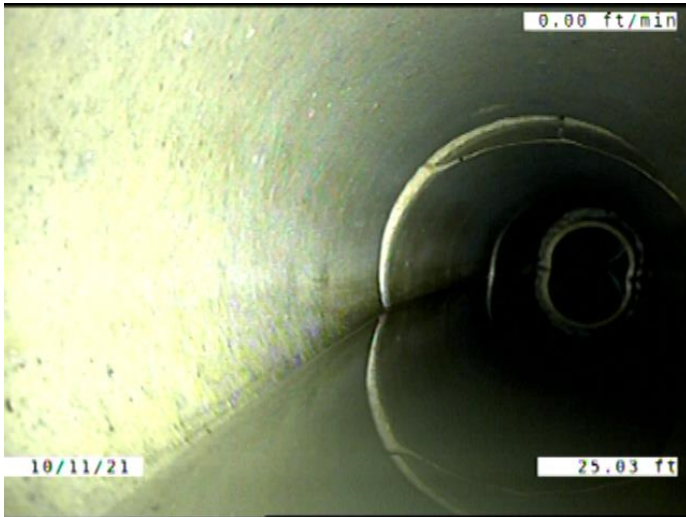
Code: **MWLS**
 Description: **Miscellaneous Water Level Sag**

Distance (ft): **25.0**
 Structural Grade: **2**
 O&M Grade: **0**
 Clock Start/From:
 Clock To:
 1st Value:
 2nd Value:
 Value Percent: **20.000**
 Continuous Index: **S02**
 Within 8" of Joint: **NO**
 Remarks:

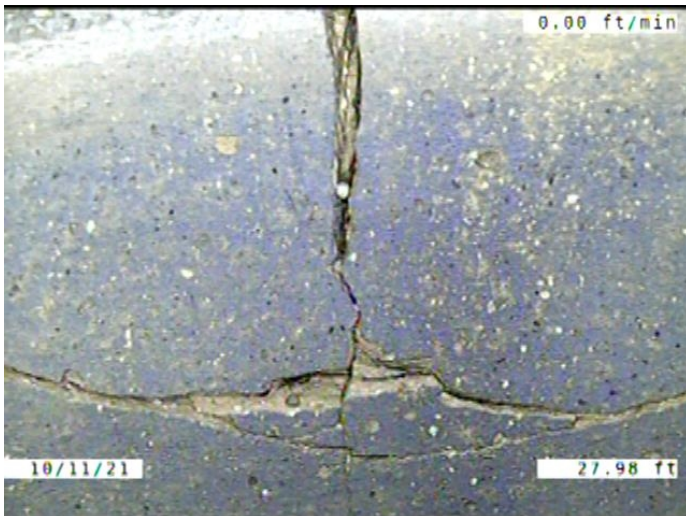
Code: **B**
 Description: **Broken**

Distance (ft): **28.0**
 Structural Grade: **4**
 O&M Grade: **0**
 Clock Start/From: **10**
 Clock To: **2**
 1st Value:
 2nd Value:
 Value Percent:
 Continuous Index:
 Within 8" of Joint: **YES**
 Remarks:
