Profile/Photo Observation Report

Date:	10/11/2021	Weather:		Coding:	PACP 7.0
Pipe Length (ft):	35.0	Owner:	City of Hobart	Pre Clean:	Heavy Cleaning
P.O.#:	YES502259	Surveyor:	S. Bucklin	PSR:	P-804-077-018
Customer:	City of Hobart	Clean Date:	10/09/2021	Shape:	C

Street:	East Home Avenue	Flow Control:	Not Controlled
City:	Hobart, IN	Year Renewed:	
Location:	Local rural streets with light traffic, t	Tape/Media #:	
Purpose:	Routine Assessment	Dia/Height:	12"
Use:	Sanitary Sewage Pipe	Material:	VCP
Drain Area:		Lining:	
Category:	NA		
Comment:			
Location Details:		Direction of Survey:	Upstream
US MH:	M-804-018	DS MH:	M-804-077
		Total Length Surveyed (ft):	34.0

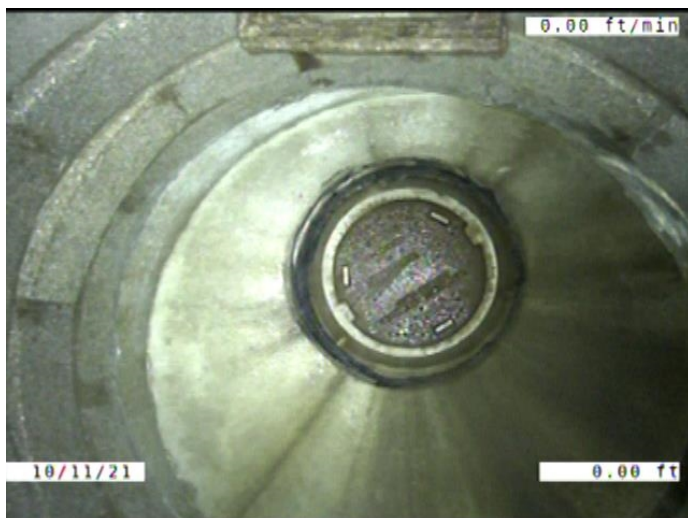
Code: **AMH**
 Description: **Manhole**

Distance (ft): **.0**
 Structural Grade: **0**
 O&M Grade: **0**
 Clock Start/From:
 Clock To:
 1st Value:
 2nd Value:
 Value Percent:
 Continuous Index:
 Within 8" of Joint: **NO**
 Remarks: **M-804-077**

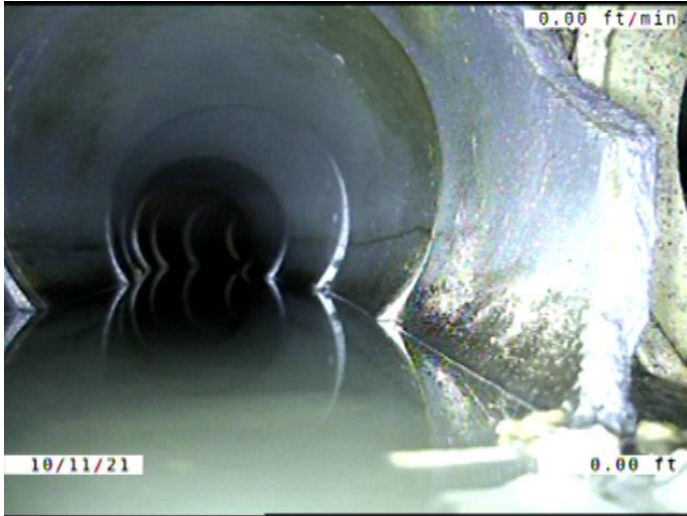
Code: **MWL**
 Description: **Miscellaneous Water Level**

Distance (ft): **.0**
 Structural Grade: **0**
 O&M Grade: **0**
 Clock Start/From:
 Clock To:
 1st Value:
 2nd Value:
 Value Percent: **5.000**
 Continuous Index:
 Within 8" of Joint: **NO**
 Remarks:

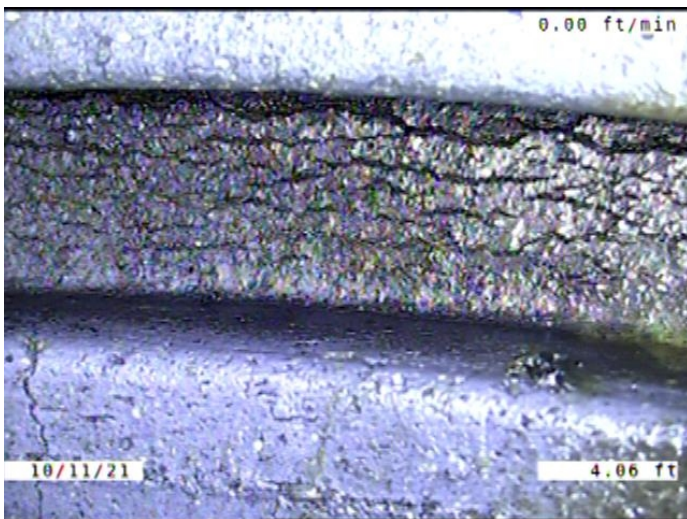
Code: **CM**
 Description: **Crack Multiple**

Distance (ft): **4.1**
 Structural Grade: **3**
 O&M Grade: **0**
 Clock Start/From: **12**
 Clock To: **4**
 1st Value:
 2nd Value:
 Value Percent:
 Continuous Index:
 Within 8" of Joint: **YES**
 Remarks:

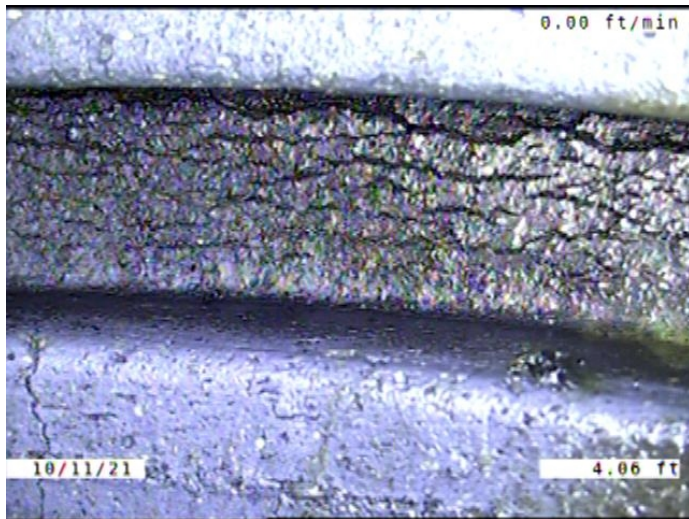
Code: **JAM**
 Description: **Joint Angular Medium**

Distance (ft): **4.1**
 Structural Grade: **3**
 O&M Grade: **0**
 Clock Start/From:
 Clock To:
 1st Value:
 2nd Value:
 Value Percent:
 Continuous Index:
 Within 8" of Joint: **NO**
 Remarks:

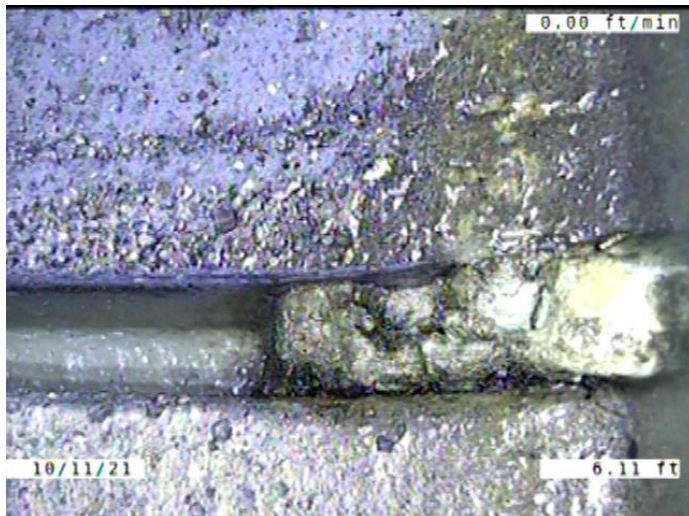
Code: **DAE**
 Description: **Deposits Attached Encrustation**

Distance (ft): **6.1**
 Structural Grade: **0**
 O&M Grade: **2**
 Clock Start/From: **8**
 Clock To: **9**
 1st Value:
 2nd Value:
 Value Percent: **5.000**
 Continuous Index:
 Within 8" of Joint: **YES**
 Remarks:

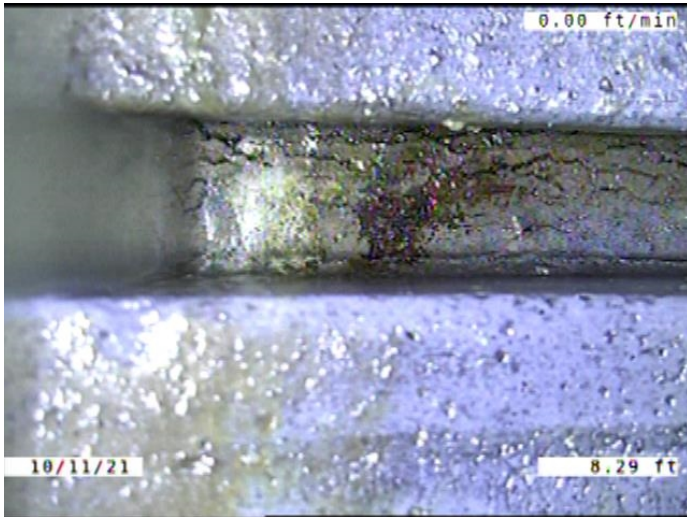
Code: **JAM**
 Description: **Joint Angular Medium**

Distance (ft): **8.3**
 Structural Grade: **3**
 O&M Grade: **0**
 Clock Start/From:
 Clock To:
 1st Value:
 2nd Value:
 Value Percent:
 Continuous Index: **S01**
 Within 8" of Joint: **NO**
 Remarks:

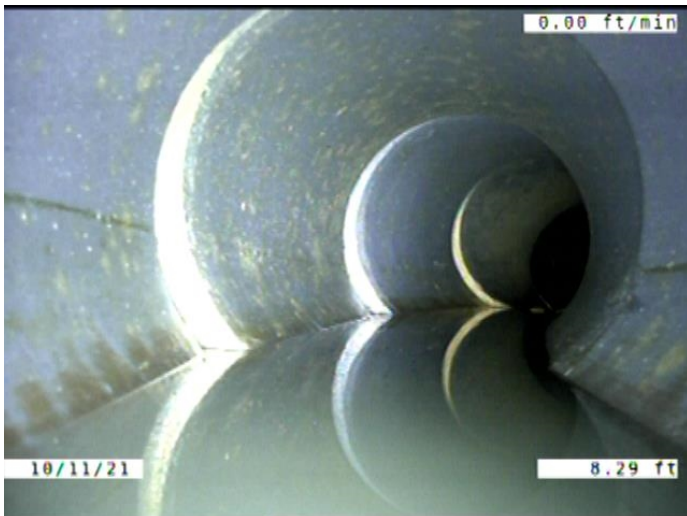
Code: **LR**
 Description: **Line Right**

Distance (ft): **8.3**
 Structural Grade: **0**
 O&M Grade: **1**
 Clock Start/From:
 Clock To:
 1st Value:
 2nd Value:
 Value Percent: **10.000**
 Continuous Index:
 Within 8" of Joint: **NO**
 Remarks:

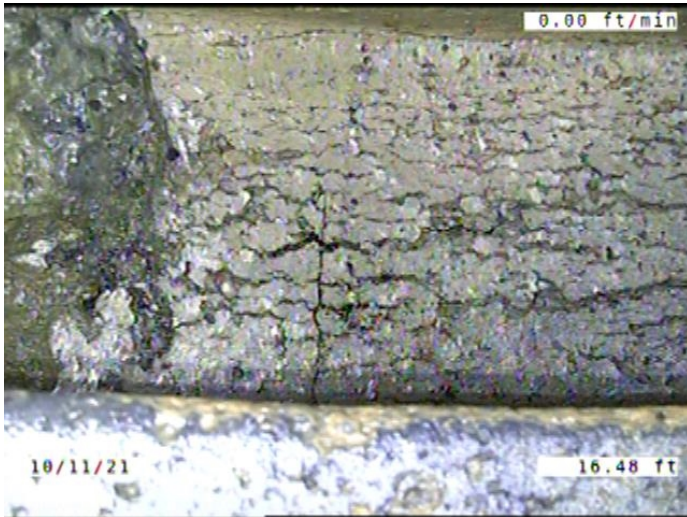
Code: **JAL**
 Description: **Joint Angular Large**

Distance (ft): **16.5**
 Structural Grade: **4**
 O&M Grade: **0**
 Clock Start/From:
 Clock To:
 1st Value:
 2nd Value:
 Value Percent:
 Continuous Index:
 Within 8" of Joint: **NO**
 Remarks:

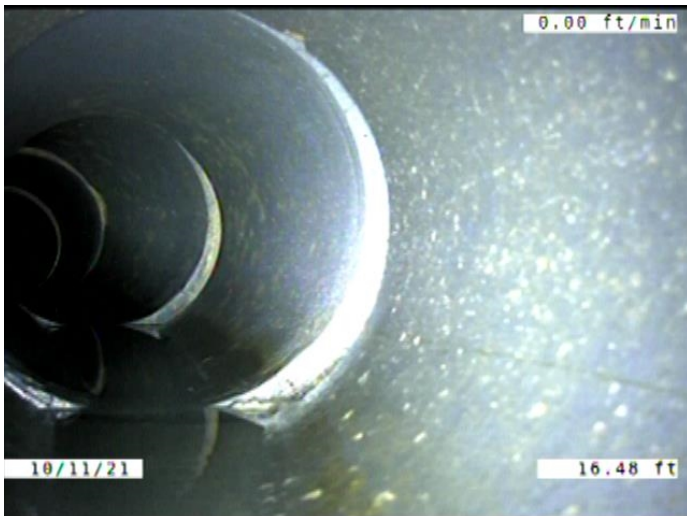
Code: **LL**
 Description: **Line Left**

Distance (ft): **16.5**
 Structural Grade: **0**
 O&M Grade: **1**
 Clock Start/From:
 Clock To:
 1st Value:
 2nd Value:
 Value Percent: **5.000**
 Continuous Index:
 Within 8" of Joint: **NO**
 Remarks:

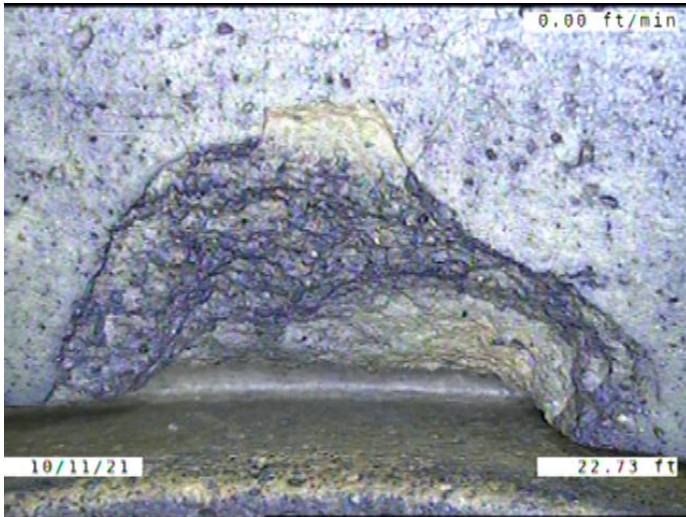
Code: **SZ**
 Description: **Surface Damage Other**

Distance (ft): **22.7**
 Structural Grade: **0**
 O&M Grade: **0**
 Clock Start/From: **2**
 Clock To: **3**
 1st Value:
 2nd Value:
 Value Percent:
 Continuous Index:
 Within 8" of Joint: **YES**
 Remarks: **A PIECE CHIPPED AWAY FROM THE JOINT**

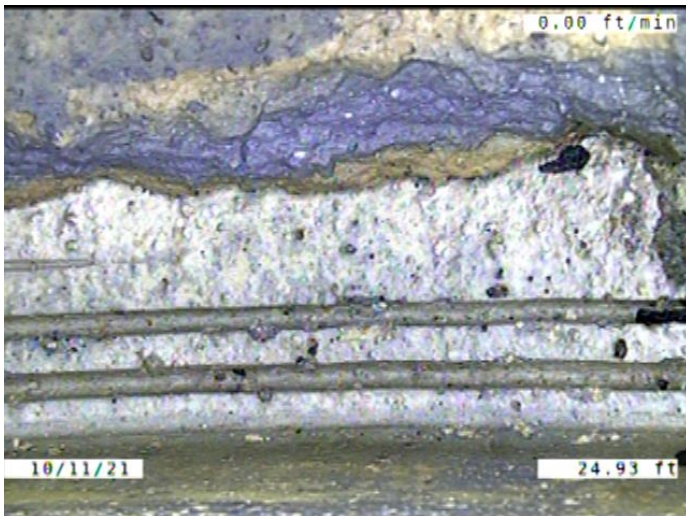
Code: **SMW**
 Description: **Surface Damage Missing Wall**

Distance (ft): **24.9**
 Structural Grade: **5**
 O&M Grade: **0**
 Clock Start/From: **12**
 Clock To: **5**
 1st Value:
 2nd Value:
 Value Percent:
 Continuous Index:
 Within 8" of Joint: **YES**
 Remarks: **INSIDE OF THE JOINT**

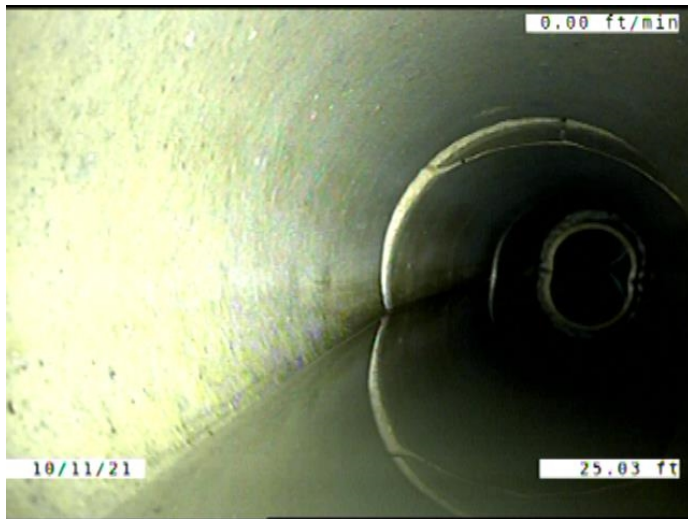
Code: **MWLS**
 Description: **Miscellaneous Water Level Sag**

Distance (ft): **25.0**
 Structural Grade: **2**
 O&M Grade: **0**
 Clock Start/From:
 Clock To:
 1st Value:
 2nd Value:
 Value Percent: **20.000**
 Continuous Index: **S02**
 Within 8" of Joint: **NO**
 Remarks:

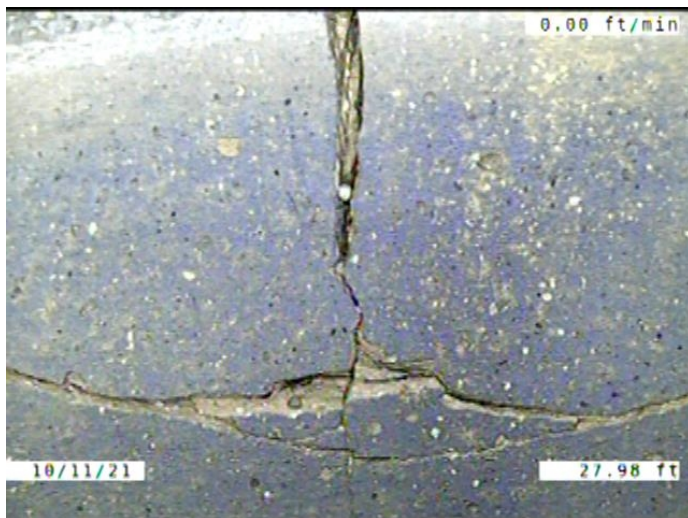
Code: **B**
 Description: **Broken**

Distance (ft): **28.0**
 Structural Grade: **4**
 O&M Grade: **0**
 Clock Start/From: **10**
 Clock To: **2**
 1st Value:
 2nd Value:
 Value Percent:
 Continuous Index:
 Within 8" of Joint: **YES**
 Remarks:

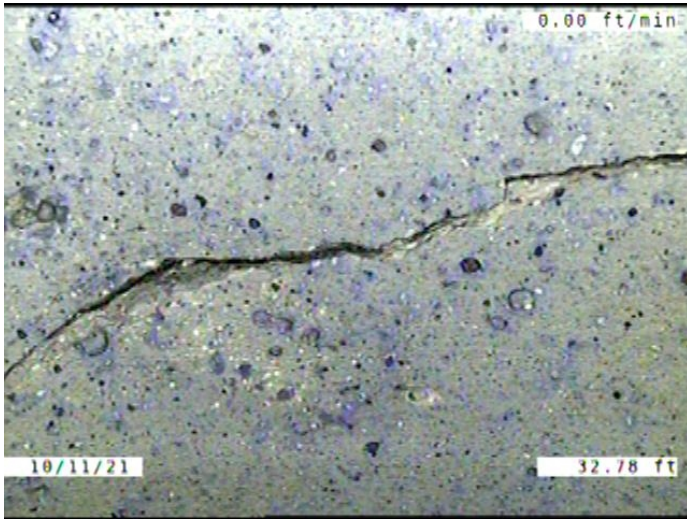
Code: **FS**
 Description: **Fracture Spiral**

Distance (ft): **32.8**
 Structural Grade: **3**
 O&M Grade: **0**
 Clock Start/From: **9**
 Clock To: **3**
 1st Value:
 2nd Value:
 Value Percent:
 Continuous Index:
 Within 8" of Joint: **NO**
 Remarks:

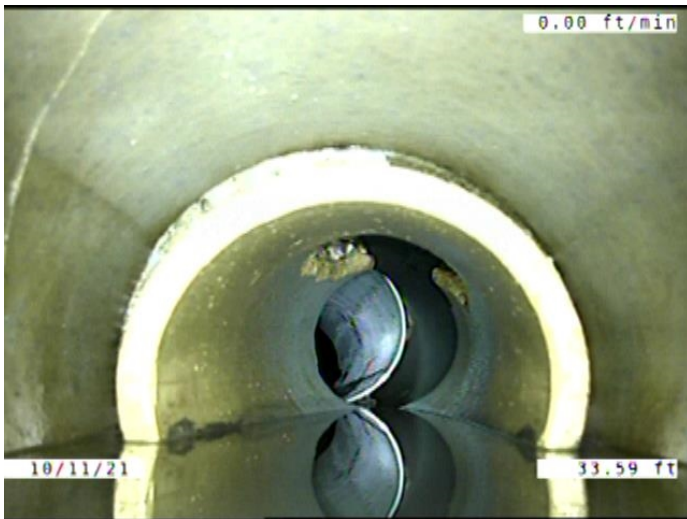
Code: **MSC**
 Description: **Miscellaneous Shape/Size Change**

Distance (ft): **33.6**
 Structural Grade: **0**
 O&M Grade: **0**
 Clock Start/From:
 Clock To:
 1st Value: **8.000**
 2nd Value:
 Value Percent:
 Continuous Index:
 Within 8" of Joint: **NO**
 Remarks:

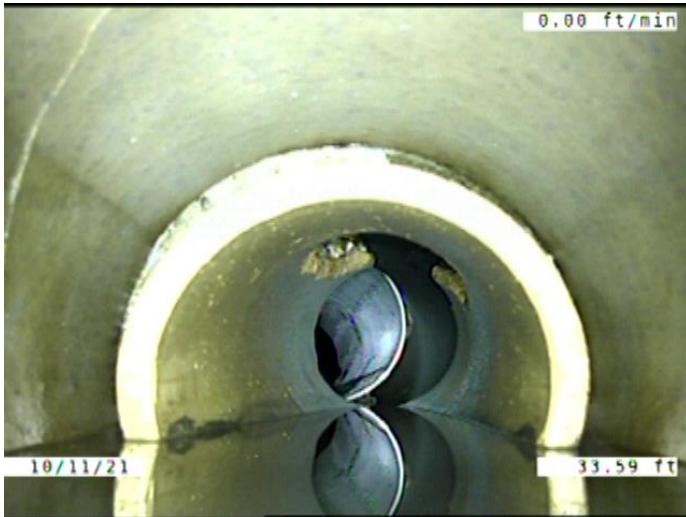
Code: **JAM**
Description: **Joint Angular Medium**

Distance (ft): **33.6**
Structural Grade: **3**
O&M Grade: **0**
Clock Start/From:
Clock To:
1st Value:
2nd Value:
Value Percent:
Continuous Index: **F01**
Within 8" of Joint: **NO**
Remarks:

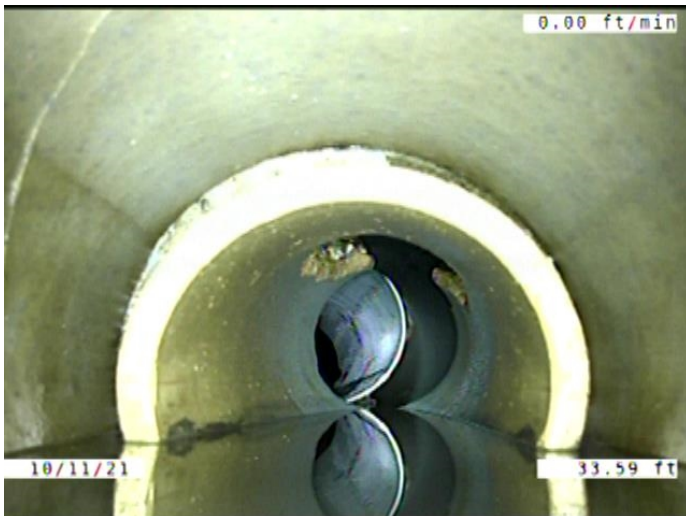
Code: **MWLS**
Description: **Miscellaneous Water Level Sag**

Distance (ft): **33.6**
Structural Grade: **2**
O&M Grade: **0**
Clock Start/From:
Clock To:
1st Value:
2nd Value:
Value Percent: **20.000**
Continuous Index: **F02**
Within 8" of Joint: **NO**
Remarks:

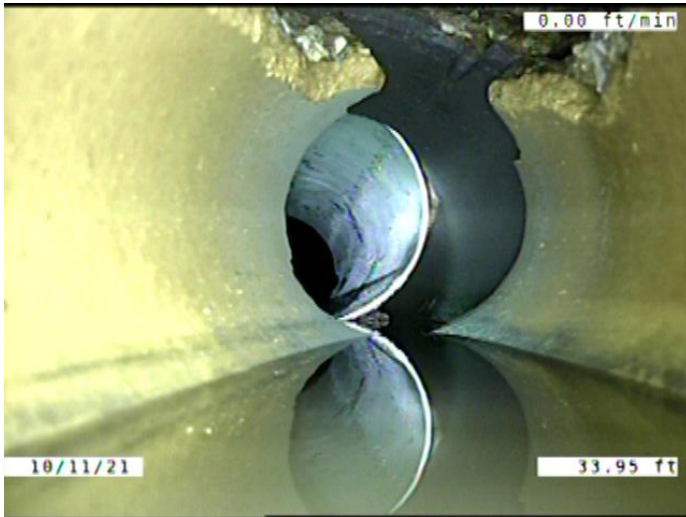
Code: **MGO**
 Description: **Miscellaneous General Observation**

Distance (ft): **34.0**
 Structural Grade: **0**
 O&M Grade: **0**
 Clock Start/From:
 Clock To:
 1st Value:
 2nd Value:
 Value Percent:
 Continuous Index:
 Within 8" of Joint: **NO**
 Remarks: **PIPE IS 8" IN THE MANHOLE.
 CAMERA CANT MAKE IT INTO THE PI**

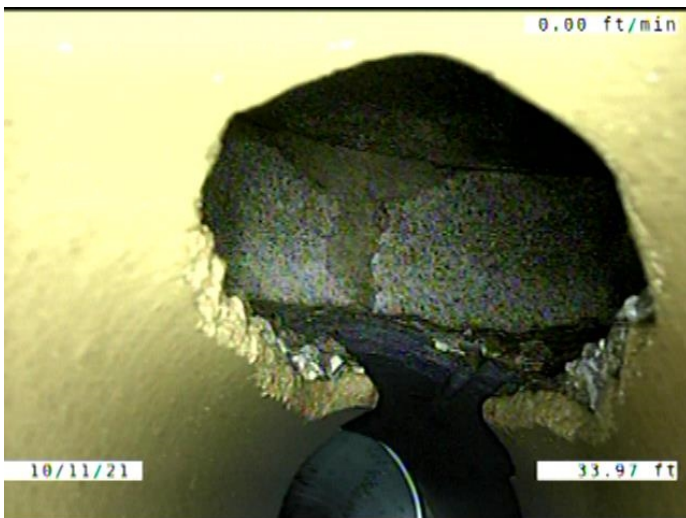
Code: **MSA**
 Description: **Miscellaneous Survey Abandoned**

Distance (ft): **34.0**
 Structural Grade: **0**
 O&M Grade: **0**
 Clock Start/From:
 Clock To:
 1st Value:
 2nd Value:
 Value Percent:
 Continuous Index:
 Within 8" of Joint: **NO**
 Remarks: **CAMERA CANT FIT INTO 8" PIPE.**
