## Profile/Photo Observation Report

Date:	<b>10/17/2021</b>	Weather:		Coding:	<b>PACP 6.0</b>
Pipe Length (ft):		Owner:	<b>Hobart, IN</b>	Pre Clean:	<b>Not Known</b>
P.O.#:	<b>847_1</b>	Surveyor:	<b>M. Pielacha</b>	PSR:	<b>P-804-077-018</b>
Customer:	<b>Hobart, IN</b>	Clean Date:		Shape:	<b>C</b>

Location Details:		Direction of Survey:	<b>Downstream</b>
US MH:	<b>M-804-77</b>	DS MH:	<b>M-804-18</b>
		Total Length Surveyed (ft):	<b>27.7</b>

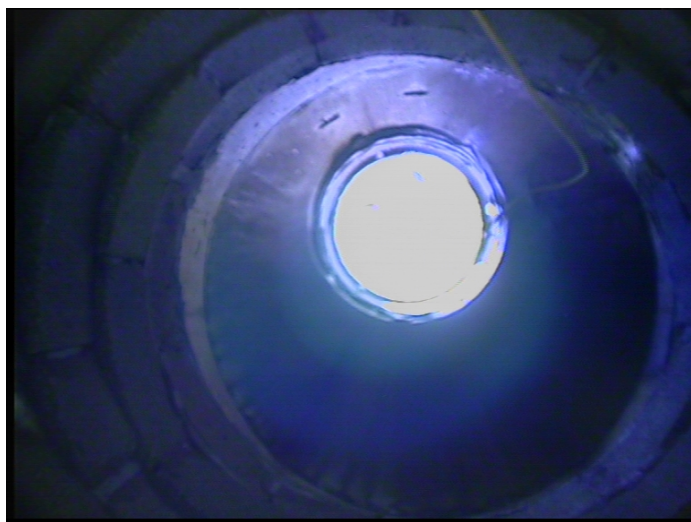
Code: **AMH**  
Description: **Manhole**

Distance (ft): **.0**  
Structural Grade: **0**  
O&M Grade: **0**  
Clock Start/From:  
Clock To:  
1st Value:  
2nd Value:  
Value Percent:  
Continuous Index:  
Within 8" of Joint: **NO**  
Remarks: **M-804-77**

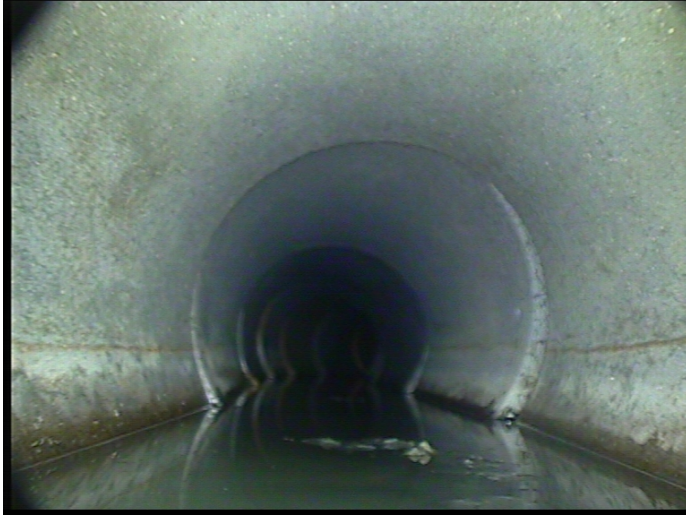
Code: **MWL**  
Description: **Water Level**

Distance (ft): **.0**  
Structural Grade: **0**  
O&M Grade: **0**  
Clock Start/From:  
Clock To:  
1st Value:  
2nd Value:  
Value Percent: **10.000**  
Continuous Index:  
Within 8" of Joint: **NO**  
Remarks:

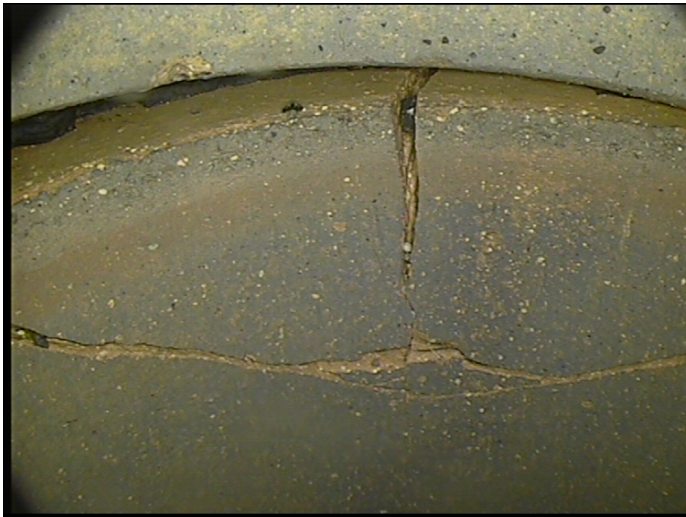
Code: **CM**  
Description: **Crack Multiple**

Distance (ft): **27.7**  
Structural Grade: **3**  
O&M Grade: **0**  
Clock Start/From: **10**  
Clock To: **2**  
1st Value:  
2nd Value:  
Value Percent:  
Continuous Index:  
Within 8" of Joint: **YES**  
Remarks:

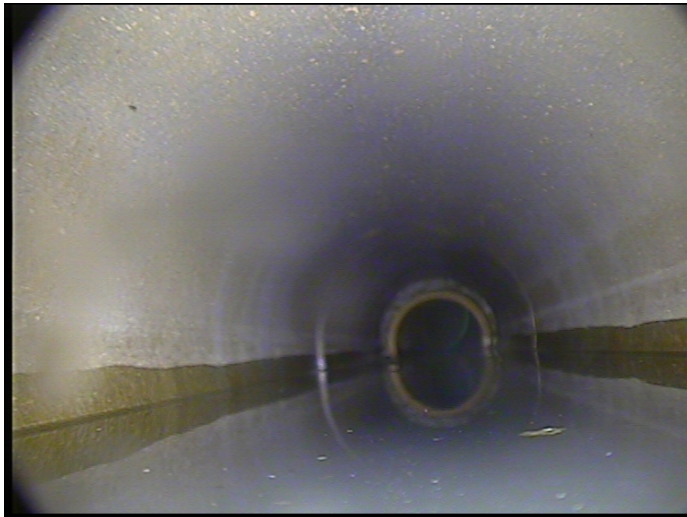
Code:	<b>MGO</b>
Description:	<b>General Observation</b>
Distance (ft):	<b>27.7</b>
Structural Grade:	<b>0</b>
O&M Grade:	<b>0</b>
Clock Start/From:	
Clock To:	
1st Value:	
2nd Value:	
Value Percent:	
Continuous Index:	
Within 8" of Joint:	<b>NO</b>
Remarks:	<b>Unsure if there a size change at this joint but the camera goes under wat</b>

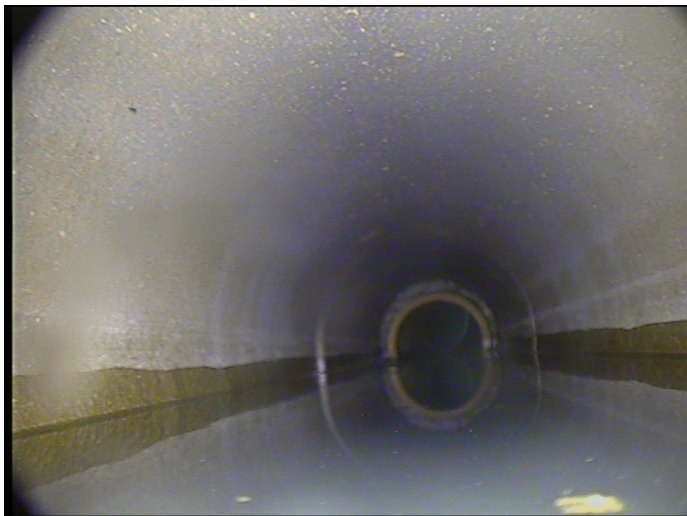
Code:	<b>MSA</b>
Description:	<b>Abandoned Survey</b>
Distance (ft):	<b>27.7</b>
Structural Grade:	<b>0</b>
O&M Grade:	<b>0</b>
Clock Start/From:	
Clock To:	
1st Value:	
2nd Value:	
Value Percent:	
Continuous Index:	
Within 8" of Joint:	<b>NO</b>
Remarks:	<b>Inspection ended due to possible size change and high water level ahe</b>
