Profile/Photo Observation Report

Date:	05/02/2018	Weather:		Coding:	PACP 6.0
Pipe Length (ft):		Owner:	City of Hobart	Pre Clean:	No Pre-Cleaning
P.O.#:	170	Surveyor:	M. Pielacha	PSR:	P-804-080-081
Customer:	City of Hobart	Clean Date:		Shape:	C

Street:	Hobart Street	Flow Control:	Not Controlled
City:	Hobart, IN	Year Renewed:	
Location:	Light Highway	Tape/Media #:	DEP 170
Purpose:	Routine Assessment	Dia/Height:	6"
Use:	Sanitary	Material:	VCP
Drain Area:		Lining:	
Category:	NA		
Comment:	5-21-2018		
Location Details:		Direction of Survey:	Downstream
US MH:	M-804-080	DS MH:	M-804-081
		Total Length Surveyed (ft):	.1

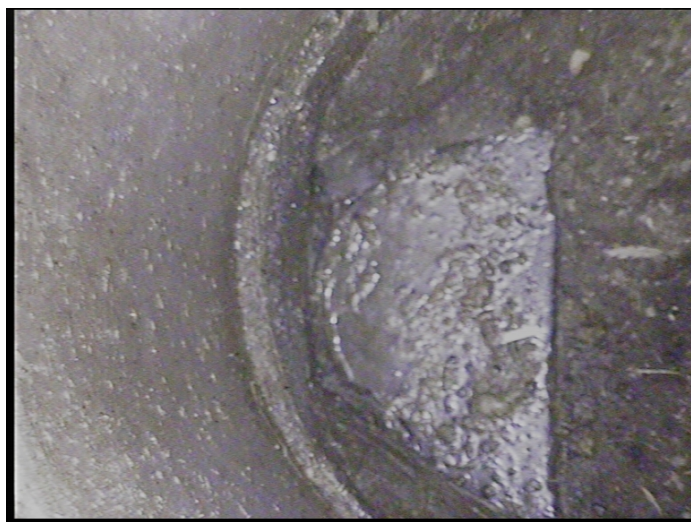
Code: **AMH**
Description: **Manhole**

Distance (ft): **.0**
Structural Grade: **0**
O&M Grade: **0**
Clock Start/From:
Clock To:
1st Value:
2nd Value:
Value Percent:
Continuous Index:
Within 8" of Joint: **NO**
Remarks: **M-804-080**

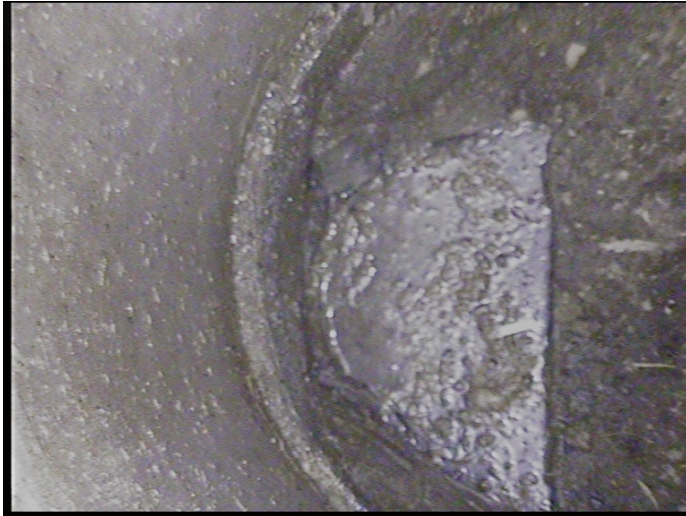
Code: **MWL**
Description: **Water Level**

Distance (ft): **.0**
Structural Grade: **0**
O&M Grade: **0**
Clock Start/From:
Clock To:
1st Value:
2nd Value:
Value Percent: **70.000**
Continuous Index:
Within 8" of Joint: **NO**
Remarks:

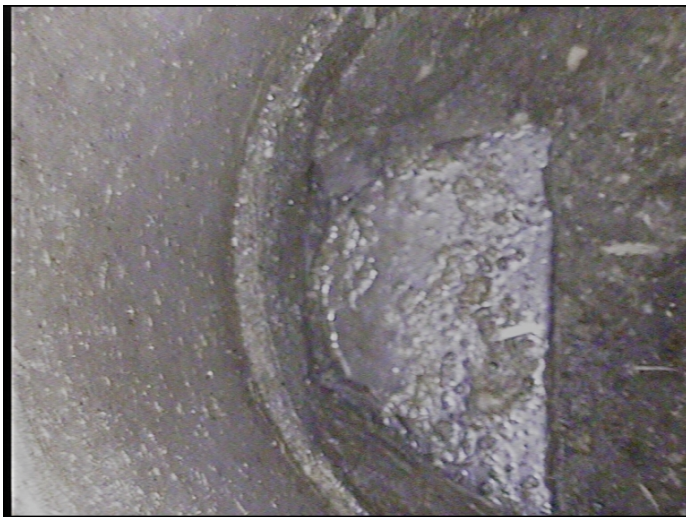
Code: **MSA**
Description: **Abandoned Survey**

Distance (ft): **.0**
Structural Grade: **0**
O&M Grade: **0**
Clock Start/From:
Clock To:
1st Value:
2nd Value:
Value Percent:
Continuous Index:
Within 8" of Joint: **NO**
Remarks: **sediment and high water level.**
