Profile/Photo Observation Report

Date:	05/02/2018	Weather:		Coding:	PACP 6.0
Pipe Length (ft):		Owner:	City of Hobart	Pre Clean:	No Pre-Cleaning
P.O.#:	169	Surveyor:	M. Pielacha	PSR:	P-804-081-007
Customer:	City of Hobart	Clean Date:		Shape:	C

Street:	Hobart Road	Flow Control:	Not Controlled
City:	Hobart, IN	Year Renewed:	
Location:	Light Highway	Tape/Media #:	DEP 169
Purpose:	Routine Assessment	Dia/Height:	6"
Use:	Sanitary	Material:	VCP
Drain Area:		Lining:	
Category:	NA		
Comment:	5-21-2018		
Location Details:		Direction of Survey:	Downstream
US MH:	M-804-081	DS MH:	M-804-007
		Total Length Surveyed (ft):	.2

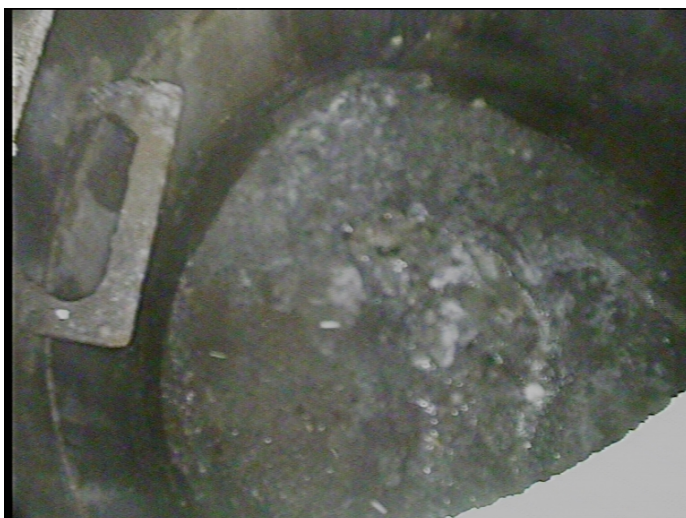
Code: **AMH**
Description: **Manhole**

Distance (ft): **.0**
Structural Grade: **0**
O&M Grade: **0**
Clock Start/From:
Clock To:
1st Value:
2nd Value:
Value Percent:
Continuous Index:
Within 8" of Joint: **NO**
Remarks: **M-804-081**

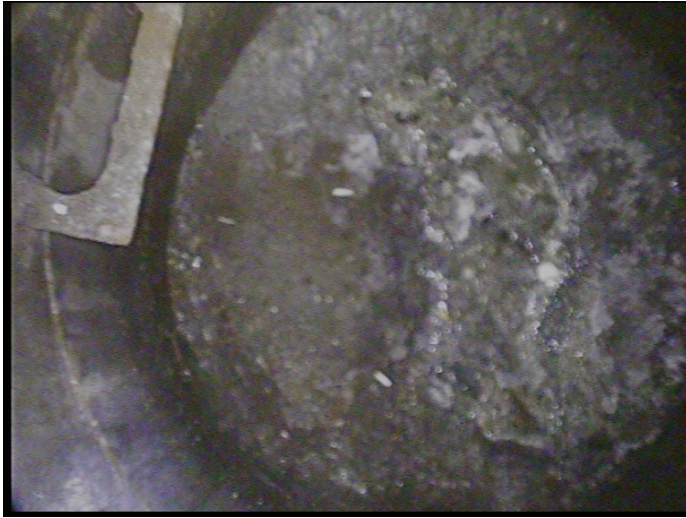
Code: **MWL**
Description: **Water Level**

Distance (ft): **.0**
Structural Grade: **0**
O&M Grade: **0**
Clock Start/From:
Clock To:
1st Value:
2nd Value:
Value Percent: **0.000**
Continuous Index:
Within 8" of Joint: **NO**
Remarks:

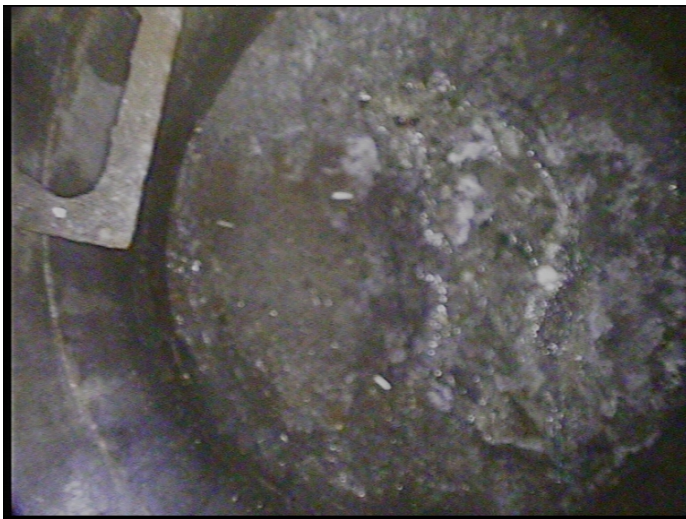
Code: **MGO**
Description: **General Observation**

Distance (ft): **.0**
Structural Grade: **0**
O&M Grade: **0**
Clock Start/From:
Clock To:
1st Value:
2nd Value:
Value Percent:
Continuous Index:
Within 8" of Joint: **NO**
Remarks: **dberis blocking both end of pipe**

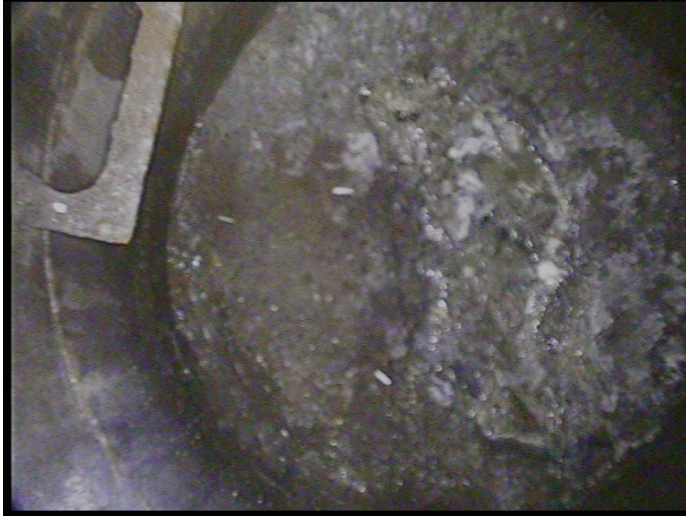
Code:	MSA
Description:	Abandoned Survey
Distance (ft):	.0
Structural Grade:	0
O&M Grade:	0
Clock Start/From:	
Clock To:	
1st Value:	
2nd Value:	
Value Percent:	
Continuous Index:	
Within 8" of Joint:	NO
Remarks:	debris blocking pipe
