Profile/Photo Observation Report

Date:	05/02/2018	Weather:		Coding:	PACP 6.0
Pipe Length (ft):		Owner:	City of Hobart	Pre Clean:	No Pre-Cleaning
P.O.#:	171	Surveyor:	M. Pielacha	PSR:	P-804-081-007
Customer:	City of Hobart	Clean Date:		Shape:	C

Street:	Hobart Road	Flow Control:	Not Controlled
City:	Hobart, IN	Year Renewed:	
Location:	Light Highway	Tape/Media #:	DEP 171
Purpose:	Routine Assessment	Dia/Height:	6"
Use:	Sanitary	Material:	VCP
Drain Area:		Lining:	
Category:	NA		
Comment:	5-21-2018		
Location Details:		Direction of Survey:	Upstream
US MH:	M-804-081	DS MH:	M-804-007
		Total Length Surveyed (ft):	.1

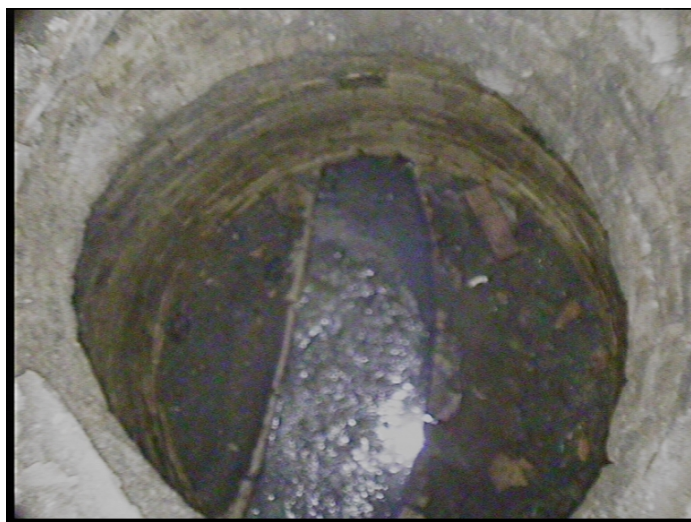
Code: **AMH**
Description: **Manhole**

Distance (ft): **.0**
Structural Grade: **0**
O&M Grade: **0**
Clock Start/From:
Clock To:
1st Value:
2nd Value:
Value Percent:
Continuous Index:
Within 8" of Joint: **NO**
Remarks: **M-804-007**

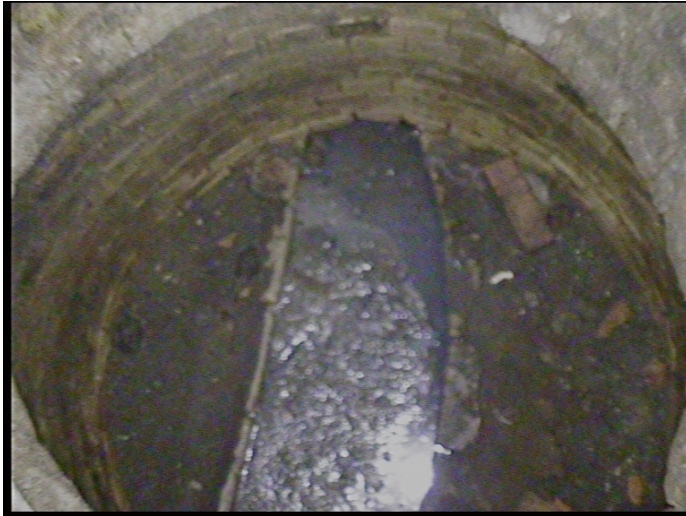
Code: **MWL**
Description: **Water Level**

Distance (ft): **.0**
Structural Grade: **0**
O&M Grade: **0**
Clock Start/From:
Clock To:
1st Value:
2nd Value:
Value Percent: **10.000**
Continuous Index:
Within 8" of Joint: **NO**
Remarks:

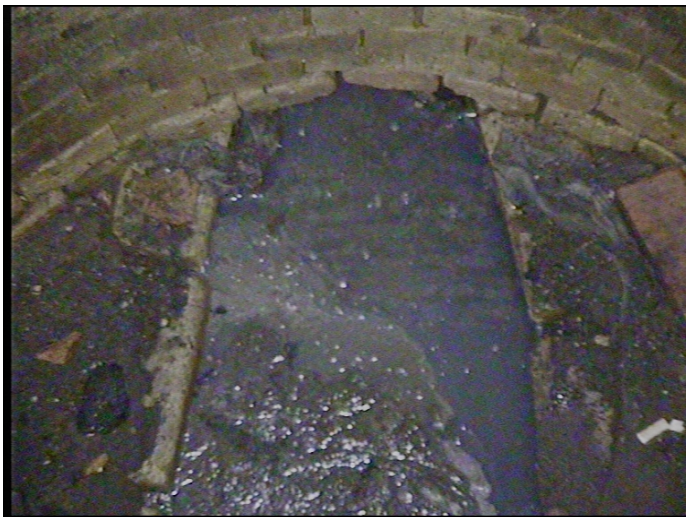
Code: **MSA**
Description: **Abandoned Survey**

Distance (ft): **.0**
Structural Grade: **0**
O&M Grade: **0**
Clock Start/From:
Clock To:
1st Value:
2nd Value:
Value Percent:
Continuous Index:
Within 8" of Joint: **NO**
Remarks: **pipe is full of debris**
