## **Profile/Photo Observation Report**

Profile/Photo Observation Report									
Date: Pipe Length (ft	194	Weather: Owner: Surveyor:	City of Hob M. Pielacha		Coding: Pre Clean: PSR:	PACP 6.0 No Pre-Cleaning P-805-002-003			
Customer:	City of Hobart	Clean Date:			Shape:	<u>C</u>			
Street:	<b>Hobart Road</b>		Flow Control	:	Not Controlled				
City:	Hobart, IN		Year Renewe	d:					
Location:	<b>Light Highway</b>		Tape/Media	#:	<b>DEP 194</b>				
Purpose:	<b>Routine Assessment</b>		Dia/Height:		18"				
Use:	Sanitary		Material:		VCP				
Drain Area:			Lining:						
Category:	NA

Comment:	5-21-2018								
Location Details:			Direction of Survey:		Downstream				
US MH:	M-805-003	DS MH:	M-805-002		Total Length Surveyed (ft):	312.3			
O&M Index:	0.00	O&M Quick:		0000	O&M Rating:	0.00			
Structural Index	. 0.00	— Structural Qı	uick:	0000	Structural Rating:	0.00			
Overall Index:	0.00	 _Overall Quicl	<b>c</b> :	0000	Overall Rating:	0.00

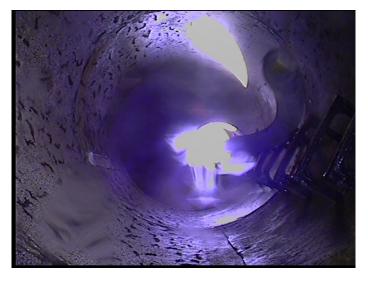
**AMH**

Description: Manhole Distance (ft): .0 Structural Grade: 0 O&M Grade: 0 Clock Start/From: Clock To: 1st Value: 2nd Value: Value Percent: Continuous Index: Within 8" of Joint: NO Remarks: M-805-002

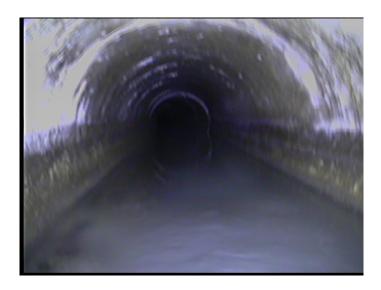
Code: MWL
Description: Water Level

Distance (ft): .0
Structural Grade: 0
O&M Grade: 0

Value Percent: 15.000

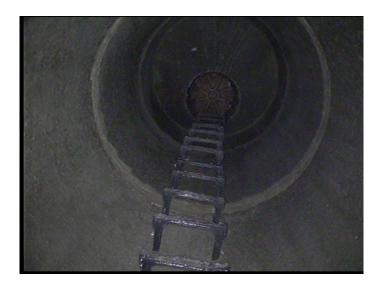
Code: AMH
Description: Manhole

Distance (ft): 312.3
Structural Grade: 0
O&M Grade: 0
Clock Start/From:

Remarks: M-805-003
