Profile/Photo Observation Report

Date:	04/23/2018	Weather:		Coding:	PACP 6.0
Pipe Length (ft):	40.1	Owner:	NA	Pre Clean:	Not Known
P.O.#:		Surveyor:	Jen Costello	PSR:	P-805-068-004
Customer:		Clean Date:	01/01/1900	Shape:	C

Street:	Hobart	Flow Control:	Not Controlled
City:	Hobart, IN	Year Renewed:	
Location:	Alley	Tape/Media #:	
Purpose:	Maintenance Related	Dia/Height:	8"
Use:	Sanitary	Material:	PVC
Drain Area:	NA	Lining:	Cured in Place
Category:	NA		
Comment:	Flow direction wrong.		
Location Details:		Direction of Survey:	Upstream
US MH:	M-805-004	DS MH:	M-805-068
		Total Length Surveyed (ft):	34.5

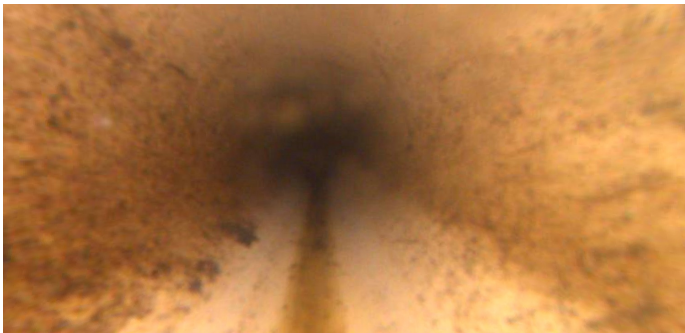
Code: **AMH**
Description: **Manhole**

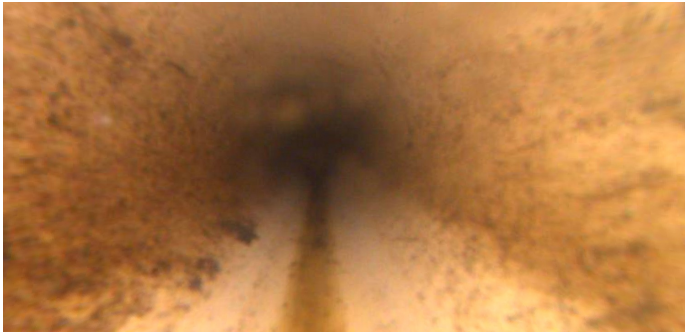
Code:	MWL
Description:	Water Level

Distance (ft):	.0
Structural Grade:	0
O&M Grade:	0
Clock Start/From:	
Clock To:	
1st Value:	
2nd Value:	
Value Percent:	5.000
Continuous Index:	
Within 8" of Joint:	NO
Remarks:

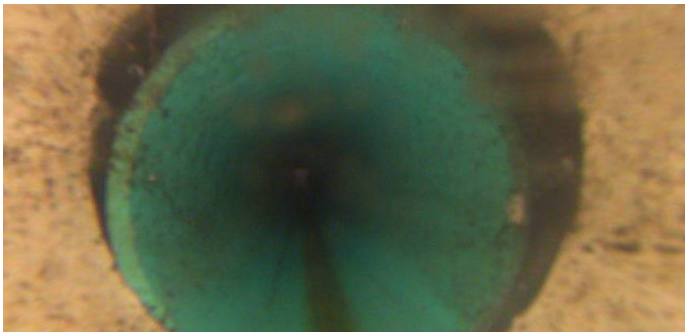
Code:	JSM
Description:	Joint Separated Medium

Distance (ft):	26.3
Structural Grade:	1
O&M Grade:	0
Clock Start/From:	
Clock To:	
1st Value:	
2nd Value:	
Value Percent:	
Continuous Index:	
Within 8" of Joint:	NO
Remarks:

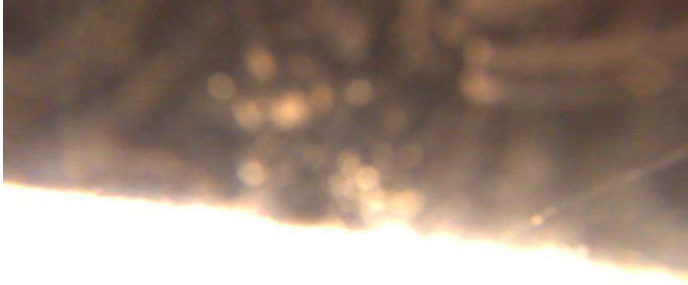
Code:	AMH
Description:	Manhole
Distance (ft):	34.5
Structural Grade:	0
O&M Grade:	0
Clock Start/From:	
Clock To:	
1st Value:	
2nd Value:	
Value Percent:	
Continuous Index:	
Within 8" of Joint:	NO
Remarks:	M-805-004
