Profile/Photo Observation Report

Date:	04/23/2018	Weather:		Coding:	PACP 6.0
Pipe Length (ft):	218.8	Owner:	NA	Pre Clean:	Not Known
P.O.#:		Surveyor:	Jen Costello	PSR:	P-805-008-009
Customer:		Clean Date:	01/01/1900	Shape:	C

Street:	E 5TH ST	Flow Control:	Not Controlled
City:	Hobart, IN	Year Renewed:	
Location:	Alley	Tape/Media #:	
Purpose:	Maintenance Related	Dia/Height:	8"
Use:	Sanitary	Material:	VCP
Drain Area:	NA	Lining:	Cured in Place
Category:	NA		
Comment:	Flow direction wrong. Line full of mud.		
Location Details:		Direction of Survey:	Upstream
US MH:	M-805-009	DS MH:	M-805-008
		Total Length Surveyed (ft):	2.6

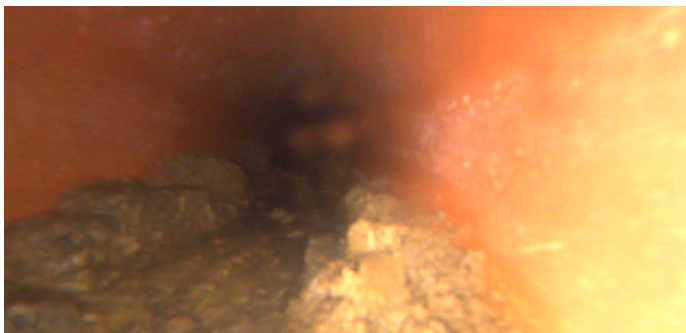
Code: **AMH**
Description: **Manhole**

Distance (ft): **.0**
Structural Grade: **0**
O&M Grade: **0**
Clock Start/From:
Clock To:
1st Value:
2nd Value:
Value Percent:
Continuous Index:
Within 8" of Joint: **NO**
Remarks: **M-805-008**

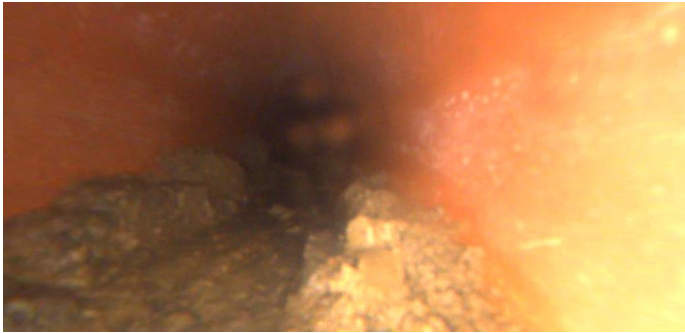
Code:	MWL
Description:	Water Level

Distance (ft):	.0
Structural Grade:	0
O&M Grade:	0
Clock Start/From:	
Clock To:	
1st Value:	
2nd Value:	
Value Percent:	0.000
Continuous Index:	
Within 8" of Joint:	NO
Remarks:

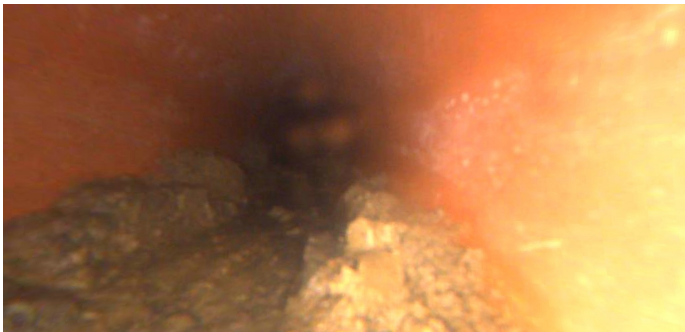
Code:	DSF
Description:	Deposits Settled Fine

Distance (ft):	.0
Structural Grade:	0
O&M Grade:	3
Clock Start/From:	4
Clock To:	8
1st Value:	
2nd Value:	
Value Percent:	20.000
Continuous Index:	
Within 8" of Joint:	NO
Remarks:

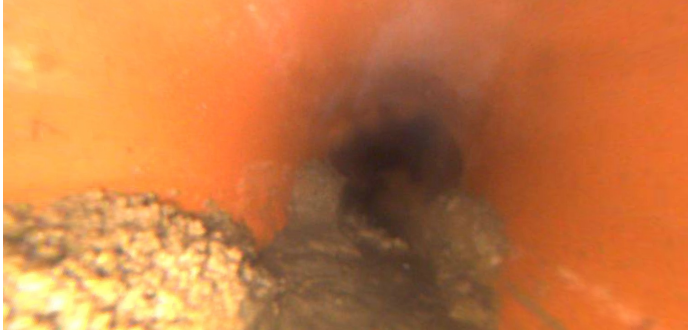
Code:	MSA
Description:	Abandoned Survey
Distance (ft):	2.6
Structural Grade:	0
O&M Grade:	0
Clock Start/From:	
Clock To:	
1st Value:	
2nd Value:	
Value Percent:	
Continuous Index:	
Within 8" of Joint:	NO
Remarks:	dsf
