## Profile/Photo Observation Report

Date:	<b>04/23/2018</b>	Weather:		Coding:	<b>PACP 6.0</b>
Pipe Length (ft):	<b>218.8</b>	Owner:	<b>NA</b>	Pre Clean:	<b>Not Known</b>
P.O.#:		Surveyor:	<b>Jen Costello</b>	PSR:	<b>P-805-008-009</b>
Customer:		Clean Date:	<b>01/01/1900</b>	Shape:	<b>C</b>

Street:	<b>Liberty</b>	Flow Control:	<b>Not Controlled</b>
City:	<b>Hobart, IN</b>	Year Renewed:	
Location:	<b>Alley</b>	Tape/Media #:	
Purpose:	<b>Maintenance Related</b>	Dia/Height:	<b>8"</b>
Use:	<b>Sanitary</b>	Material:	<b>VCP</b>
Drain Area:	<b>NA</b>	Lining:	<b>Cured in Place</b>
Category:	<b>NA</b>		
Comment:	<b>Flow direction wrong. Line full of mud.</b>		
Location Details:		Direction of Survey:	<b>Upstream</b>
US MH:	<b>M-805-009</b>	DS MH:	<b>M-805-008</b>
		Total Length Surveyed (ft):	<b>2.6</b>

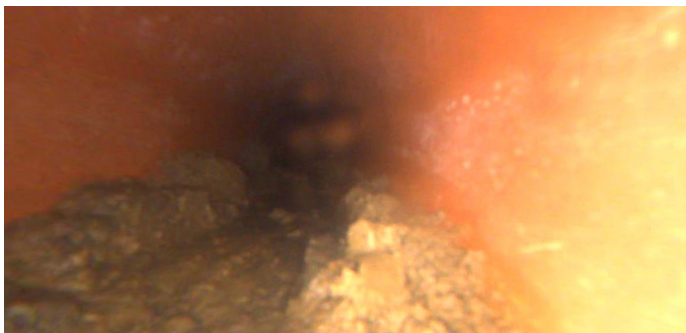
Code: **AMH**  
Description: **Manhole**

Distance (ft): **.0**  
Structural Grade: **0**  
O&M Grade: **0**  
Clock Start/From:  
Clock To:  
1st Value:  
2nd Value:  
Value Percent:  
Continuous Index:  
Within 8" of Joint: **NO**  
Remarks: **M-805-008**

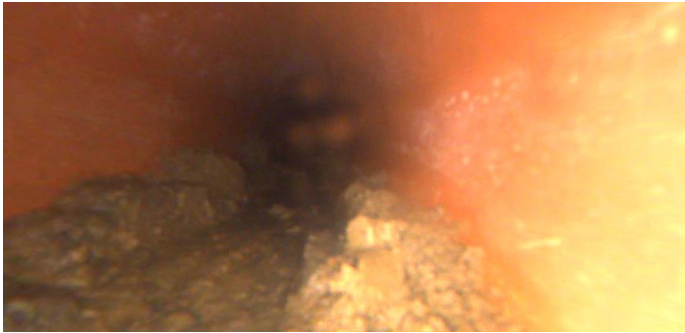
Code:	<b>MWL</b>
Description:	<b>Water Level</b>

Distance (ft):	<b>.0</b>
Structural Grade:	<b>0</b>
O&M Grade:	<b>0</b>
Clock Start/From:	
Clock To:	
1st Value:	
2nd Value:	
Value Percent:	<b>0.000</b>
Continuous Index:	
Within 8" of Joint:	<b>NO</b>
Remarks:

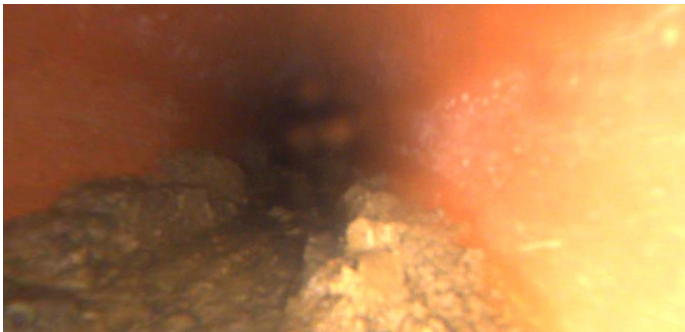
Code:	<b>DSF</b>
Description:	<b>Deposits Settled Fine</b>

Distance (ft):	<b>.0</b>
Structural Grade:	<b>0</b>
O&M Grade:	<b>3</b>
Clock Start/From:	<b>4</b>
Clock To:	<b>8</b>
1st Value:	
2nd Value:	
Value Percent:	<b>20.000</b>
Continuous Index:	
Within 8" of Joint:	<b>NO</b>
Remarks:

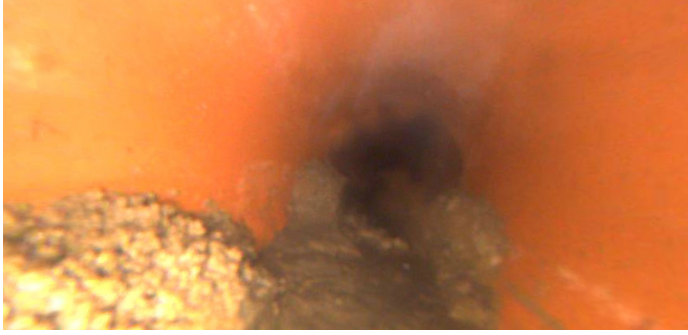
Code:	<b>MSA</b>
Description:	<b>Abandoned Survey</b>
Distance (ft):	<b>2.6</b>
Structural Grade:	<b>0</b>
O&M Grade:	<b>0</b>
Clock Start/From:	
Clock To:	
1st Value:	
2nd Value:	
Value Percent:	
Continuous Index:	
Within 8" of Joint:	<b>NO</b>
Remarks:	<b>dsf</b>
