Profile/Photo Observation Report

Date:	04/23/2018	Weather:		Coding:	PACP 6.0
Pipe Length (ft):	227.3	Owner:	NA	Pre Clean:	Not Known
P.O.#:		Surveyor:	Jen Costello	PSR:	P-805-008-009
Customer:		Clean Date:	01/01/1900	Shape:	C

Street:	E 5TH ST	Flow Control:	Not Controlled
City:	Hobart, IN	Year Renewed:	
Location:	Alley	Tape/Media #:	
Purpose:	Maintenance Related	Dia/Height:	8"
Use:	Sanitary	Material:	PVC
Drain Area:	NA	Lining:	Cured in Place
Category:	NA		
Comment:	Flow direction wrong. Redeployment. Debris at 42'.		
Location Details:		Direction of Survey:	Upstream
US MH:	M-805-009	DS MH:	M-805-008
		Total Length Surveyed (ft):	44.0

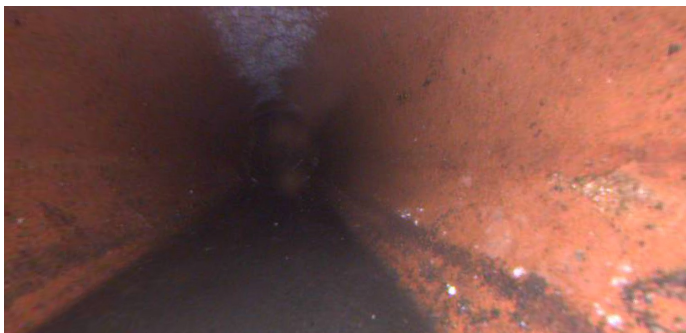
Code: **AMH**
Description: **Manhole**

Distance (ft): **.0**
Structural Grade: **0**
O&M Grade: **0**
Clock Start/From:
Clock To:
1st Value:
2nd Value:
Value Percent:
Continuous Index:
Within 8" of Joint: **NO**
Remarks: **M-805-008**

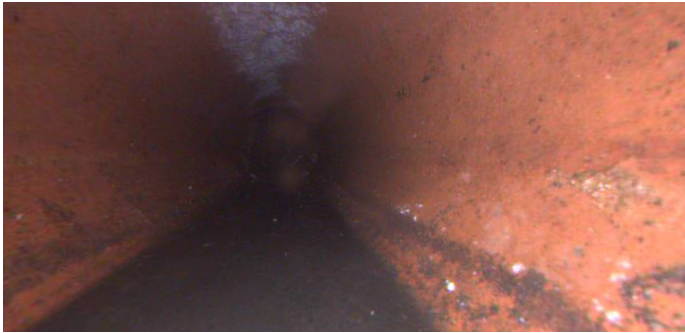
Code:	MWL
Description:	Water Level

Distance (ft):	.0
Structural Grade:	0
O&M Grade:	0
Clock Start/From:	
Clock To:	
1st Value:	
2nd Value:	
Value Percent:	10.000
Continuous Index:	
Within 8" of Joint:	NO
Remarks:

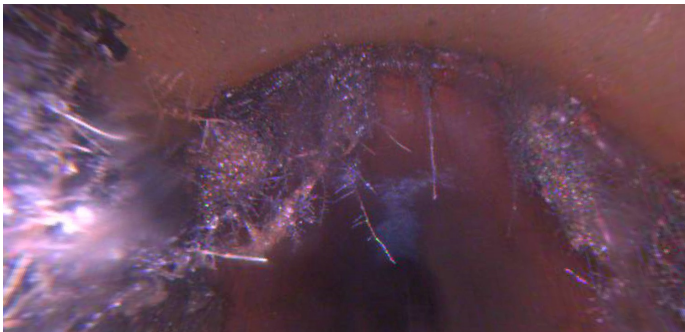
Code:	RMJ
Description:	Roots Medium Joint

Distance (ft):	4.4
Structural Grade:	0
O&M Grade:	3
Clock Start/From:	8
Clock To:	4
1st Value:	
2nd Value:	
Value Percent:	20.000
Continuous Index:	S01
Within 8" of Joint:	YES
Remarks:

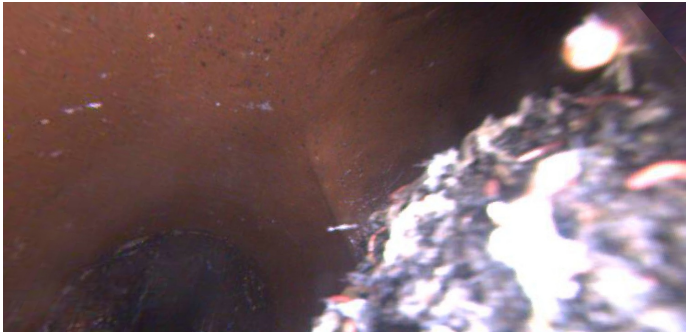
Code: **TFD**
Description: **Tap Factory Defective**

Distance (ft): **4.4**
Structural Grade: **0**
O&M Grade: **2**
Clock Start/From: **2**
Clock To:
1st Value: **4.000**
2nd Value:
Value Percent:
Continuous Index:
Within 8" of Joint:
Remarks: **RML**

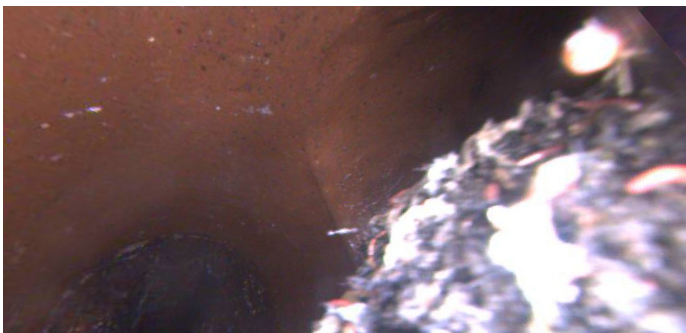
Code: **RML**
Description: **Roots Medium Lateral**

Distance (ft): **4.4**
Structural Grade: **0**
O&M Grade: **3**
Clock Start/From: **1**
Clock To: **4**
1st Value:
2nd Value:
Value Percent: **40.000**
Continuous Index:
Within 8" of Joint: **NO**
Remarks:

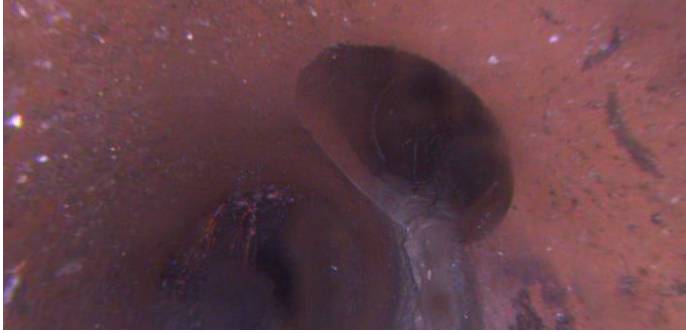
Code: **TFA**
Description: **Tap Factory Active**

Distance (ft): **11.4**
Structural Grade: **0**
O&M Grade: **0**
Clock Start/From: **10**
Clock To:
1st Value: **4.000**
2nd Value:
Value Percent:
Continuous Index:
Within 8" of Joint:
Remarks:

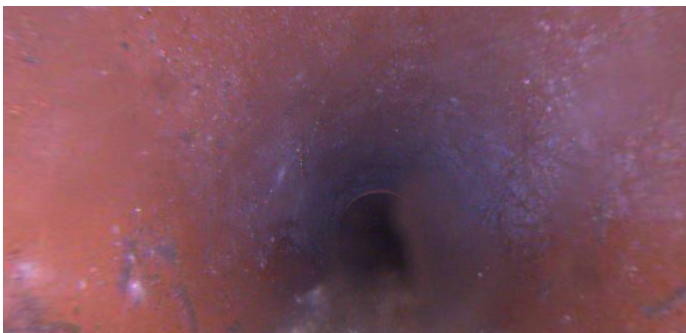
Code: **RMJ**
Description: **Roots Medium Joint**

Distance (ft): **23.0**
Structural Grade: **0**
O&M Grade: **3**
Clock Start/From: **8**
Clock To: **4**
1st Value:
2nd Value:
Value Percent: **20.000**
Continuous Index: **F01**
Within 8" of Joint: **YES**
Remarks:

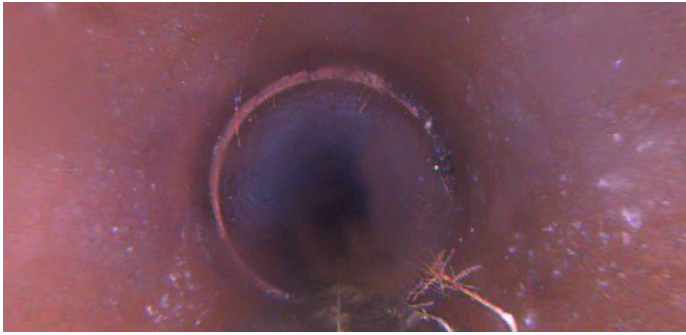
Code: **RFJ**
Description: **Roots Fine Joint**

Distance (ft): **32.9**
Structural Grade: **0**
O&M Grade: **1**
Clock Start/From: **8**
Clock To: **4**
1st Value:
2nd Value:
Value Percent:
Continuous Index:
Within 8" of Joint: **YES**
Remarks:

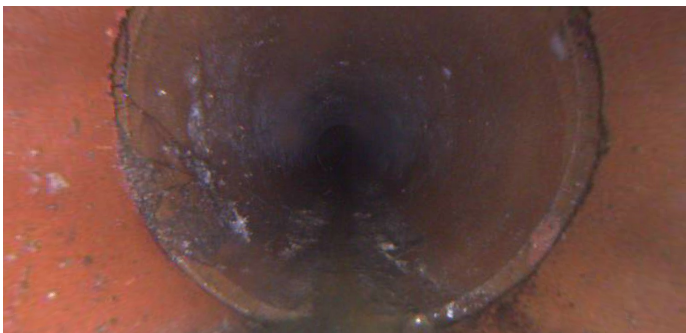
Code: **RFJ**
Description: **Roots Fine Joint**

Distance (ft): **35.4**
Structural Grade: **0**
O&M Grade: **1**
Clock Start/From: **8**
Clock To: **9**
1st Value:
2nd Value:
Value Percent:
Continuous Index:
Within 8" of Joint: **YES**
Remarks:

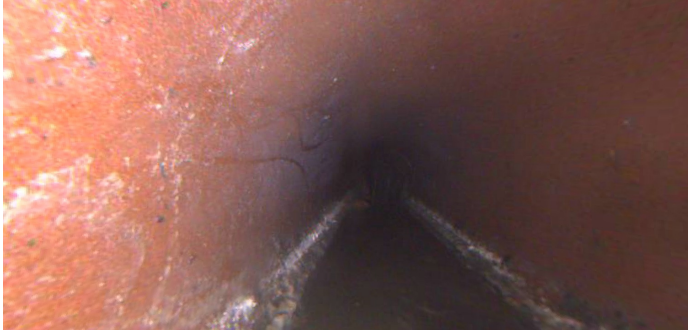
Code:	MSA
Description:	Abandoned Survey
Distance (ft):	44.0
Structural Grade:	0
O&M Grade:	0
Clock Start/From:	
Clock To:	
1st Value:	
2nd Value:	
Value Percent:	
Continuous Index:	
Within 8" of Joint:	NO
Remarks:	DEBRIS UNDER WATER
