Profile/Photo Observation Report

Date:	04/23/2018	Weather:		Coding:	PACP 6.0
Pipe Length (ft):	227.3	Owner:	NA	Pre Clean:	Not Known
P.O.#:		Surveyor:	Jen Costello	PSR:	P-805-008-009
Customer:		Clean Date:	01/01/1900	Shape:	C

Street:	Lawrence	Flow Control:	Not Controlled
City:	Hobart, IN	Year Renewed:	
Location:	Alley	Tape/Media #:	
Purpose:	Maintenance Related	Dia/Height:	8"
Use:	Sanitary	Material:	PVC
Drain Area:	NA	Lining:	Cured in Place
Category:	NA		
Comment:	Flow direction wrong. Redeployment. Debris at 42'.		
Location Details:		Direction of Survey:	Upstream
US MH:	M-805-009	DS MH:	M-805-008
		Total Length Surveyed (ft):	44.0

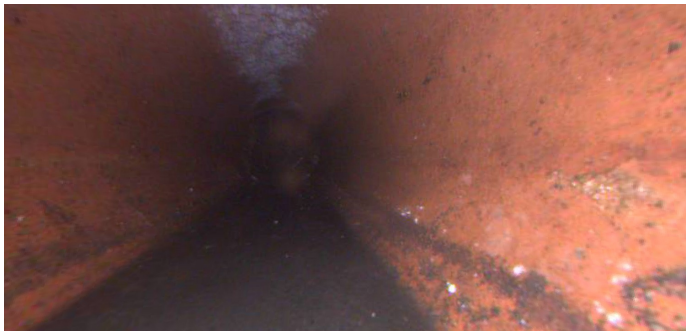
Code: **AMH**
Description: **Manhole**

Distance (ft): **.0**
Structural Grade: **0**
O&M Grade: **0**
Clock Start/From:
Clock To:
1st Value:
2nd Value:
Value Percent:
Continuous Index:
Within 8" of Joint: **NO**
Remarks: **M-805-008**

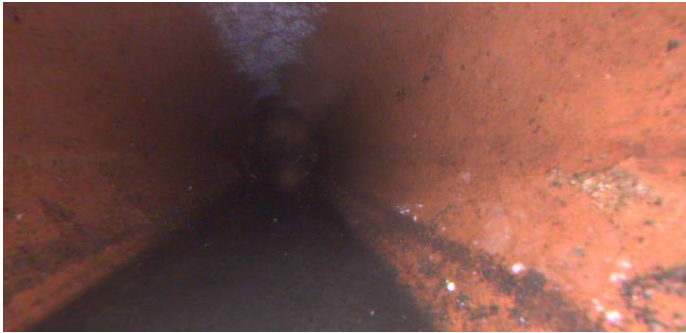
Code:	MWL
Description:	Water Level

Distance (ft):	.0
Structural Grade:	0
O&M Grade:	0
Clock Start/From:	
Clock To:	
1st Value:	
2nd Value:	
Value Percent:	10.000
Continuous Index:	
Within 8" of Joint:	NO
Remarks:

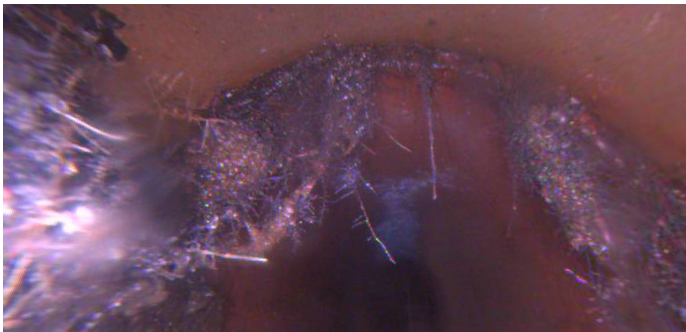
Code:	RMJ
Description:	Roots Medium Joint

Distance (ft):	4.4
Structural Grade:	0
O&M Grade:	3
Clock Start/From:	8
Clock To:	4
1st Value:	
2nd Value:	
Value Percent:	20.000
Continuous Index:	S01
Within 8" of Joint:	YES
Remarks:

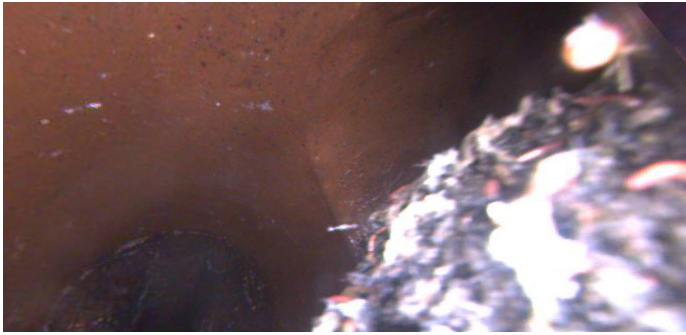
Code: **TFD**
Description: **Tap Factory Defective**

Distance (ft): **4.4**
Structural Grade: **0**
O&M Grade: **2**
Clock Start/From: **2**
Clock To:
1st Value: **4.000**
2nd Value:
Value Percent:
Continuous Index:
Within 8" of Joint:
Remarks: **RML**

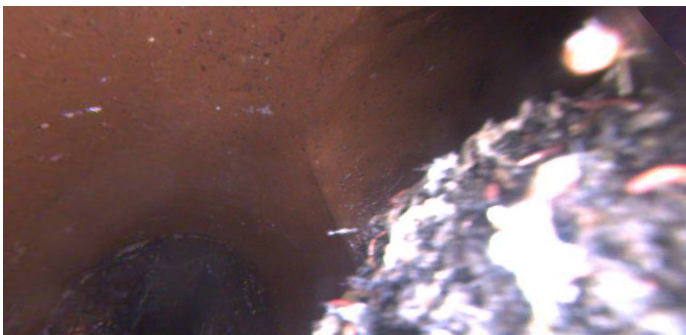
Code: **RML**
Description: **Roots Medium Lateral**

Distance (ft): **4.4**
Structural Grade: **0**
O&M Grade: **3**
Clock Start/From: **1**
Clock To: **4**
1st Value:
2nd Value:
Value Percent: **40.000**
Continuous Index:
Within 8" of Joint: **NO**
Remarks:

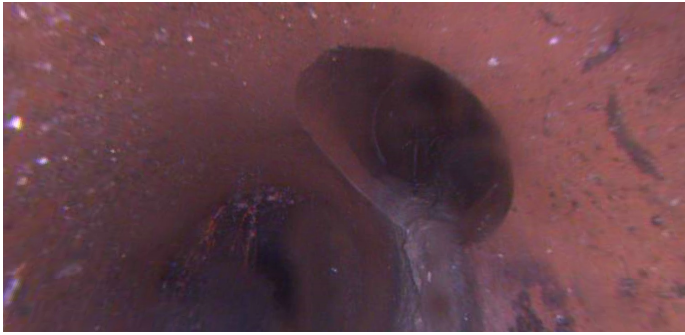
Code: **TFA**
Description: **Tap Factory Active**

Distance (ft): **11.4**
Structural Grade: **0**
O&M Grade: **0**
Clock Start/From: **10**
Clock To:
1st Value: **4.000**
2nd Value:
Value Percent:
Continuous Index:
Within 8" of Joint:
Remarks:

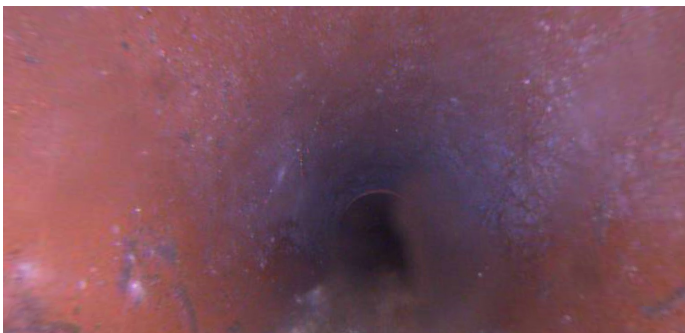
Code: **RMJ**
Description: **Roots Medium Joint**

Distance (ft): **23.0**
Structural Grade: **0**
O&M Grade: **3**
Clock Start/From: **8**
Clock To: **4**
1st Value:
2nd Value:
Value Percent: **20.000**
Continuous Index: **F01**
Within 8" of Joint: **YES**
Remarks:

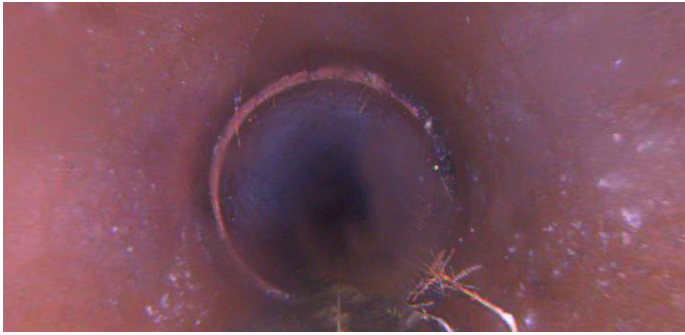
Code: **RFJ**
Description: **Roots Fine Joint**

Distance (ft): **32.9**
Structural Grade: **0**
O&M Grade: **1**
Clock Start/From: **8**
Clock To: **4**
1st Value:
2nd Value:
Value Percent:
Continuous Index:
Within 8" of Joint: **YES**
Remarks:

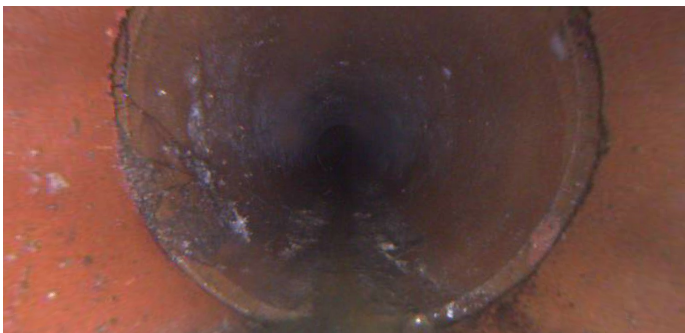
Code: **RFJ**
Description: **Roots Fine Joint**

Distance (ft): **35.4**
Structural Grade: **0**
O&M Grade: **1**
Clock Start/From: **8**
Clock To: **9**
1st Value:
2nd Value:
Value Percent:
Continuous Index:
Within 8" of Joint: **YES**
Remarks:

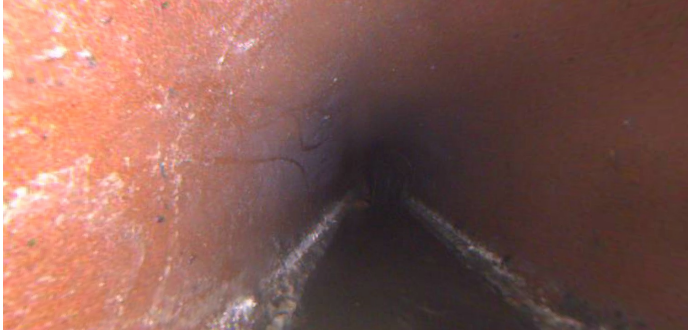
Code:	MSA
Description:	Abandoned Survey
Distance (ft):	44.0
Structural Grade:	0
O&M Grade:	0
Clock Start/From:	
Clock To:	
1st Value:	
2nd Value:	
Value Percent:	
Continuous Index:	
Within 8" of Joint:	NO
Remarks:	DEBRIS UNDER WATER
