Profile/Photo Observation Report

Date:	04/22/2018	Weather:		Coding:	PACP 6.0
Pipe Length (ft):	250.2	Owner:	NA	Pre Clean:	Not Known
P.O.#:		Surveyor:	Mark Ruby	PSR:	P-805-010-009
Customer:		Clean Date:	01/01/1900	Shape:	C

Street:	E 5TH ST	Flow Control:	Not Controlled
City:	Hobart, IN	Year Renewed:	
Location:	Alley	Tape/Media #:	
Purpose:	Maintenance Related	Dia/Height:	12"
Use:	Sanitary	Material:	PVC
Drain Area:	NA	Lining:	Cured in Place
Category:	NA		
Comment:	flow incorrect. User Set max at 251'.		
Location Details:		Direction of Survey:	Upstream
US MH:	M-805-009	DS MH:	M-805-010
		Total Length Surveyed (ft):	252.5

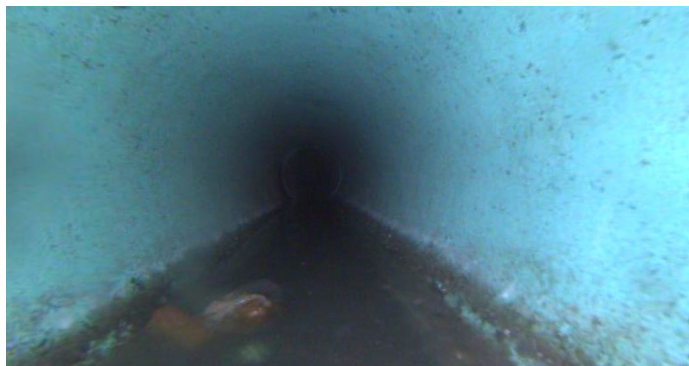
Code: **AMH**
Description: **Manhole**

Distance (ft): **.0**
Structural Grade: **0**
O&M Grade: **0**
Clock Start/From:
Clock To:
1st Value:
2nd Value:
Value Percent:
Continuous Index:
Within 8" of Joint: **NO**
Remarks: **M-805-010**

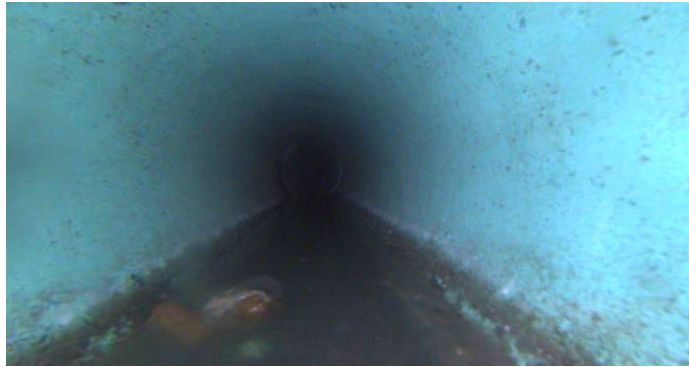
Code: **MWL**
Description: **Water Level**

Distance (ft): **.0**
Structural Grade: **0**
O&M Grade: **0**
Clock Start/From:
Clock To:
1st Value:
2nd Value:
Value Percent: **10.000**
Continuous Index:
Within 8" of Joint: **NO**
Remarks:

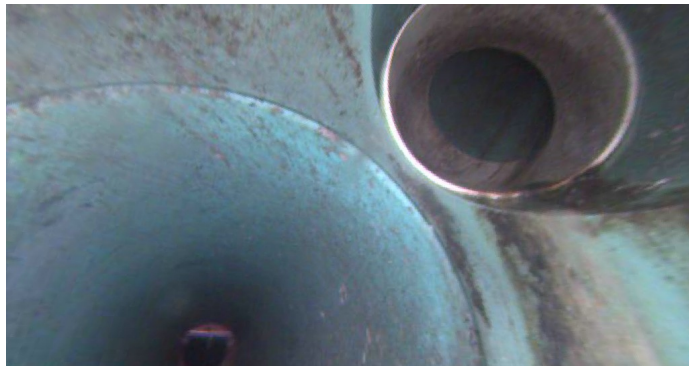
Code: **TF**
Description: **Tap Factory**

Distance (ft): **6.2**
Structural Grade: **0**
O&M Grade: **0**
Clock Start/From: **10**
Clock To:
1st Value: **4.000**
2nd Value:
Value Percent:
Continuous Index:
Within 8" of Joint:
Remarks:

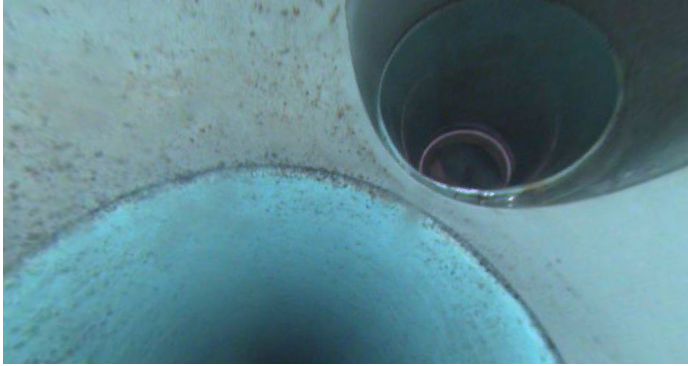
Code: **TF**
Description: **Tap Factory**

Distance (ft): **54.1**
Structural Grade: **0**
O&M Grade: **0**
Clock Start/From: **10**
Clock To:
1st Value: **4.000**
2nd Value:
Value Percent:
Continuous Index:
Within 8" of Joint:
Remarks:

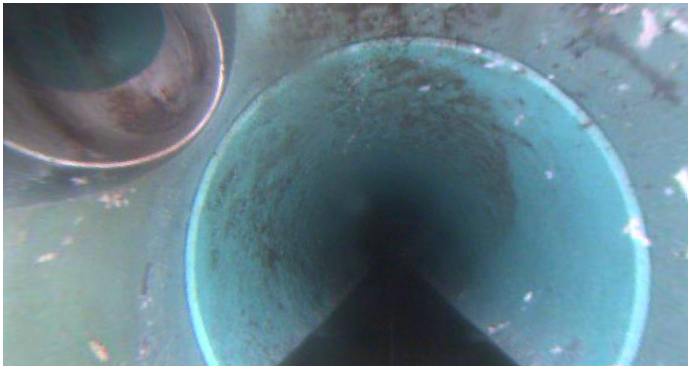
Code: **TF**
Description: **Tap Factory**

Distance (ft): **65.8**
Structural Grade: **0**
O&M Grade: **0**
Clock Start/From: **2**
Clock To:
1st Value: **4.000**
2nd Value:
Value Percent:
Continuous Index:
Within 8" of Joint:
Remarks:

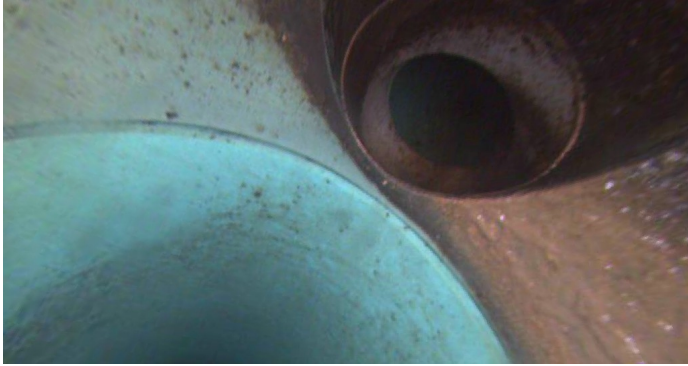
Code: **TF**
Description: **Tap Factory**

Distance (ft): **96.7**
Structural Grade: **0**
O&M Grade: **0**
Clock Start/From: **10**
Clock To:
1st Value: **4.000**
2nd Value:
Value Percent:
Continuous Index:
Within 8" of Joint:
Remarks:

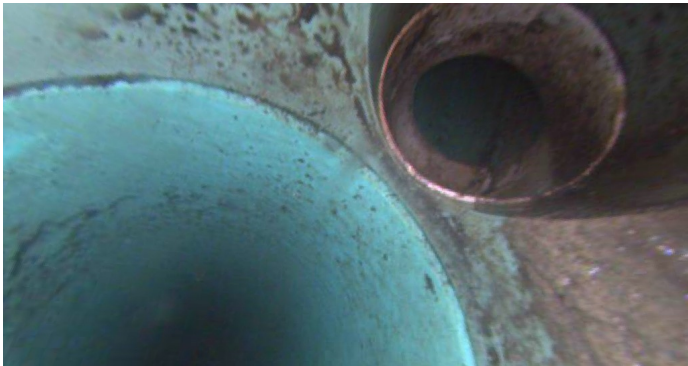
Code: **TF**
Description: **Tap Factory**

Distance (ft): **176.9**
Structural Grade: **0**
O&M Grade: **0**
Clock Start/From: **10**
Clock To:
1st Value: **4.000**
2nd Value:
Value Percent:
Continuous Index:
Within 8" of Joint:
Remarks:

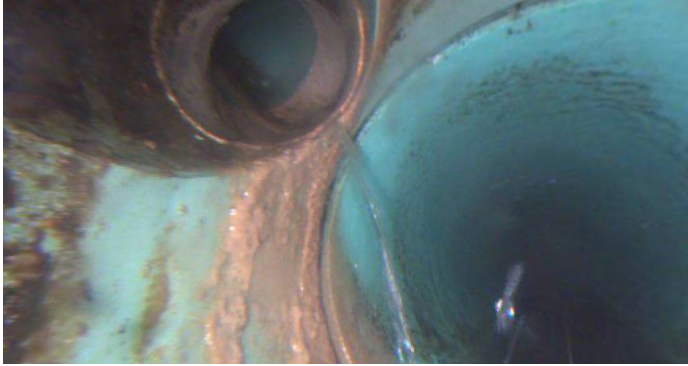
Code: **TFA**
Description: **Tap Factory Active**

Distance (ft): **210.2**
Structural Grade: **0**
O&M Grade: **0**
Clock Start/From: **2**
Clock To:
1st Value: **4.000**
2nd Value:
Value Percent:
Continuous Index:
Within 8" of Joint:
Remarks:

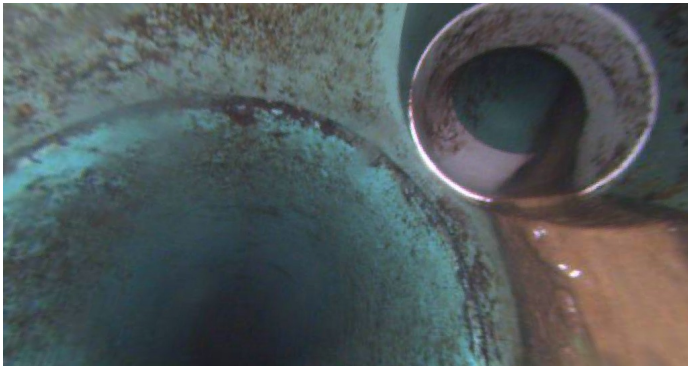
Code: **TF**
Description: **Tap Factory**

Distance (ft): **228.3**
Structural Grade: **0**
O&M Grade: **0**
Clock Start/From: **10**
Clock To:
1st Value: **4.000**
2nd Value:
Value Percent:
Continuous Index:
Within 8" of Joint:
Remarks:

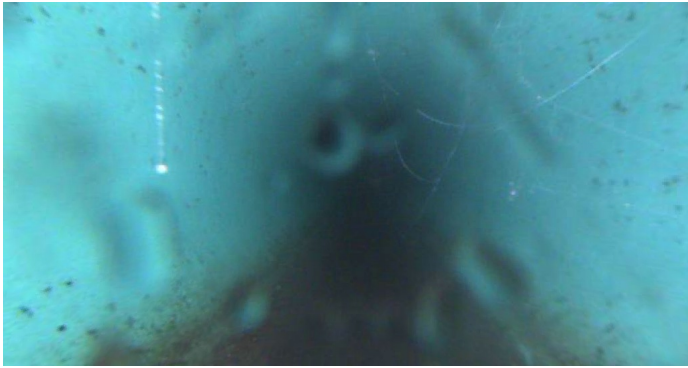
Code:	MSA
Description:	Abandoned Survey
Distance (ft):	252.5
Structural Grade:	0
O&M Grade:	0
Clock Start/From:	
Clock To:	
1st Value:	
2nd Value:	
Value Percent:	
Continuous Index:	
Within 8" of Joint:	NO
Remarks:	No blockage
