Profile/Photo Observation Report

Street:	Capitol	Flow Control:	Not Controlled
City:	Hobart, IN	Year Renewed:	
Location:	Alley	Tape/Media #:	
Purpose:	Maintenance Related	Dia/Height:	12"
Use:	Sanitary	Material:	PVC
Drain Area:	NA	Lining:	Cured in Place
Category:	NA		
Comment:	flow incorrect. User Set max at 251'.

Location Details:		Direction of Survey:	Upstream
US MH:	M-805-009	DS MH:	M-805-010
		Total Length Surveyed (ft):	252.5

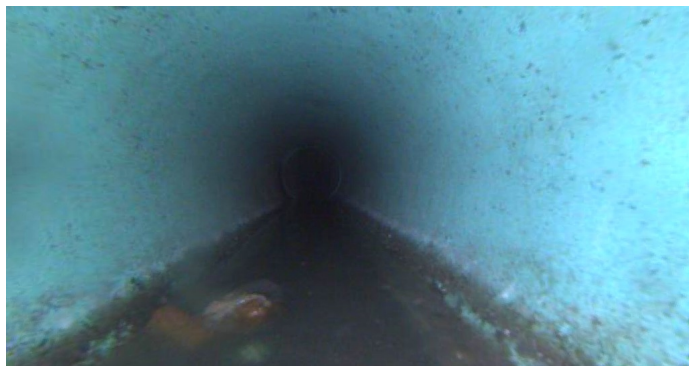
Code: **AMH**
 Description: **Manhole**

Distance (ft): **.0**
 Structural Grade: **0**
 O&M Grade: **0**
 Clock Start/From:
 Clock To:
 1st Value:
 2nd Value:
 Value Percent:
 Continuous Index:
 Within 8" of Joint: **NO**
 Remarks: **M-805-010**

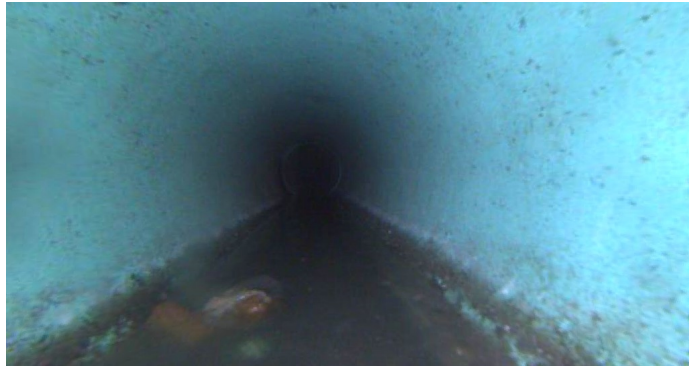
Code:	MWL
Description:	Water Level
Distance (ft):	.0
Structural Grade:	0
O&M Grade:	0
Clock Start/From:	
Clock To:	
1st Value:	
2nd Value:	
Value Percent:	10.000
Continuous Index:	
Within 8" of Joint:	NO
Remarks:

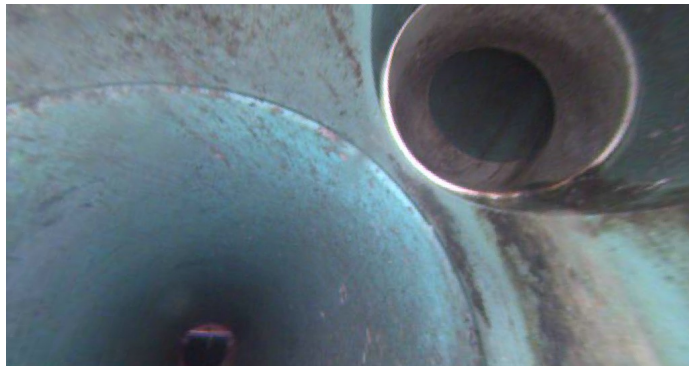
Code:	TF
Description:	Tap Factory
Distance (ft):	6.2
Structural Grade:	0
O&M Grade:	0
Clock Start/From:	10
Clock To:	
1st Value:	4.000
2nd Value:	
Value Percent:	
Continuous Index:	
Within 8" of Joint:	
Remarks:

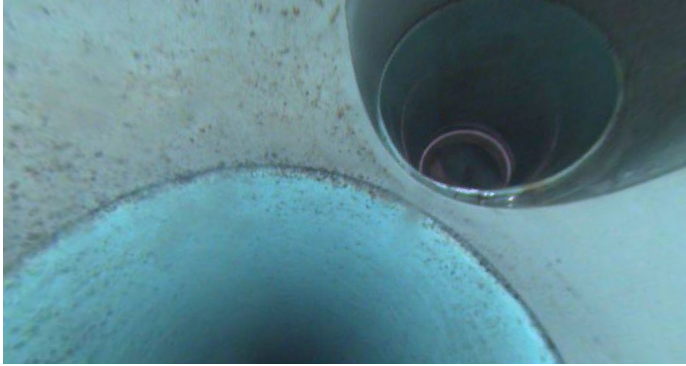
Code: **TF**
Description: **Tap Factory**

Distance (ft): **54.1**
Structural Grade: **0**
O&M Grade: **0**
Clock Start/From: **10**
Clock To:
1st Value: **4.000**
2nd Value:
Value Percent:
Continuous Index:
Within 8" of Joint:
Remarks:

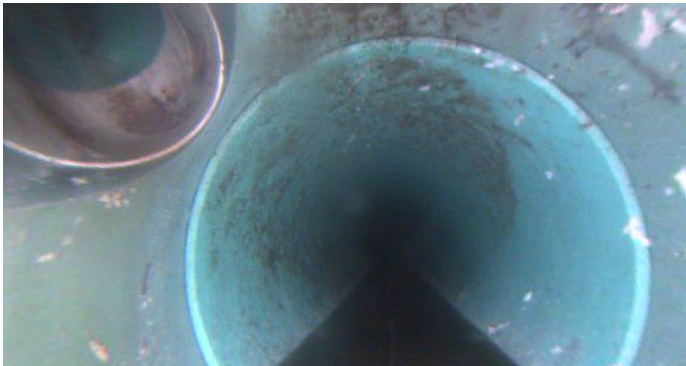
Code: **TF**
Description: **Tap Factory**

Distance (ft): **65.8**
Structural Grade: **0**
O&M Grade: **0**
Clock Start/From: **2**
Clock To:
1st Value: **4.000**
2nd Value:
Value Percent:
Continuous Index:
Within 8" of Joint:
Remarks:

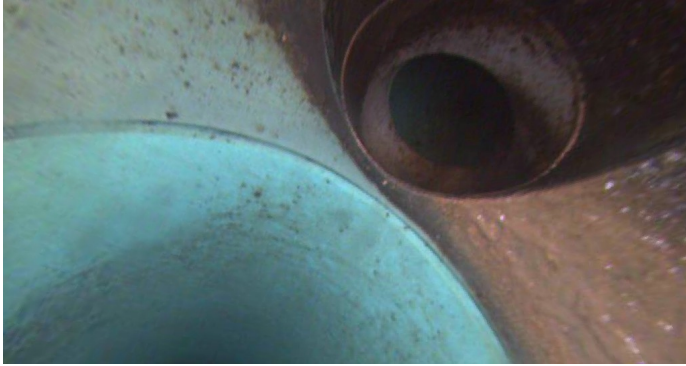
Code: **TF**
Description: **Tap Factory**

Distance (ft): **96.7**
Structural Grade: **0**
O&M Grade: **0**
Clock Start/From: **10**
Clock To:
1st Value: **4.000**
2nd Value:
Value Percent:
Continuous Index:
Within 8" of Joint:
Remarks:

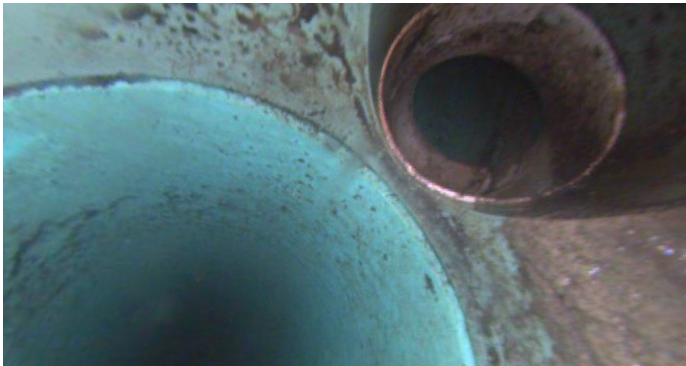
Code: **TF**
Description: **Tap Factory**

Distance (ft): **176.9**
Structural Grade: **0**
O&M Grade: **0**
Clock Start/From: **10**
Clock To:
1st Value: **4.000**
2nd Value:
Value Percent:
Continuous Index:
Within 8" of Joint:
Remarks:

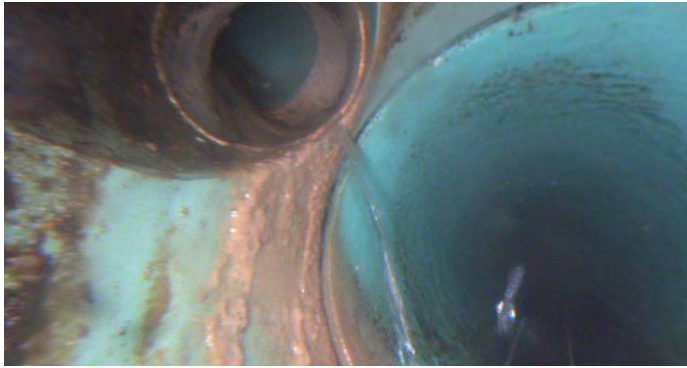
Code: **TFA**
Description: **Tap Factory Active**

Distance (ft): **210.2**
Structural Grade: **0**
O&M Grade: **0**
Clock Start/From: **2**
Clock To:
1st Value: **4.000**
2nd Value:
Value Percent:
Continuous Index:
Within 8" of Joint:
Remarks:

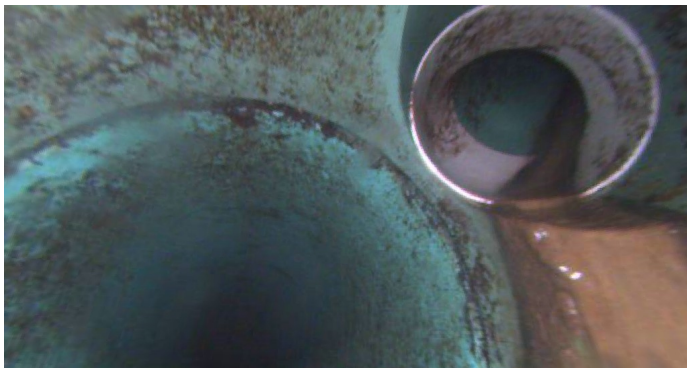
Code: **TF**
Description: **Tap Factory**

Distance (ft): **228.3**
Structural Grade: **0**
O&M Grade: **0**
Clock Start/From: **10**
Clock To:
1st Value: **4.000**
2nd Value:
Value Percent:
Continuous Index:
Within 8" of Joint:
Remarks:

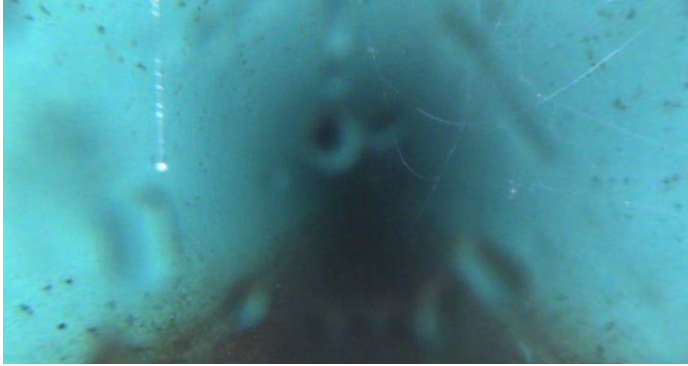
Code:	MSA
Description:	Abandoned Survey
Distance (ft):	252.5
Structural Grade:	0
O&M Grade:	0
Clock Start/From:	
Clock To:	
1st Value:	
2nd Value:	
Value Percent:	
Continuous Index:	
Within 8" of Joint:	NO
Remarks:	No blockage
