Profile/Photo Observation Report

Date:	04/22/2018	Weather:		Coding:	PACP 6.0
Pipe Length (ft):	238.3	Owner:	NA	Pre Clean:	Not Known
P.O.#:		Surveyor:	Mark Ruby	PSR:	P-805-012-013
Customer:		Clean Date:	01/01/1900	Shape:	C

Street:	E 5TH ST	Flow Control:	Not Controlled
City:	Hobart, IN	Year Renewed:	
Location:	Alley	Tape/Media #:	
Purpose:	Maintenance Related	Dia/Height:	10"
Use:	Sanitary	Material:	VCP
Drain Area:	NA	Lining:	Cured in Place
Category:	NA		
Comment:	flow reversed. false MH near tap at 127'.

Location Details:		Direction of Survey:	Upstream
US MH:	M-805-013	DS MH:	M-805-012
		Total Length Surveyed (ft):	128.6

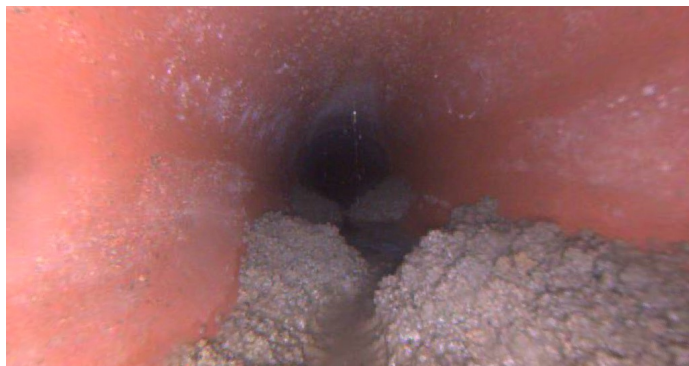
Code: **AMH**
Description: **Manhole**

Distance (ft): **.0**
Structural Grade: **0**
O&M Grade: **0**
Clock Start/From:
Clock To:
1st Value:
2nd Value:
Value Percent:
Continuous Index:
Within 8" of Joint: **NO**
Remarks: **M-805-012**

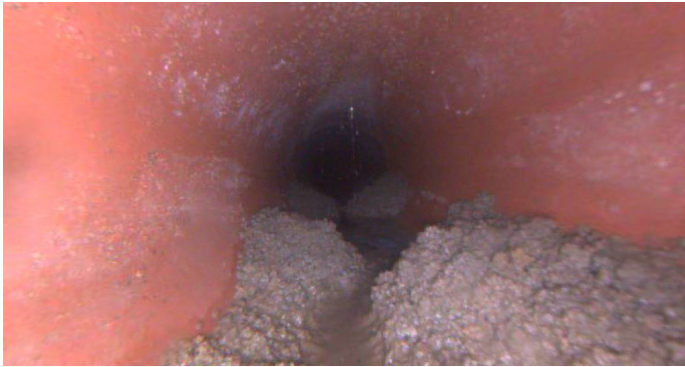
Code:	MWL
Description:	Water Level

Distance (ft):	.0
Structural Grade:	0
O&M Grade:	0
Clock Start/From:	
Clock To:	
1st Value:	
2nd Value:	
Value Percent:	10.000
Continuous Index:	
Within 8" of Joint:	NO
Remarks:

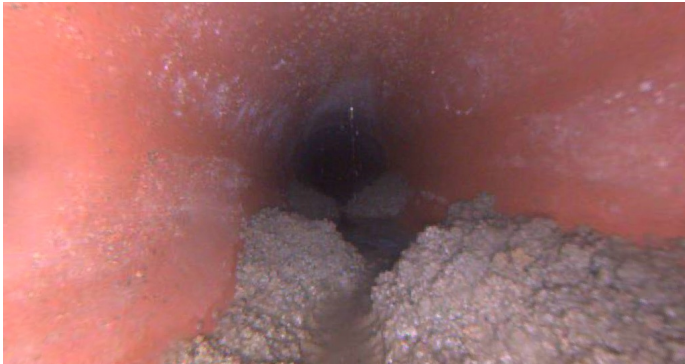
Code:	DAZ
Description:	Deposits Attached Other

Distance (ft):	.0
Structural Grade:	0
O&M Grade:	2
Clock Start/From:	5
Clock To:	7
1st Value:	
2nd Value:	
Value Percent:	5.000
Continuous Index:	
Within 8" of Joint:	NO
Remarks:

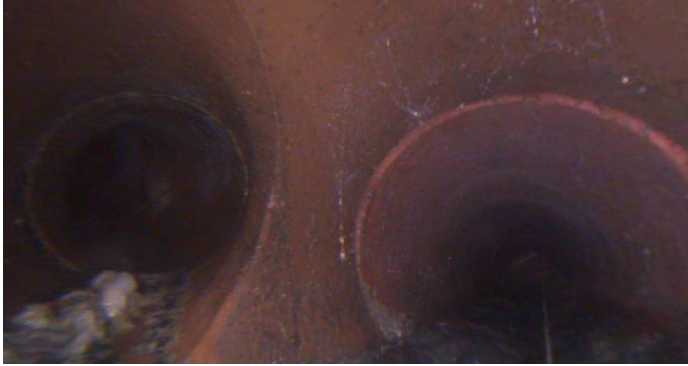
Code: **TF**
Description: **Tap Factory**

Distance (ft): **8.9**
Structural Grade: **0**
O&M Grade: **0**
Clock Start/From: **4**
Clock To:
1st Value: **4.000**
2nd Value:
Value Percent:
Continuous Index:
Within 8" of Joint:
Remarks:

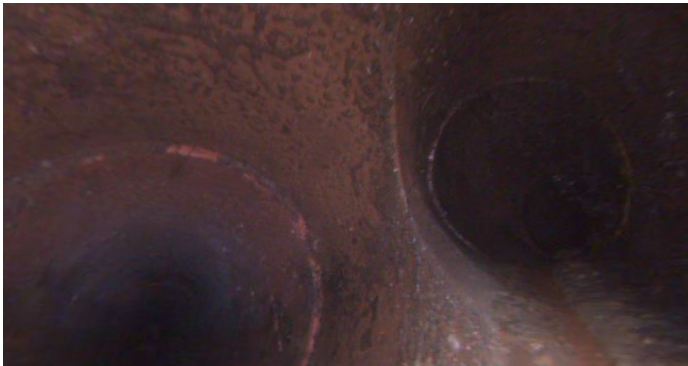
Code: **TF**
Description: **Tap Factory**

Distance (ft): **27.2**
Structural Grade: **0**
O&M Grade: **0**
Clock Start/From: **9**
Clock To:
1st Value: **4.000**
2nd Value:
Value Percent:
Continuous Index:
Within 8" of Joint:
Remarks:

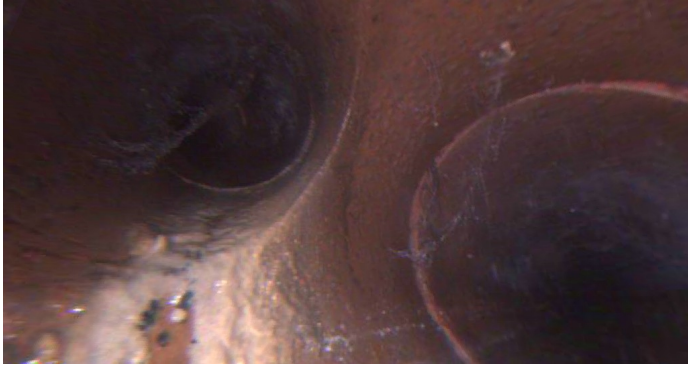
Code: **TF**
Description: **Tap Factory**

Distance (ft): **49.6**
Structural Grade: **0**
O&M Grade: **0**
Clock Start/From: **3**
Clock To:
1st Value: **4.000**
2nd Value:
Value Percent:
Continuous Index:
Within 8" of Joint:
Remarks:

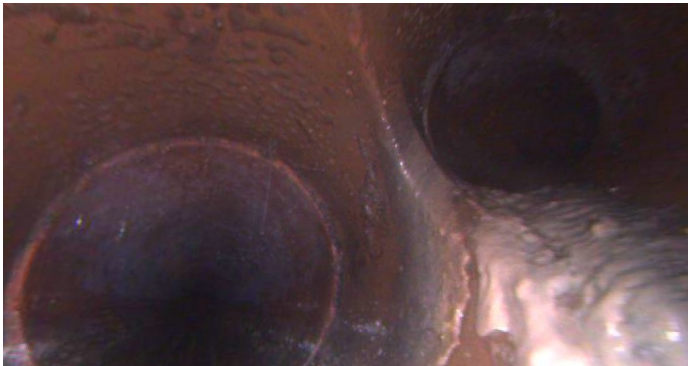
Code: **TF**
Description: **Tap Factory**

Distance (ft): **64.1**
Structural Grade: **0**
O&M Grade: **0**
Clock Start/From: **10**
Clock To:
1st Value: **4.000**
2nd Value:
Value Percent:
Continuous Index:
Within 8" of Joint:
Remarks:

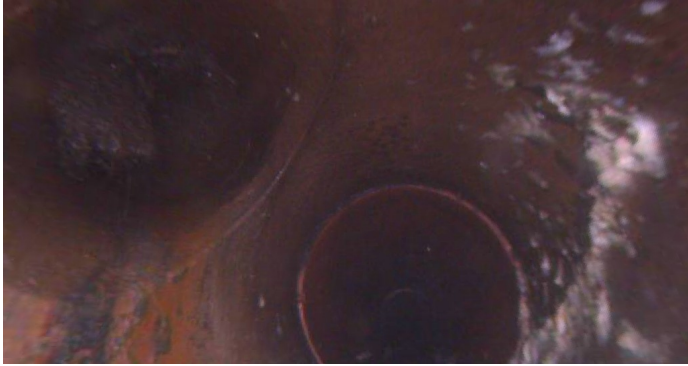
Code: **TF**
Description: **Tap Factory**

Distance (ft): **111.2**
Structural Grade: **0**
O&M Grade: **0**
Clock Start/From: **2**
Clock To:
1st Value: **4.000**
2nd Value:
Value Percent:
Continuous Index:
Within 8" of Joint:
Remarks:

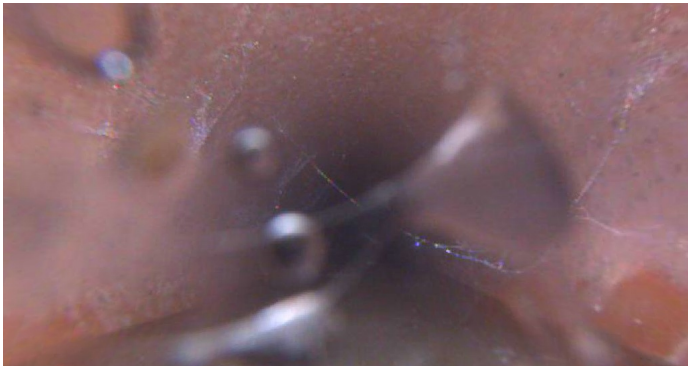
Code: **MSA**
Description: **Abandoned Survey**

Distance (ft): **128.6**
Structural Grade: **0**
O&M Grade: **0**
Clock Start/From:
Clock To:
1st Value:
2nd Value:
Value Percent:
Continuous Index:
Within 8" of Joint: **NO**
Remarks: **Debris under water**
