## Profile/Photo Observation Report

Date:	<b>04/22/2018</b>	Weather:		Coding:	<b>PACP 6.0</b>
Pipe Length (ft):	<b>238.3</b>	Owner:	<b>NA</b>	Pre Clean:	<b>Not Known</b>
P.O.#:		Surveyor:	<b>Mark Ruby</b>	PSR:	<b>P-805-012-013</b>
Customer:		Clean Date:	<b>01/01/1900</b>	Shape:	<b>C</b>

Street:	<b>Capitol</b>	Flow Control:	<b>Not Controlled</b>
City:	<b>Hobart, IN</b>	Year Renewed:	
Location:	<b>Alley</b>	Tape/Media #:	
Purpose:	<b>Maintenance Related</b>	Dia/Height:	<b>10"</b>
Use:	<b>Sanitary</b>	Material:	<b>VCP</b>
Drain Area:	<b>NA</b>	Lining:	<b>Cured in Place</b>
Category:	<b>NA</b>		
Comment:	<b>flow reversed. false MH near tap at 127'.</b>

Location Details:		Direction of Survey:	<b>Upstream</b>
US MH:	<b>M-805-013</b>	DS MH:	<b>M-805-012</b>
		Total Length Surveyed (ft):	<b>128.6</b>

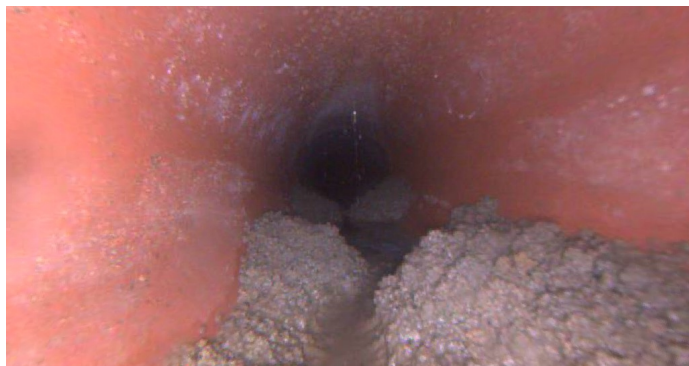
Code: **AMH**  
 Description: **Manhole**

Distance (ft): **.0**  
 Structural Grade: **0**  
 O&M Grade: **0**  
 Clock Start/From:  
 Clock To:  
 1st Value:  
 2nd Value:  
 Value Percent:  
 Continuous Index:  
 Within 8" of Joint: **NO**  
 Remarks: **M-805-012**

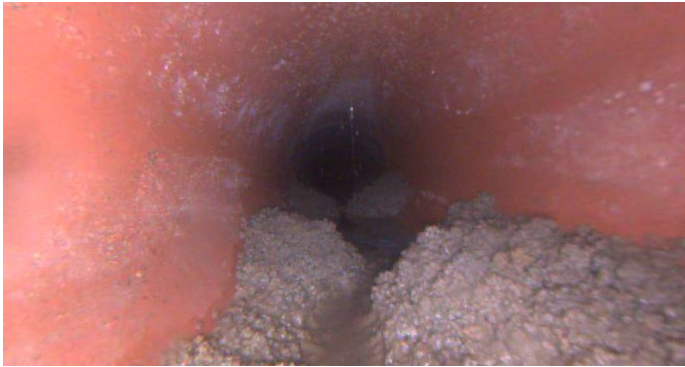
Code:	<b>MWL</b>
Description:	<b>Water Level</b>

Distance (ft):	<b>.0</b>
Structural Grade:	<b>0</b>
O&M Grade:	<b>0</b>
Clock Start/From:	
Clock To:	
1st Value:	
2nd Value:	
Value Percent:	<b>10.000</b>
Continuous Index:	
Within 8" of Joint:	<b>NO</b>
Remarks:

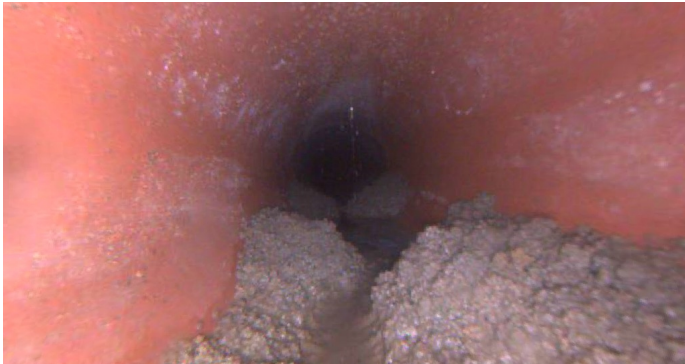
Code:	<b>DAZ</b>
Description:	<b>Deposits Attached Other</b>

Distance (ft):	<b>.0</b>
Structural Grade:	<b>0</b>
O&M Grade:	<b>2</b>
Clock Start/From:	<b>5</b>
Clock To:	<b>7</b>
1st Value:	
2nd Value:	
Value Percent:	<b>5.000</b>
Continuous Index:	
Within 8" of Joint:	<b>NO</b>
Remarks:

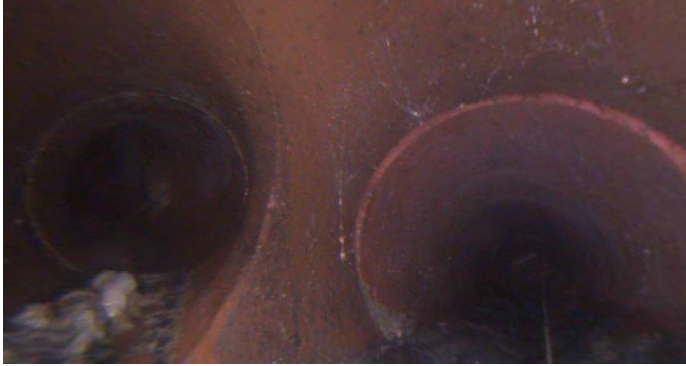
Code: **TF**  
Description: **Tap Factory**

Distance (ft): **8.9**  
Structural Grade: **0**  
O&M Grade: **0**  
Clock Start/From: **4**  
Clock To:  
1st Value: **4.000**  
2nd Value:  
Value Percent:  
Continuous Index:  
Within 8" of Joint:  
Remarks:

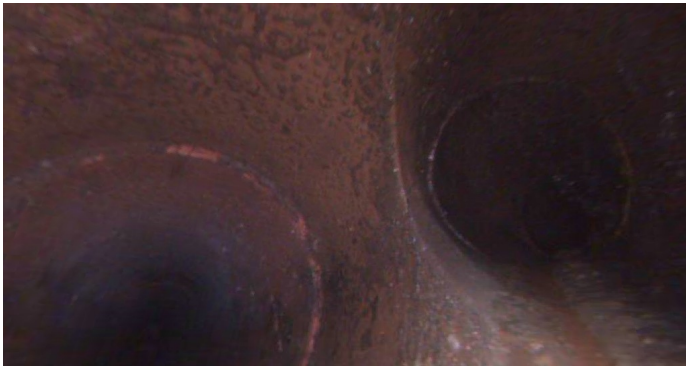
Code: **TF**  
Description: **Tap Factory**

Distance (ft): **27.2**  
Structural Grade: **0**  
O&M Grade: **0**  
Clock Start/From: **9**  
Clock To:  
1st Value: **4.000**  
2nd Value:  
Value Percent:  
Continuous Index:  
Within 8" of Joint:  
Remarks:

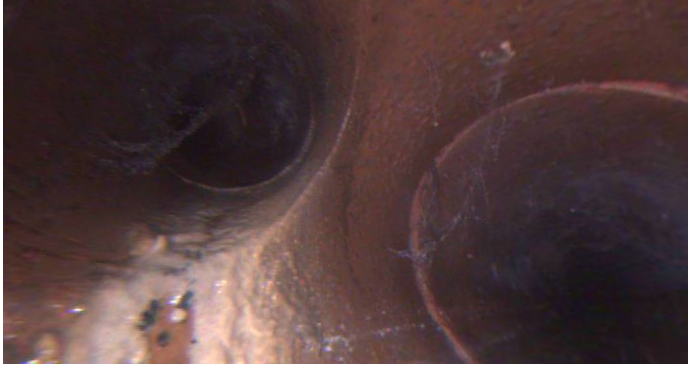
Code: **TF**  
Description: **Tap Factory**

Distance (ft): **49.6**  
Structural Grade: **0**  
O&M Grade: **0**  
Clock Start/From: **3**  
Clock To:  
1st Value: **4.000**  
2nd Value:  
Value Percent:  
Continuous Index:  
Within 8" of Joint:  
Remarks:

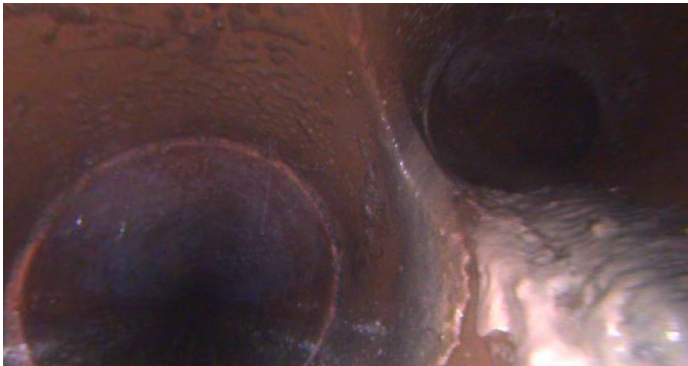
Code: **TF**  
Description: **Tap Factory**

Distance (ft): **64.1**  
Structural Grade: **0**  
O&M Grade: **0**  
Clock Start/From: **10**  
Clock To:  
1st Value: **4.000**  
2nd Value:  
Value Percent:  
Continuous Index:  
Within 8" of Joint:  
Remarks:

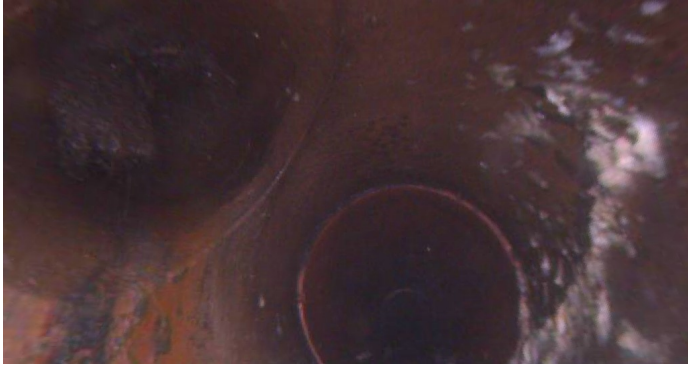
Code: **TF**  
Description: **Tap Factory**

Distance (ft): **111.2**  
Structural Grade: **0**  
O&M Grade: **0**  
Clock Start/From: **2**  
Clock To:  
1st Value: **4.000**  
2nd Value:  
Value Percent:  
Continuous Index:  
Within 8" of Joint:  
Remarks:

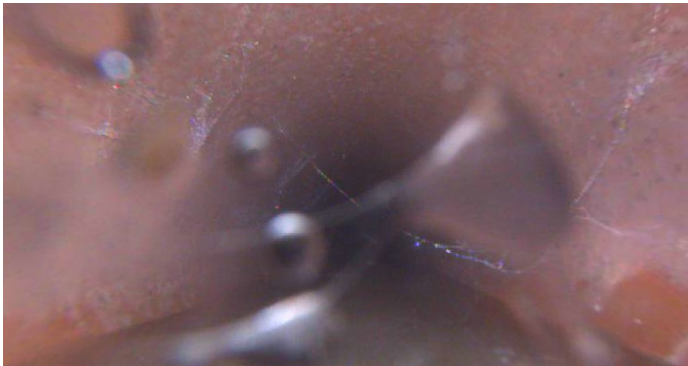
Code: **MSA**  
Description: **Abandoned Survey**

Distance (ft): **128.6**  
Structural Grade: **0**  
O&M Grade: **0**  
Clock Start/From:  
Clock To:  
1st Value:  
2nd Value:  
Value Percent:  
Continuous Index:  
Within 8" of Joint: **NO**  
Remarks: **Debris under water**
