Profile/Photo Observation Report

Date:	04/22/2018	Weather:		Coding:	PACP 6.0
Pipe Length (ft):	162.9	Owner:	NA	Pre Clean:	Not Known
P.O.#:		Surveyor:	Mark Ruby	PSR:	P-805-014-013
Customer:		Clean Date:	01/01/1900	Shape:	C

Street:	E 5TH ST	Flow Control:	Not Controlled
City:	Hobart, IN	Year Renewed:	
Location:	Alley	Tape/Media #:	
Purpose:	Maintenance Related	Dia/Height:	10"
Use:	Sanitary	Material:	VCP
Drain Area:	NA	Lining:	Cured in Place
Category:	NA		
Comment:	user set max at 153'.-flow incorrect.

Location Details:		Direction of Survey:	Upstream
US MH:	M-805-013	DS MH:	M-805-014
		Total Length Surveyed (ft):	154.4

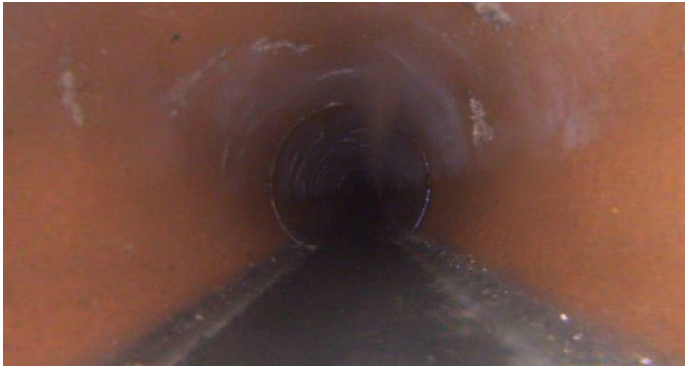
Code:	MWL
Description:	Water Level

Distance (ft):	.0
Structural Grade:	0
O&M Grade:	0
Clock Start/From:	
Clock To:	
1st Value:	
2nd Value:	
Value Percent:	10.000
Continuous Index:	
Within 8" of Joint:	NO
Remarks:

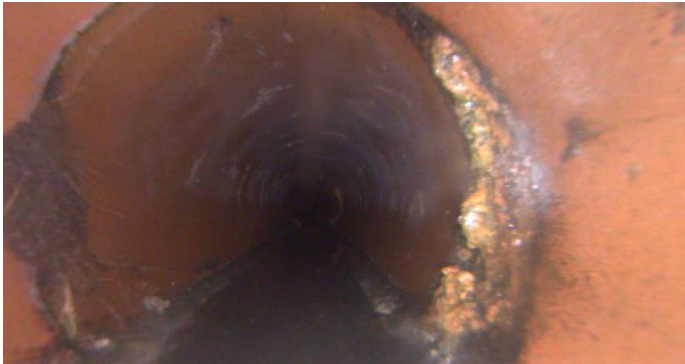
Code:	DAZ
Description:	Deposits Attached Other

Distance (ft):	5.8
Structural Grade:	0
O&M Grade:	2
Clock Start/From:	7
Clock To:	5
1st Value:	
2nd Value:	
Value Percent:	5.000
Continuous Index:	
Within 8" of Joint:	YES
Remarks:

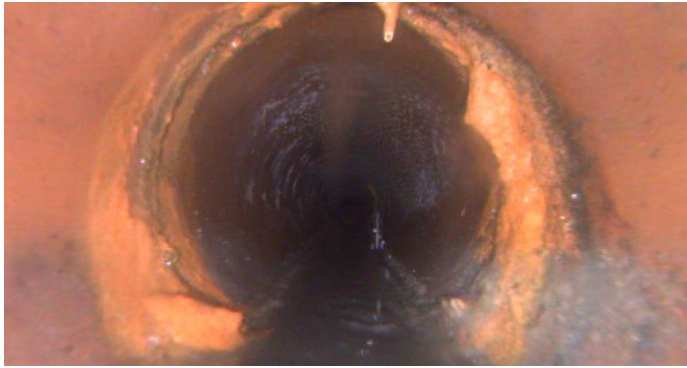
Code:	DAZ
Description:	Deposits Attached Other
Distance (ft):	9.7
Structural Grade:	0
O&M Grade:	2
Clock Start/From:	7
Clock To:	5
1st Value:	
2nd Value:	
Value Percent:	5.000
Continuous Index:	
Within 8" of Joint:	YES
Remarks:

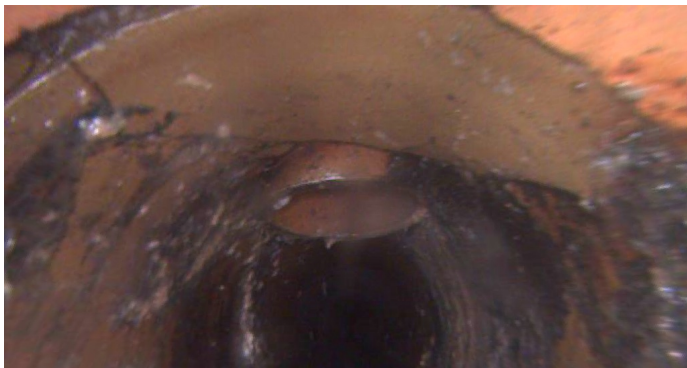
Code:	CS
Description:	Crack Spiral
Distance (ft):	62.4
Structural Grade:	2
O&M Grade:	0
Clock Start/From:	10
Clock To:	2
1st Value:	
2nd Value:	
Value Percent:	
Continuous Index:	
Within 8" of Joint:	YES
Remarks:

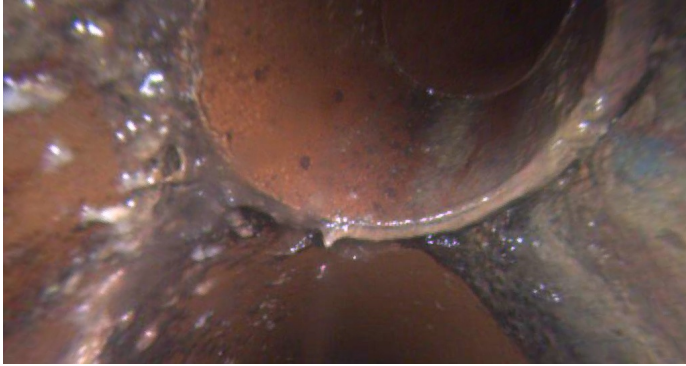
Code: **TB**
Description: **Tap Break-in**

Distance (ft): **63.2**
Structural Grade: **0**
O&M Grade: **0**
Clock Start/From: **1**
Clock To:
1st Value: **4.000**
2nd Value:
Value Percent:
Continuous Index:
Within 8" of Joint:
Remarks:

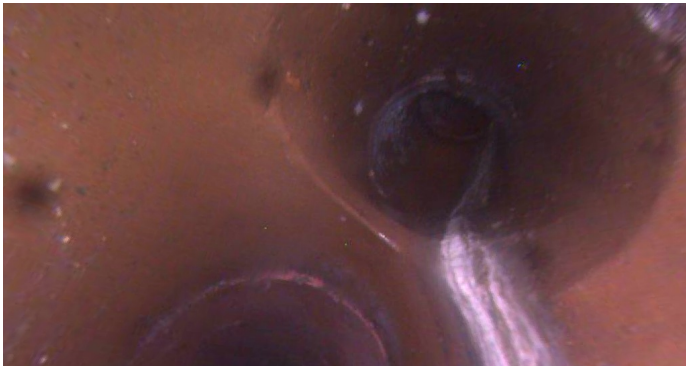
Code: **TF**
Description: **Tap Factory**

Distance (ft): **75.9**
Structural Grade: **0**
O&M Grade: **0**
Clock Start/From: **10**
Clock To:
1st Value: **4.000**
2nd Value:
Value Percent:
Continuous Index:
Within 8" of Joint:
Remarks:

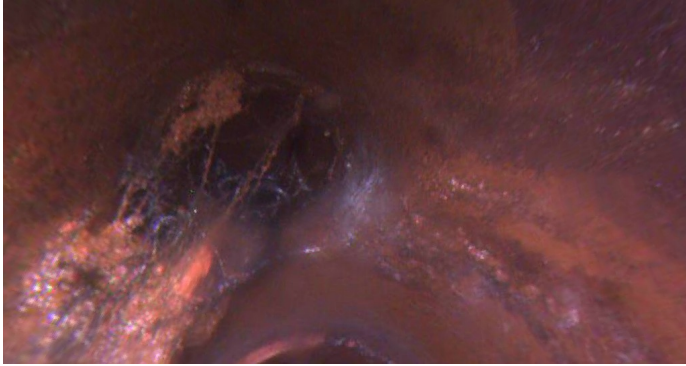
Code: **TFD**
Description: **Tap Factory Defective**

Distance (ft): **102.2**
Structural Grade: **0**
O&M Grade: **2**
Clock Start/From: **1**
Clock To:
1st Value: **4.000**
2nd Value:
Value Percent:
Continuous Index:
Within 8" of Joint:
Remarks: **RFL**

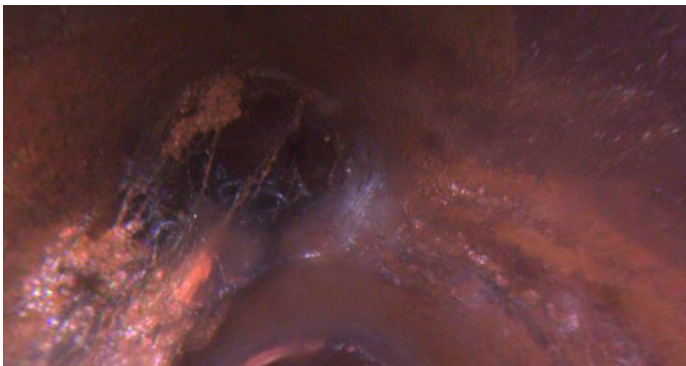
Code: **RFL**
Description: **Roots Fine Lateral**

Distance (ft): **102.2**
Structural Grade: **0**
O&M Grade: **1**
Clock Start/From: **1**
Clock To:
1st Value:
2nd Value:
Value Percent:
Continuous Index:
Within 8" of Joint: **NO**
Remarks:

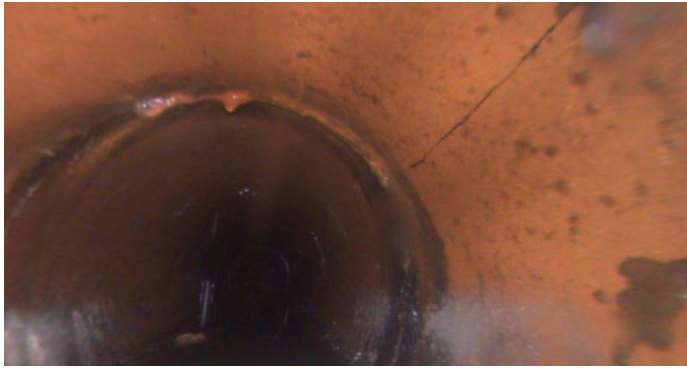
Code: **CL**
Description: **Crack Longitudinal**

Distance (ft): **146.9**
Structural Grade: **2**
O&M Grade: **0**
Clock Start/From: **2**
Clock To:
1st Value:
2nd Value:
Value Percent:
Continuous Index:
Within 8" of Joint: **YES**
Remarks:

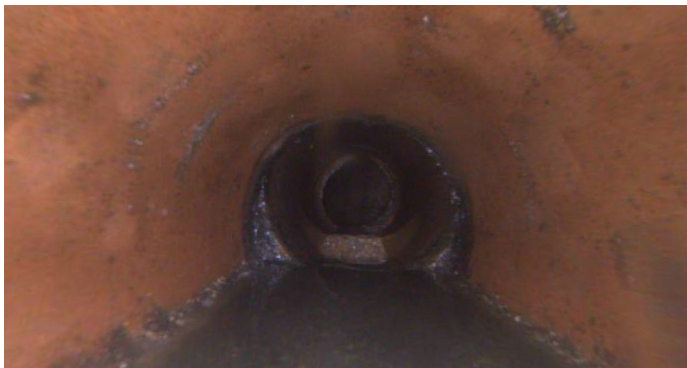
Code: **MSA**
Description: **Abandoned Survey**

Distance (ft): **154.4**
Structural Grade: **0**
O&M Grade: **0**
Clock Start/From:
Clock To:
1st Value:
2nd Value:
Value Percent:
Continuous Index:
Within 8" of Joint: **NO**
Remarks: **Debris**
