Profile/Photo Observation Report

Date:	04/22/2018	Weather:		Coding:	PACP 6.0
Pipe Length (ft):	162.9	Owner:	NA	Pre Clean:	Not Known
P.O.#:		Surveyor:	Mark Ruby	PSR:	P-805-014-013
Customer:		Clean Date:	01/01/1900	Shape:	C

Location Details:		Direction of Survey:	Upstream
US MH:	M-805-013	DS MH:	M-805-014
		Total Length Surveyed (ft):	154.4

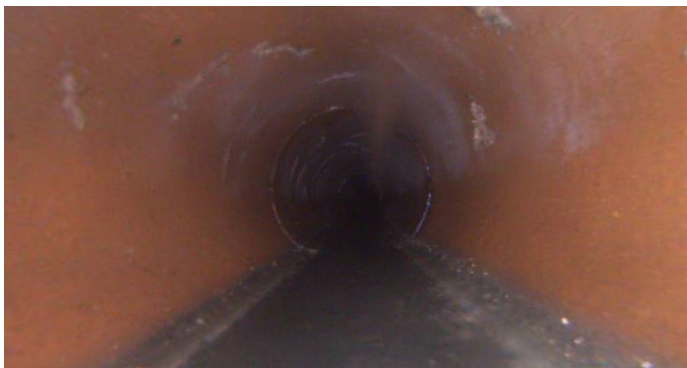
Code:	MWL
Description:	Water Level

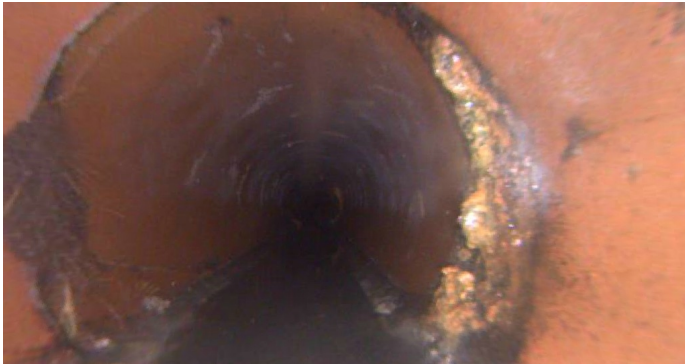
Code:	DAZ
Description:	Deposits Attached Other

Distance (ft):	5.8
Structural Grade:	0
O&M Grade:	2
Clock Start/From:	7
Clock To:	5
1st Value:	
2nd Value:	
Value Percent:	5.000
Continuous Index:	
Within 8" of Joint:	YES
Remarks:

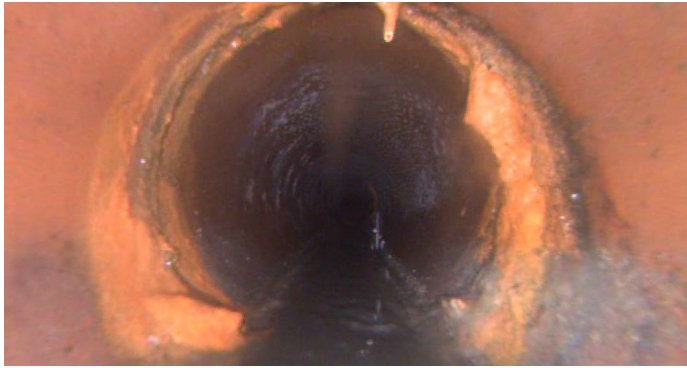
Code:	DAZ
Description:	Deposits Attached Other
Distance (ft):	9.7
Structural Grade:	0
O&M Grade:	2
Clock Start/From:	7
Clock To:	5
1st Value:	
2nd Value:	
Value Percent:	5.000
Continuous Index:	
Within 8" of Joint:	YES
Remarks:

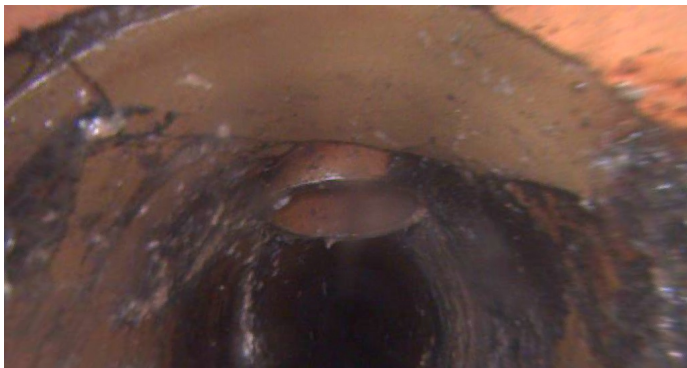
Code:	CS
Description:	Crack Spiral
Distance (ft):	62.4
Structural Grade:	2
O&M Grade:	0
Clock Start/From:	10
Clock To:	2
1st Value:	
2nd Value:	
Value Percent:	
Continuous Index:	
Within 8" of Joint:	YES
Remarks:

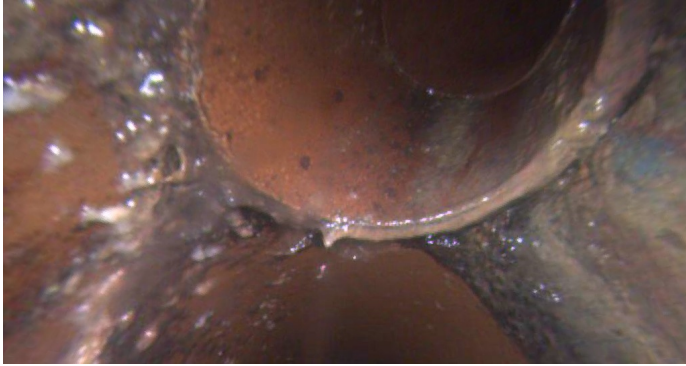
Code: **TB**
Description: **Tap Break-in**

Distance (ft): **63.2**
Structural Grade: **0**
O&M Grade: **0**
Clock Start/From: **1**
Clock To:
1st Value: **4.000**
2nd Value:
Value Percent:
Continuous Index:
Within 8" of Joint:
Remarks:

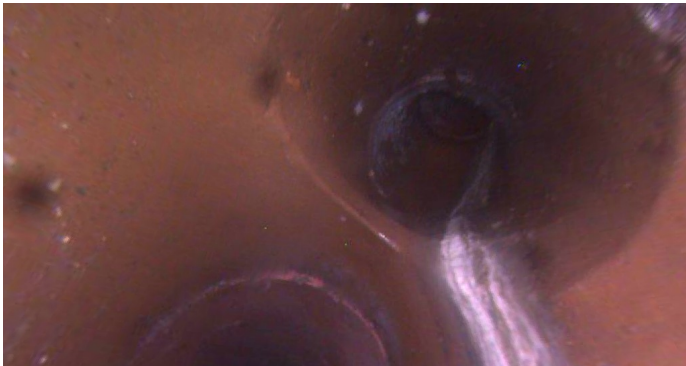
Code: **TF**
Description: **Tap Factory**

Distance (ft): **75.9**
Structural Grade: **0**
O&M Grade: **0**
Clock Start/From: **10**
Clock To:
1st Value: **4.000**
2nd Value:
Value Percent:
Continuous Index:
Within 8" of Joint:
Remarks:

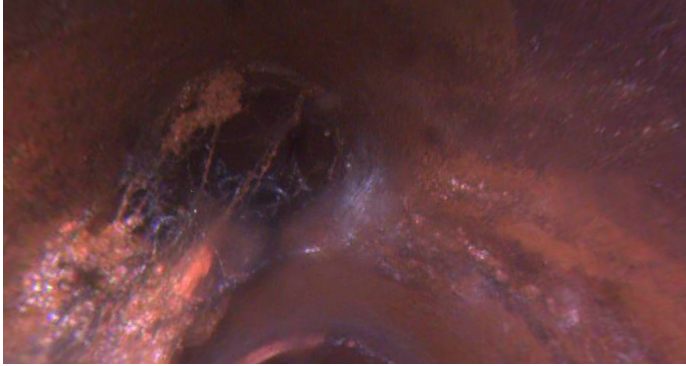
Code: **TFD**
Description: **Tap Factory Defective**

Distance (ft): **102.2**
Structural Grade: **0**
O&M Grade: **2**
Clock Start/From: **1**
Clock To:
1st Value: **4.000**
2nd Value:
Value Percent:
Continuous Index:
Within 8" of Joint:
Remarks: **RFL**

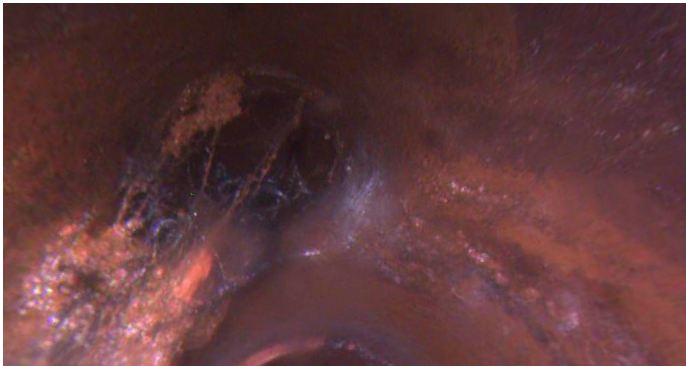
Code: **RFL**
Description: **Roots Fine Lateral**

Distance (ft): **102.2**
Structural Grade: **0**
O&M Grade: **1**
Clock Start/From: **1**
Clock To:
1st Value:
2nd Value:
Value Percent:
Continuous Index:
Within 8" of Joint: **NO**
Remarks:

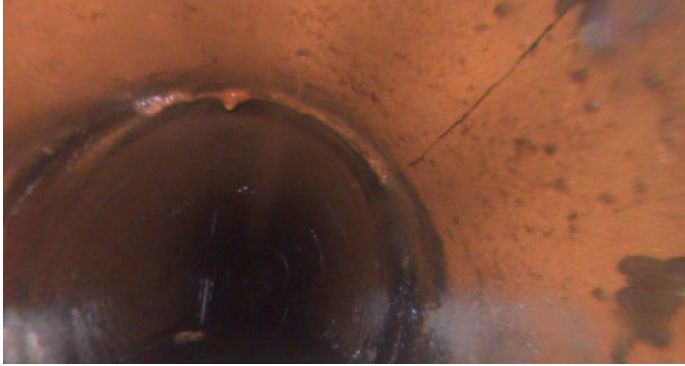
Code: **CL**
Description: **Crack Longitudinal**

Distance (ft): **146.9**
Structural Grade: **2**
O&M Grade: **0**
Clock Start/From: **2**
Clock To:
1st Value:
2nd Value:
Value Percent:
Continuous Index:
Within 8" of Joint: **YES**
Remarks:

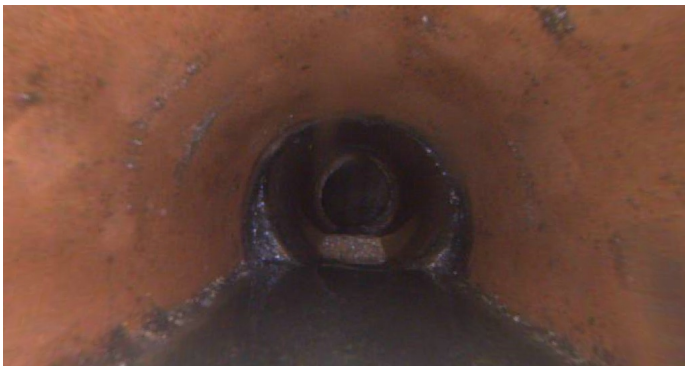
Code: **MSA**
Description: **Abandoned Survey**

Distance (ft): **154.4**
Structural Grade: **0**
O&M Grade: **0**
Clock Start/From:
Clock To:
1st Value:
2nd Value:
Value Percent:
Continuous Index:
Within 8" of Joint: **NO**
Remarks: **Debris**
