Profile/Photo Observation Report

Date:	04/22/2018	Weather:		Coding:	PACP 6.0
Pipe Length (ft):	194.1	Owner:	NA	Pre Clean:	Not Known
P.O.#:		Surveyor:	Mark Ruby	PSR:	P-805-015-014
Customer:		Clean Date:	01/01/1900	Shape:	C

Street:	ALLEY BETWEEN S LIBERTY ST & S LI	Flow Control:	Not Controlled
City:	Hobart, IN	Year Renewed:	
Location:	Alley	Tape/Media #:	
Purpose:	Maintenance Related	Dia/Height:	10"
Use:	Sanitary	Material:	VCP
Drain Area:	NA	Lining:	Cured in Place
Category:	NA		
Comment:	flow reversed. heavy silt at 164'.		
Location Details:		Direction of Survey:	Downstream
US MH:	M-805-014	DS MH:	M-805-015
		Total Length Surveyed (ft):	165.2

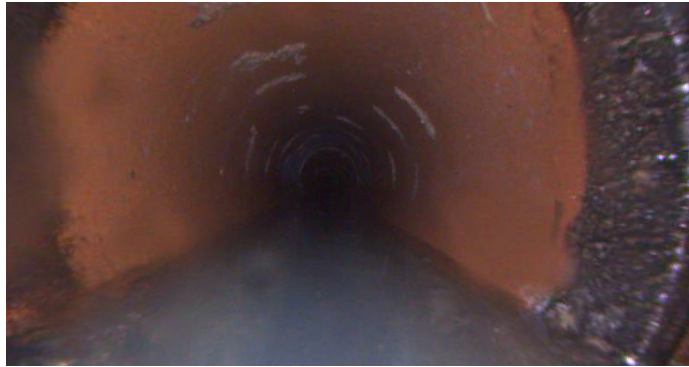
Code:	MWL
Description:	Water Level
Distance (ft):	.0
Structural Grade:	0
O&M Grade:	0
Clock Start/From:	
Clock To:	
1st Value:	
2nd Value:	
Value Percent:	10.000
Continuous Index:	
Within 8" of Joint:	NO
Remarks:

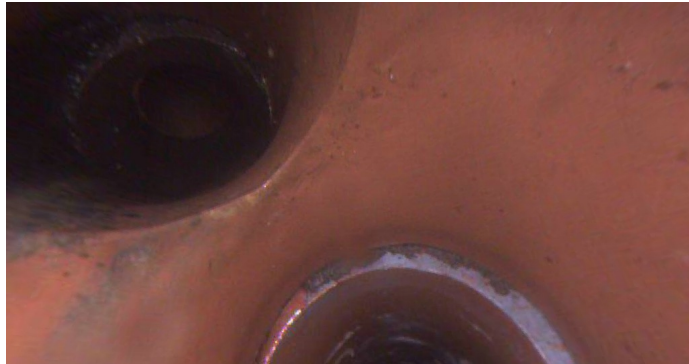
Code:	TF
Description:	Tap Factory
Distance (ft):	14.3
Structural Grade:	0
O&M Grade:	0
Clock Start/From:	10
Clock To:	
1st Value:	4.000
2nd Value:	
Value Percent:	
Continuous Index:	
Within 8" of Joint:	
Remarks:

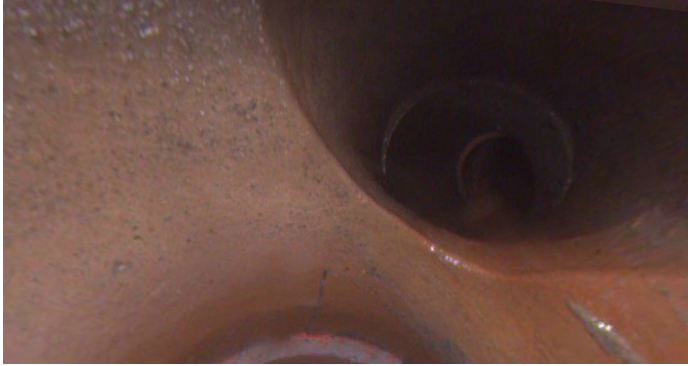
Code: **TF**
Description: **Tap Factory**

Distance (ft): **57.4**
Structural Grade: **0**
O&M Grade: **0**
Clock Start/From: **1**
Clock To:
1st Value: **4.000**
2nd Value:
Value Percent:
Continuous Index:
Within 8" of Joint:
Remarks:

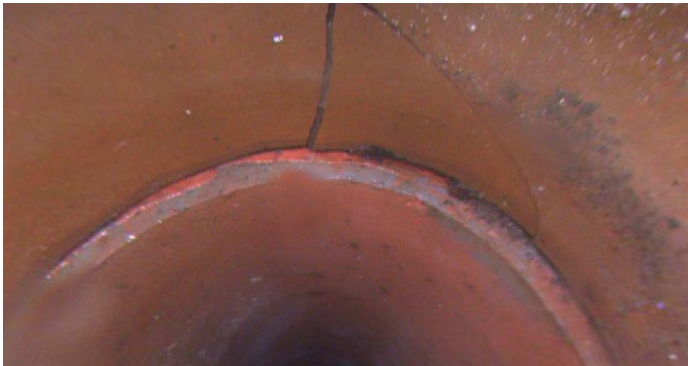
Code: **FM**
Description: **Fracture Multiple**

Distance (ft): **58.0**
Structural Grade: **4**
O&M Grade: **0**
Clock Start/From: **12**
Clock To: **2**
1st Value:
2nd Value:
Value Percent:
Continuous Index:
Within 8" of Joint: **YES**
Remarks:

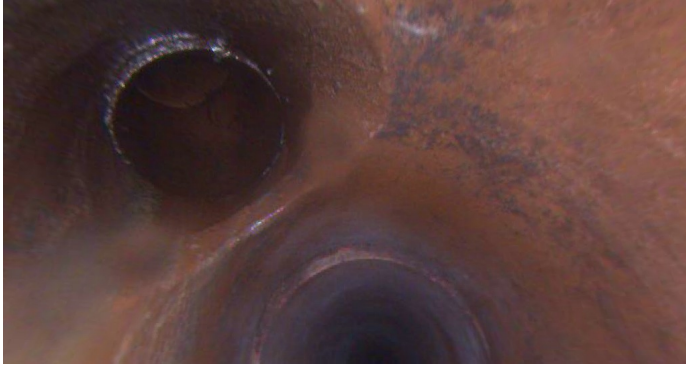
Code: **TF**
Description: **Tap Factory**

Distance (ft): **63.4**
Structural Grade: **0**
O&M Grade: **0**
Clock Start/From: **10**
Clock To:
1st Value: **4.000**
2nd Value:
Value Percent:
Continuous Index:
Within 8" of Joint:
Remarks:

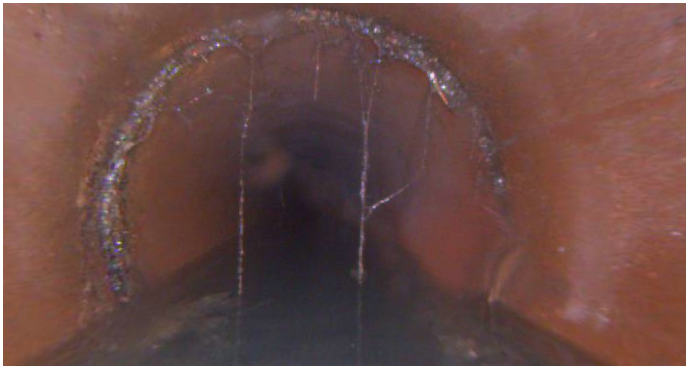
Code: **RFJ**
Description: **Roots Fine Joint**

Distance (ft): **88.2**
Structural Grade: **0**
O&M Grade: **1**
Clock Start/From: **7**
Clock To: **5**
1st Value:
2nd Value:
Value Percent:
Continuous Index:
Within 8" of Joint: **YES**
Remarks:

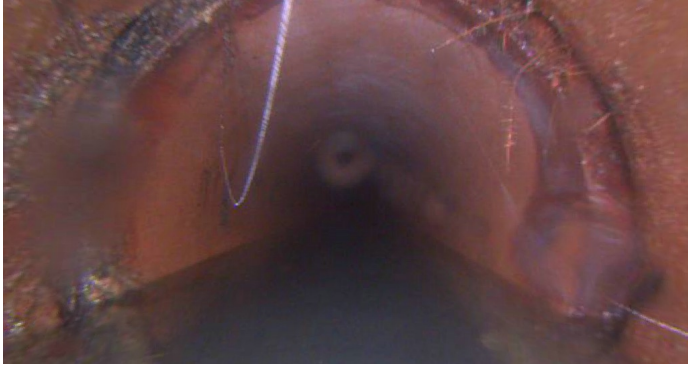
Code: **RFJ**
Description: **Roots Fine Joint**

Distance (ft): **96.6**
Structural Grade: **0**
O&M Grade: **1**
Clock Start/From: **7**
Clock To: **5**
1st Value:
2nd Value:
Value Percent:
Continuous Index:
Within 8" of Joint: **YES**
Remarks:

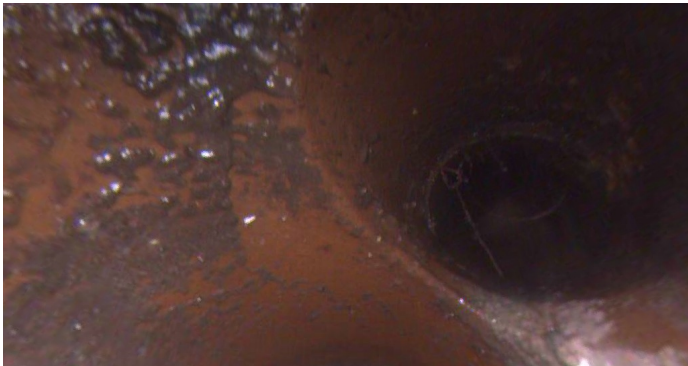
Code: **TF**
Description: **Tap Factory**

Distance (ft): **122.5**
Structural Grade: **0**
O&M Grade: **0**
Clock Start/From: **2**
Clock To:
1st Value: **4.000**
2nd Value:
Value Percent:
Continuous Index:
Within 8" of Joint:
Remarks:

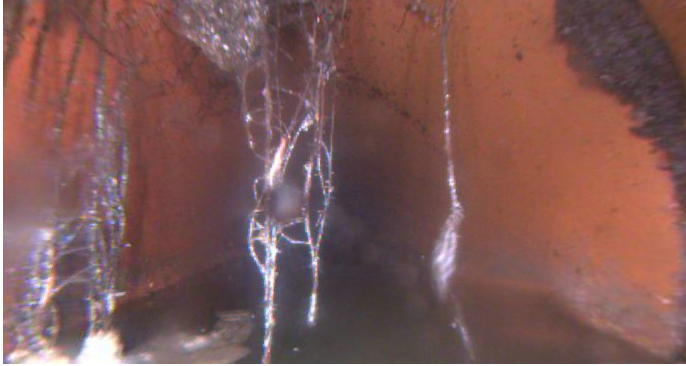
Code: **RFJ**
Description: **Roots Fine Joint**

Distance (ft): **123.3**
Structural Grade: **0**
O&M Grade: **1**
Clock Start/From: **7**
Clock To: **5**
1st Value:
2nd Value:
Value Percent:
Continuous Index:
Within 8" of Joint: **YES**
Remarks:

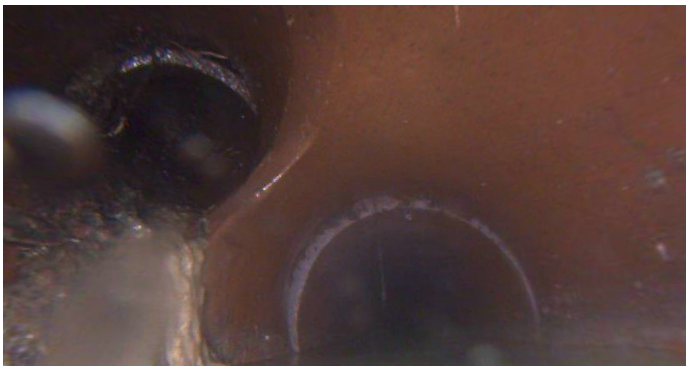
Code: **TF**
Description: **Tap Factory**

Distance (ft): **128.5**
Structural Grade: **0**
O&M Grade: **0**
Clock Start/From: **10**
Clock To:
1st Value: **4.000**
2nd Value:
Value Percent:
Continuous Index:
Within 8" of Joint:
Remarks:

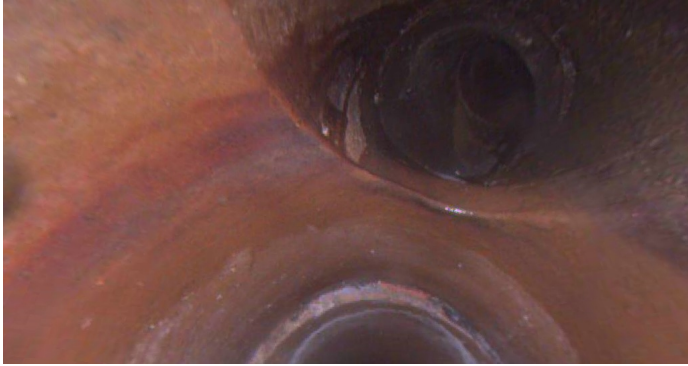
Code: **TF**
Description: **Tap Factory**

Distance (ft): **151.2**
Structural Grade: **0**
O&M Grade: **0**
Clock Start/From: **2**
Clock To:
1st Value: **4.000**
2nd Value:
Value Percent:
Continuous Index:
Within 8" of Joint:
Remarks:

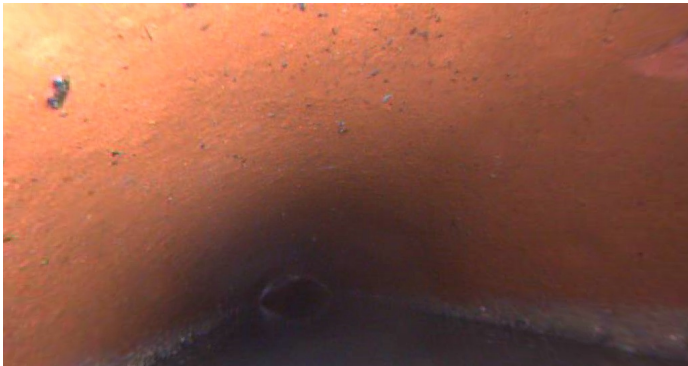
Code: **MSA**
Description: **Abandoned Survey**

Distance (ft): **165.2**
Structural Grade: **0**
O&M Grade: **0**
Clock Start/From:
Clock To:
1st Value:
2nd Value:
Value Percent:
Continuous Index:
Within 8" of Joint: **NO**
Remarks: **Debris under water**
