## Profile/Photo Observation Report

Date:	<b>09/13/2022</b>	Weather:		Coding:	<b>PACP 7.0</b>
Pipe Length (ft):	<b>194.0</b>	Owner:	<b>City of Hobart</b>	Pre Clean:	<b>Heavy Cleaning</b>
P.O.#:	<b>YES502259</b>	Surveyor:	<b>S. Bucklin</b>	PSR:	<b>P-805-015-014</b>
Customer:	<b>City of Hobart</b>	Clean Date:	<b>08/26/2022</b>	Shape:	<b>C</b>

Street:	<b>South Liberty Street</b>	Flow Control:	<b>Not Controlled</b>
City:	<b>Hobart, IN</b>	Year Renewed:	
Location:	<b>Alley</b>	Tape/Media #:	
Purpose:	<b>Routine Assessment</b>	Dia/Height:	<b>10"</b>
Use:	<b>Sanitary Sewage Pipe</b>	Material:	<b>VCP</b>
Drain Area:		Lining:	<b>None</b>
Category:	<b>NA</b>		
Comment:

Location Details:		Direction of Survey:	<b>Downstream</b>
US MH:	<b>M-805-014</b>	DS MH:	<b>M-805-015</b>
		Total Length Surveyed (ft):	<b>196.1</b>

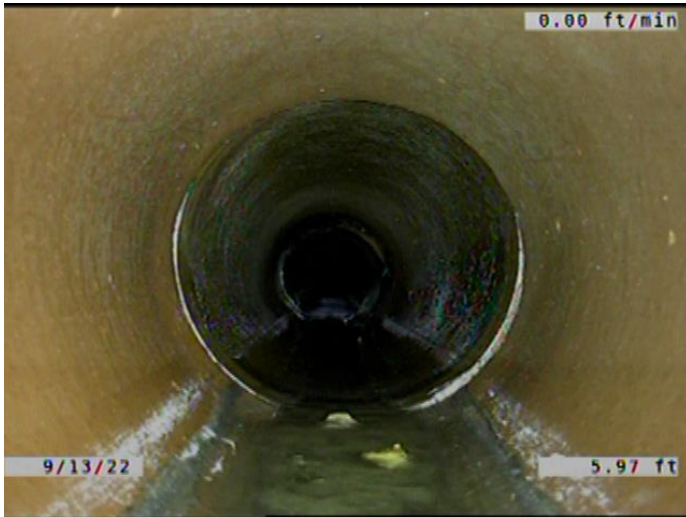
Code: **DSF**  
Description: **Deposits Settled Fine**

Distance (ft): **6.0**  
Structural Grade: **0**  
O&M Grade: **2**  
Clock Start/From: **5**  
Clock To: **7**  
1st Value:  
2nd Value:  
Value Percent: **5.000**  
Continuous Index: **S01**  
Within 8" of Joint: **YES**  
Remarks:

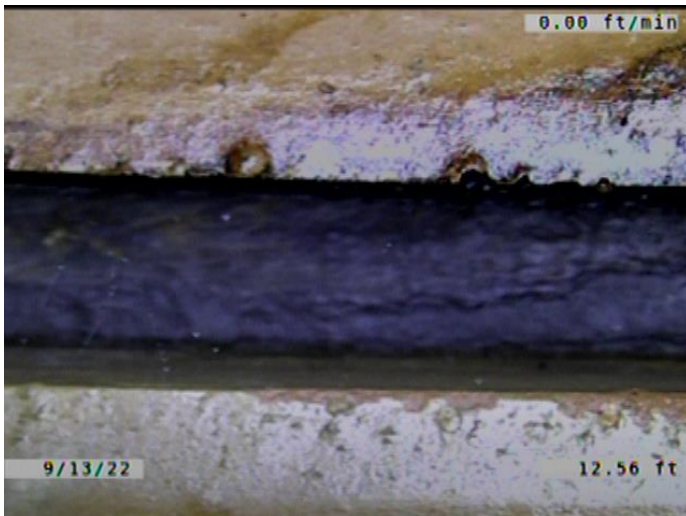
Code: **ISJ**  
Description: **Infiltration Stain Joint**

Distance (ft): **12.6**  
Structural Grade: **0**  
O&M Grade: **1**  
Clock Start/From: **1**  
Clock To: **4**  
1st Value:  
2nd Value:  
Value Percent:  
Continuous Index:  
Within 8" of Joint: **YES**  
Remarks:

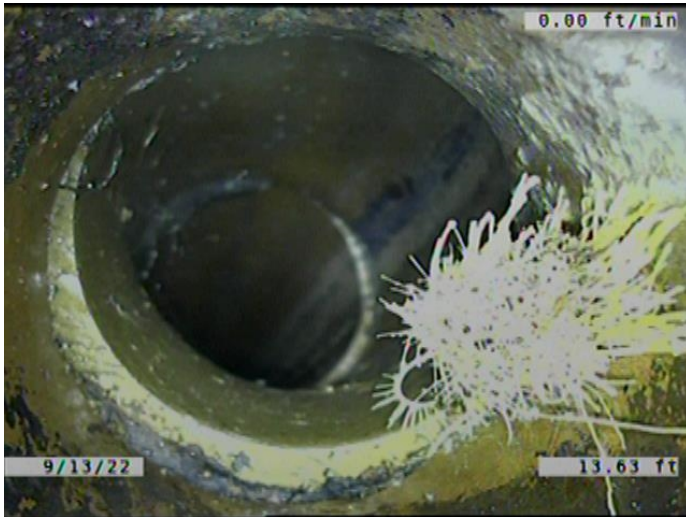
Code:	<b>TF</b>
Description:	<b>Tap Factory</b>
Distance (ft):	<b>13.6</b>
Structural Grade:	<b>0</b>
O&M Grade:	<b>0</b>
Clock Start/From:	<b>1</b>
Clock To:	
1st Value:	<b>6.000</b>
2nd Value:	
Value Percent:	
Continuous Index:	
Within 8" of Joint:	<b>YES</b>
Remarks:	<b>ROOTS GROWING FROM THE SERVICE TO MAIN CONNECTION .</b>

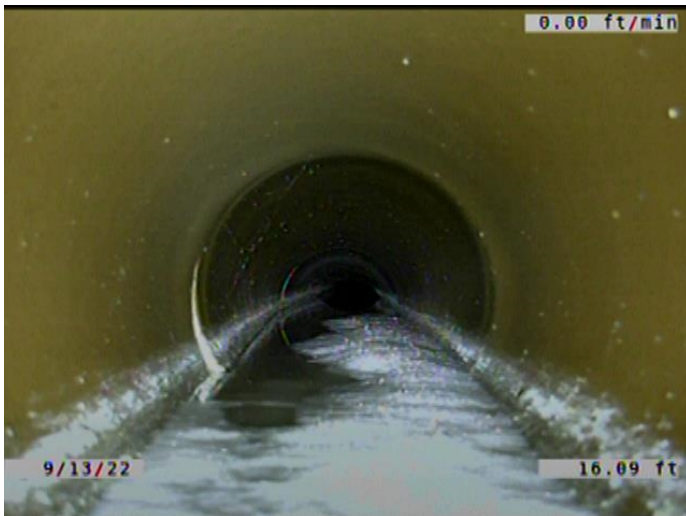
Code:	<b>MWLS</b>
Description:	<b>Miscellaneous Water Level Sag</b>
Distance (ft):	<b>16.1</b>
Structural Grade:	<b>4</b>
O&M Grade:	<b>0</b>
Clock Start/From:	
Clock To:	
1st Value:	
2nd Value:	
Value Percent:	<b>75.000</b>
Continuous Index:	<b>S02</b>
Within 8" of Joint:	<b>NO</b>
Remarks:

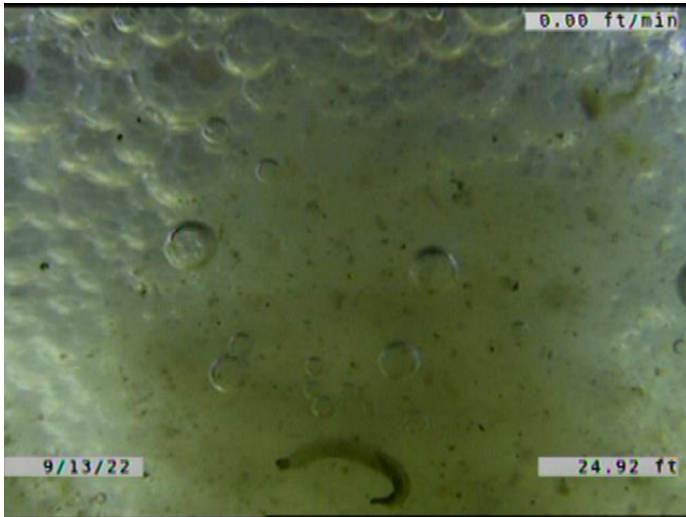
Code:	<b>MCU</b>
Description:	<b>Miscellaneous Camera Underwater</b>
Distance (ft):	<b>24.9</b>
Structural Grade:	<b>0</b>
O&M Grade:	<b>4</b>
Clock Start/From:	
Clock To:	
1st Value:	
2nd Value:	
Value Percent:	
Continuous Index:	<b>S03</b>
Within 8" of Joint:	<b>NO</b>
Remarks:

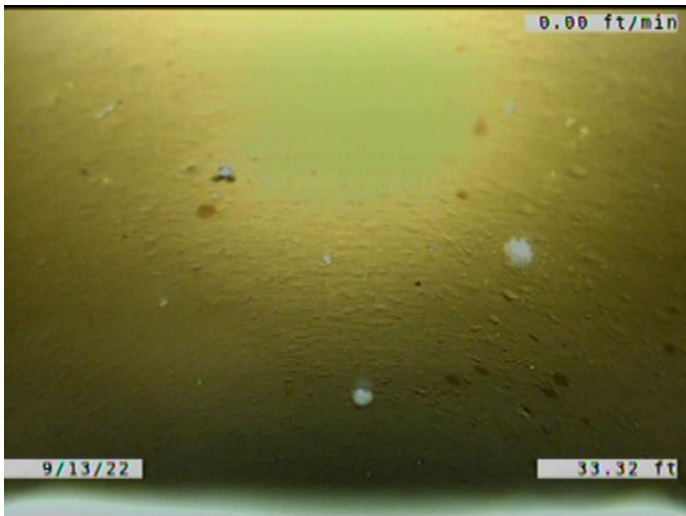
Code:	<b>MCU</b>
Description:	<b>Miscellaneous Camera Underwater</b>
Distance (ft):	<b>33.3</b>
Structural Grade:	<b>0</b>
O&M Grade:	<b>4</b>
Clock Start/From:	
Clock To:	
1st Value:	
2nd Value:	
Value Percent:	
Continuous Index:	<b>F03</b>
Within 8" of Joint:	<b>NO</b>
Remarks:

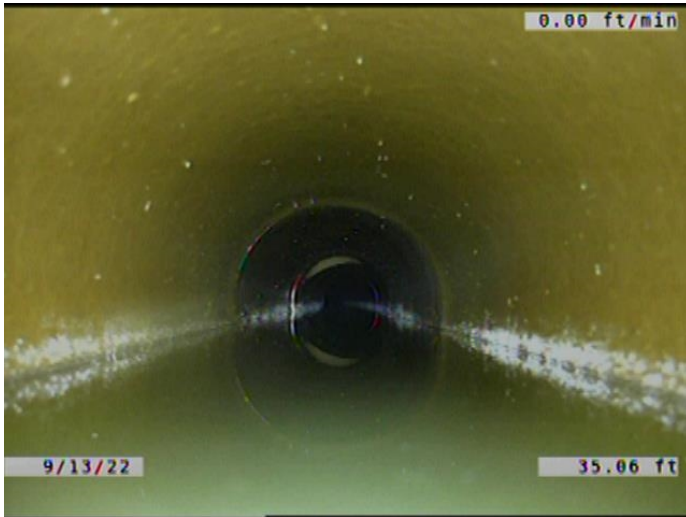
Code: **MWLS**  
Description: **Miscellaneous Water Level Sag**

Distance (ft): **35.1**  
Structural Grade: **4**  
O&M Grade: **0**  
Clock Start/From:  
Clock To:  
1st Value:  
2nd Value:  
Value Percent: **75.000**  
Continuous Index: **F02**  
Within 8" of Joint: **NO**  
Remarks:

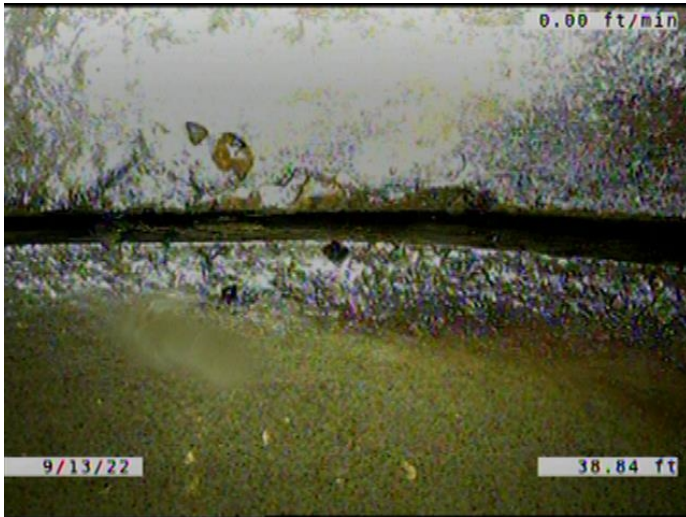
Code: **ISJ**  
 Description: **Infiltration Stain Joint**

Distance (ft): **38.8**  
 Structural Grade: **0**  
 O&M Grade: **1**  
 Clock Start/From: **8**  
 Clock To: **4**  
 1st Value:  
 2nd Value:  
 Value Percent:  
 Continuous Index:  
 Within 8" of Joint: **YES**  
 Remarks:

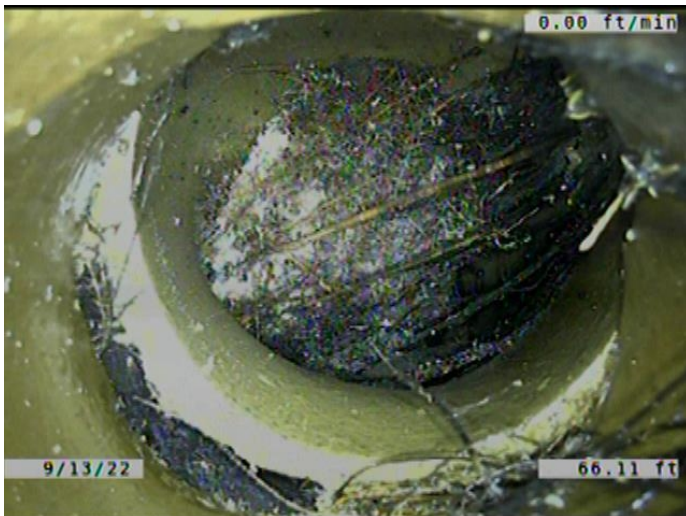
Code:	<b>TFD</b>
Description:	<b>Tap Factory Defective</b>
Distance (ft):	<b>66.1</b>
Structural Grade:	<b>0</b>
O&M Grade:	<b>3</b>
Clock Start/From:	<b>2</b>
Clock To:	
1st Value:	<b>6.000</b>
2nd Value:	
Value Percent:	
Continuous Index:	
Within 8" of Joint:	<b>YES</b>
Remarks:	<b>SERVICE TO MAIN CONNECTION OFFSET WITH ROOTS GROWING IN I</b>

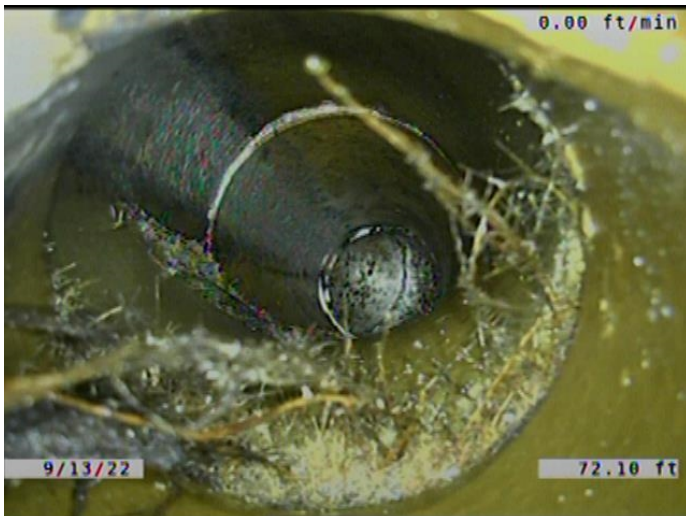
Distance (ft): **72.1**  
 Structural Grade: **0**  
 O&M Grade: **0**  
 Clock Start/From: **11**  
 Clock To:  
 1st Value: **6.000**  
 2nd Value:  
 Value Percent:  
 Continuous Index:  
 Within 8" of Joint: **YES**  
 Remarks: **ROOTS GROWING FROM THE SERVICE TO MAIN CONNECTION .**

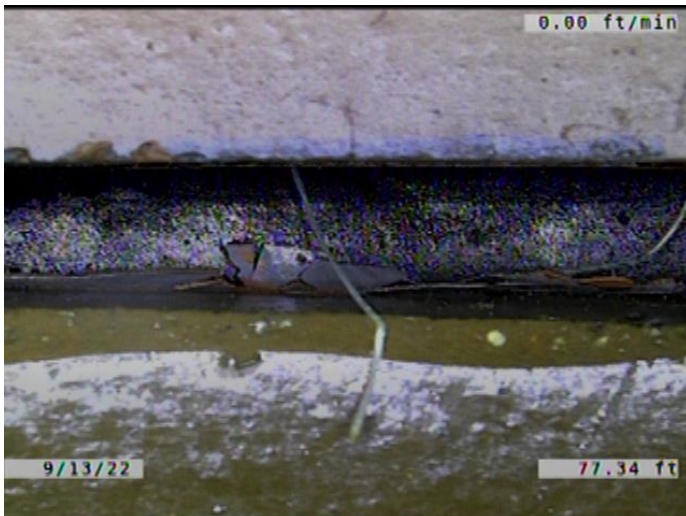
Code: **RFJ**  
 Description: **Roots Fine Joint**

Distance (ft): **77.3**  
 Structural Grade: **0**  
 O&M Grade: **1**  
 Clock Start/From: **11**  
 Clock To: **1**  
 1st Value:  
 2nd Value:  
 Value Percent:  
 Continuous Index:  
 Within 8" of Joint: **YES**  
 Remarks:

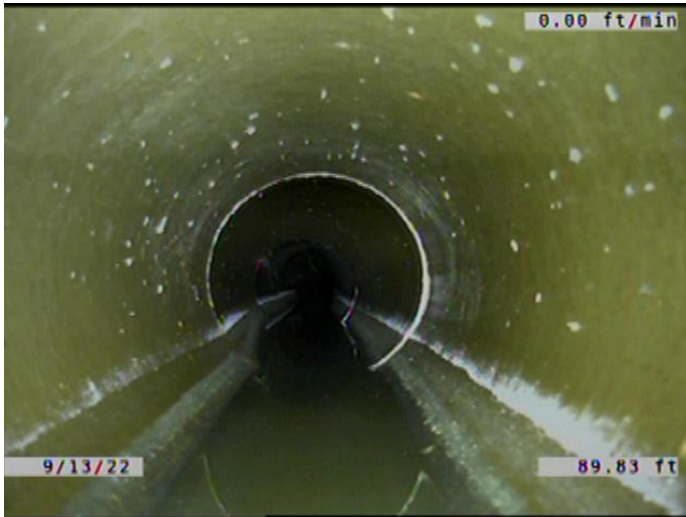
Code: **MWLS**  
Description: **Miscellaneous Water Level Sag**

Distance (ft): **89.8**  
Structural Grade: **2**  
O&M Grade: **0**  
Clock Start/From:  
Clock To:  
1st Value:  
2nd Value:  
Value Percent: **5.000**  
Continuous Index: **S04**  
Within 8" of Joint: **NO**  
Remarks:

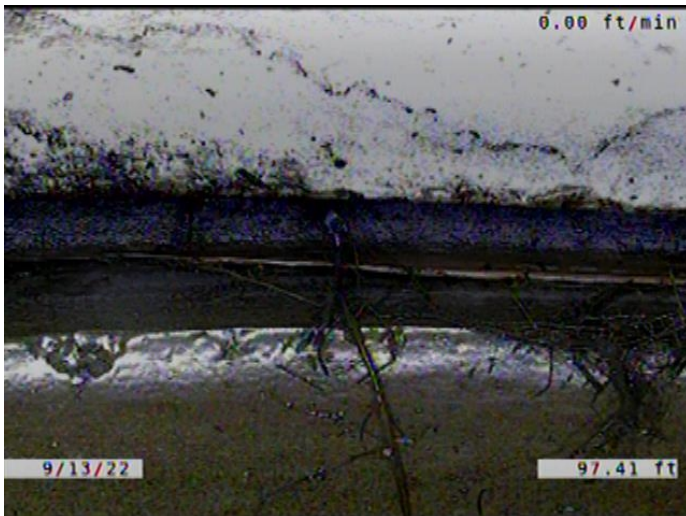
Code: **ISJ**  
Description: **Infiltration Stain Joint**

Distance (ft): **97.4**  
Structural Grade: **0**  
O&M Grade: **1**  
Clock Start/From: **8**  
Clock To: **4**  
1st Value:  
2nd Value:  
Value Percent:  
Continuous Index:  
Within 8" of Joint: **YES**  
Remarks:

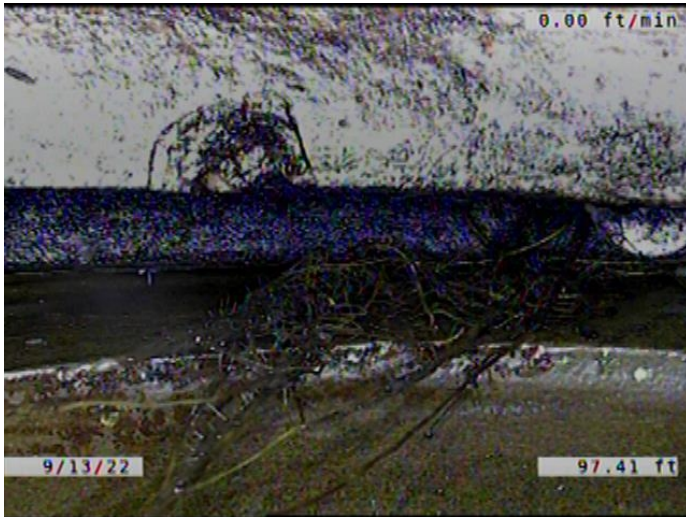
Code: **RFJ**  
 Description: **Roots Fine Joint**

Distance (ft): **97.4**  
 Structural Grade: **0**  
 O&M Grade: **1**  
 Clock Start/From: **8**  
 Clock To: **4**  
 1st Value:  
 2nd Value:  
 Value Percent:  
 Continuous Index: **S05**  
 Within 8" of Joint: **YES**  
 Remarks:

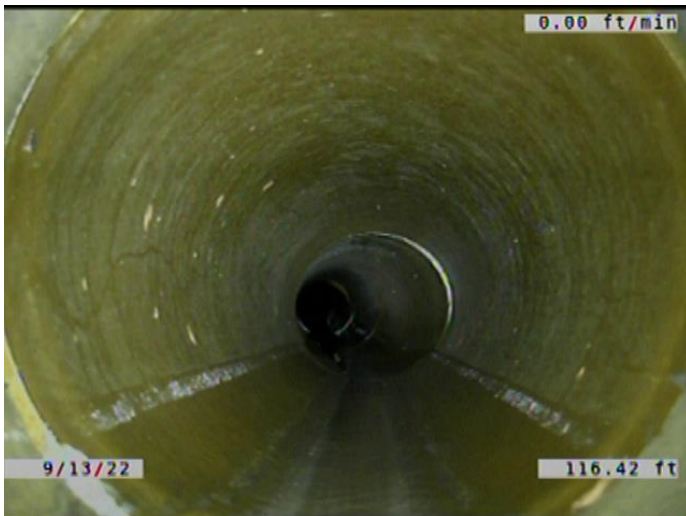
Code: **MWLS**  
 Description: **Miscellaneous Water Level Sag**

Distance (ft): **116.4**  
 Structural Grade: **2**  
 O&M Grade: **0**  
 Clock Start/From:  
 Clock To:  
 1st Value:  
 2nd Value:  
 Value Percent: **5.000**  
 Continuous Index: **F04**  
 Within 8" of Joint: **NO**  
 Remarks:

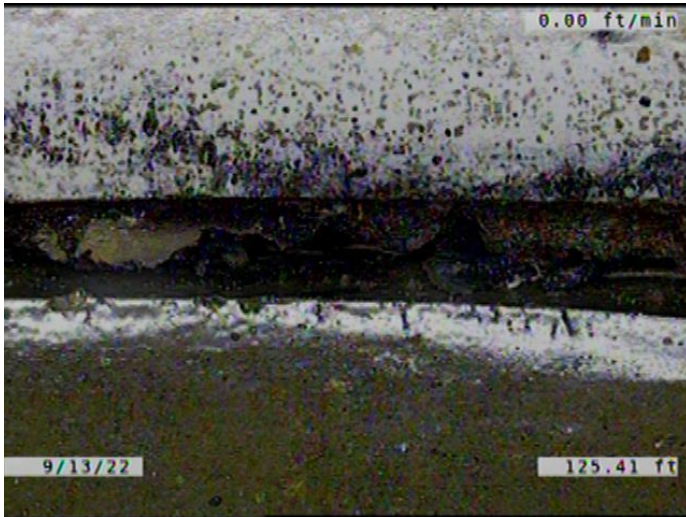
Code: **ISJ**  
 Description: **Infiltration Stain Joint**

Distance (ft): **125.4**  
 Structural Grade: **0**  
 O&M Grade: **1**  
 Clock Start/From: **8**  
 Clock To: **4**  
 1st Value:  
 2nd Value:  
 Value Percent:  
 Continuous Index:  
 Within 8" of Joint: **YES**  
 Remarks:

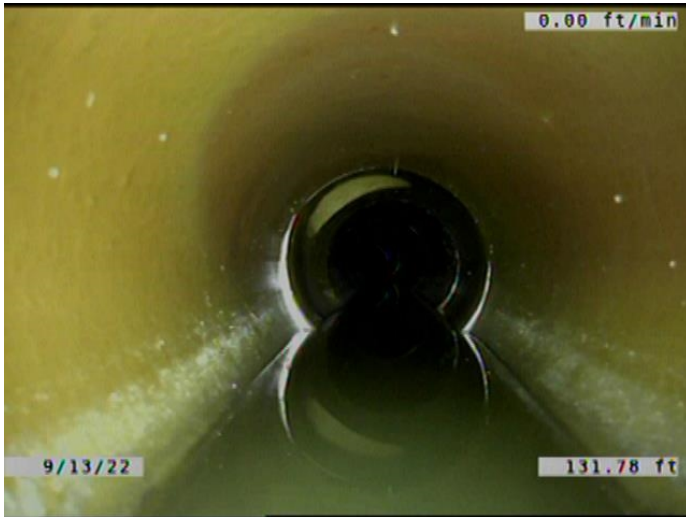
Code: **MWLS**  
Description: **Miscellaneous Water Level Sag**

Distance (ft): **131.8**  
Structural Grade: **2**  
O&M Grade: **0**  
Clock Start/From:  
Clock To:  
1st Value:  
2nd Value:  
Value Percent: **10.000**  
Continuous Index: **S06**  
Within 8" of Joint: **NO**  
Remarks:

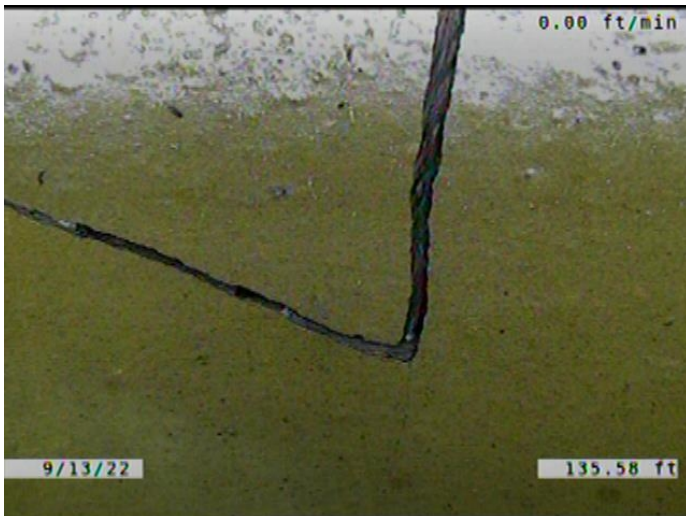
Code: **B**  
Description: **Broken**

Distance (ft): **135.6**  
Structural Grade: **4**  
O&M Grade: **0**  
Clock Start/From: **10**  
Clock To: **12**  
1st Value:  
2nd Value:  
Value Percent:  
Continuous Index:  
Within 8" of Joint: **YES**  
Remarks:

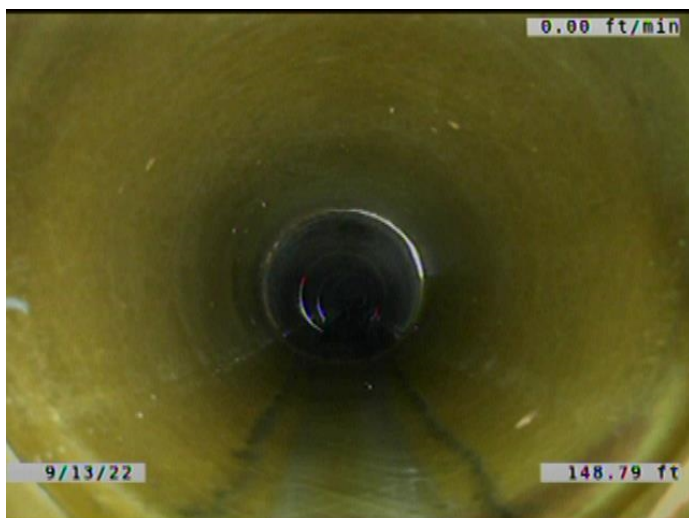
Code: **MWLS**  
 Description: **Miscellaneous Water Level Sag**

Distance (ft): **148.8**  
 Structural Grade: **2**  
 O&M Grade: **0**  
 Clock Start/From:  
 Clock To:  
 1st Value:  
 2nd Value:  
 Value Percent: **10.000**  
 Continuous Index: **F06**  
 Within 8" of Joint: **NO**  
 Remarks:

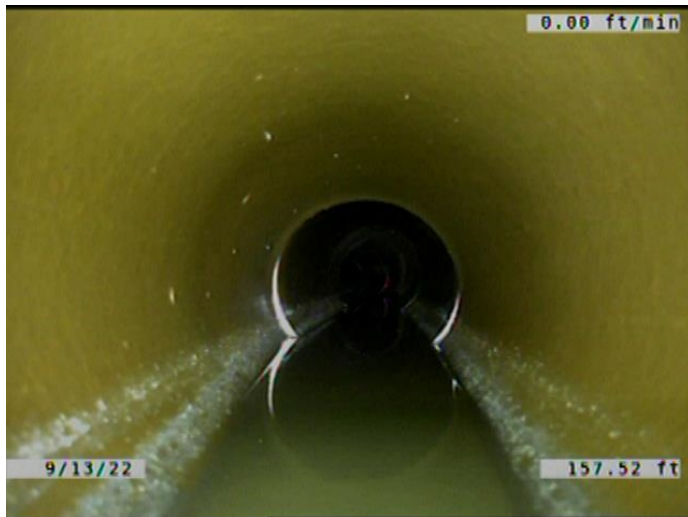
Code: **MWLS**  
Description: **Miscellaneous Water Level Sag**

Distance (ft): **157.5**  
Structural Grade: **2**  
O&M Grade: **0**  
Clock Start/From:  
Clock To:  
1st Value:  
2nd Value:  
Value Percent: **10.000**  
Continuous Index: **S07**  
Within 8" of Joint: **NO**  
Remarks:

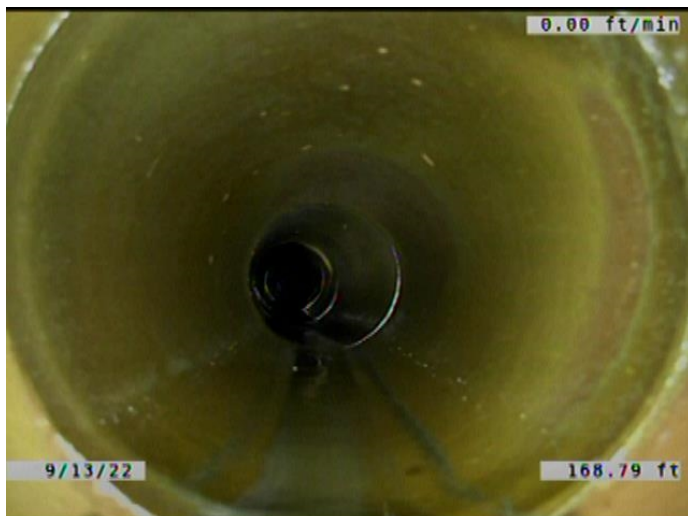
Code: **MWLS**  
Description: **Miscellaneous Water Level Sag**

Distance (ft): **168.8**  
Structural Grade: **2**  
O&M Grade: **0**  
Clock Start/From:  
Clock To:  
1st Value:  
2nd Value:  
Value Percent: **10.000**  
Continuous Index: **F07**  
Within 8" of Joint: **NO**  
Remarks:

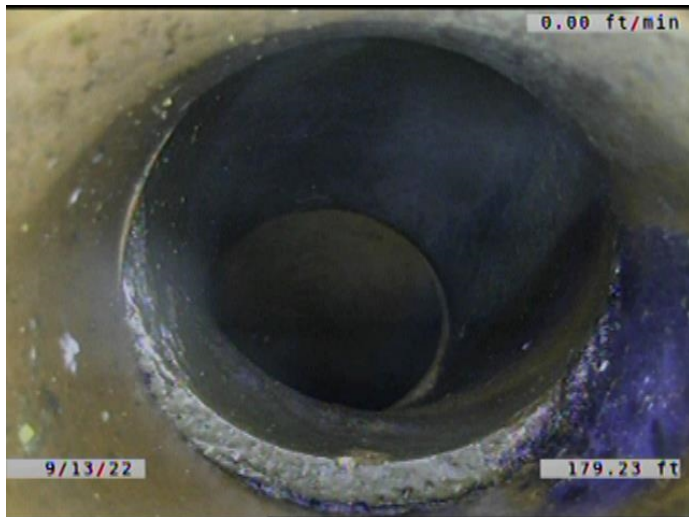
Distance (ft): **179.2**  
 Structural Grade: **0**  
 O&M Grade: **0**  
 Clock Start/From: **1**  
 Clock To:  
 1st Value: **6.000**  
 2nd Value:  
 Value Percent:  
 Continuous Index:  
 Within 8" of Joint: **YES**  
 Remarks: **SERVICE OFFSET.**

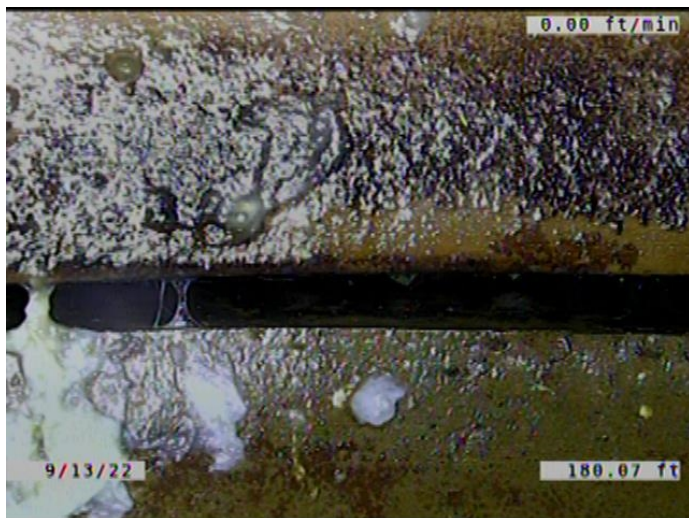
Code: **ISJ**  
 Description: **Infiltration Stain Joint**

Distance (ft): **180.1**  
 Structural Grade: **0**  
 O&M Grade: **1**  
 Clock Start/From: **8**  
 Clock To: **4**  
 1st Value:  
 2nd Value:  
 Value Percent:  
 Continuous Index:  
 Within 8" of Joint: **YES**  
 Remarks:

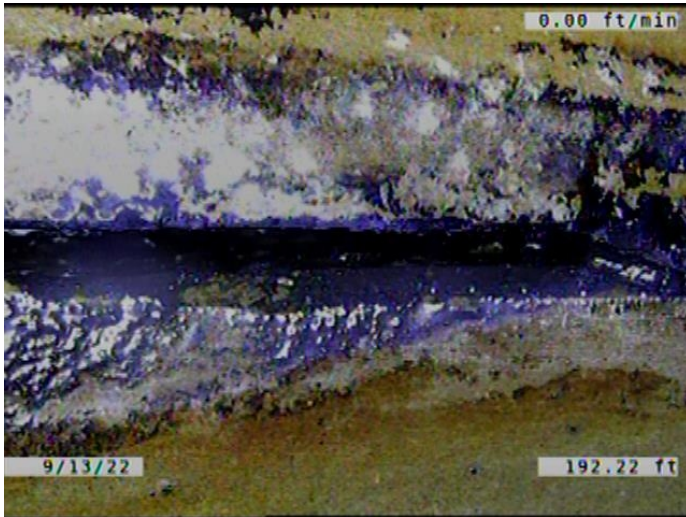
Code: **ISJ**  
 Description: **Infiltration Stain Joint**

Distance (ft): **192.2**  
 Structural Grade: **0**  
 O&M Grade: **1**  
 Clock Start/From: **8**  
 Clock To: **4**  
 1st Value:  
 2nd Value:  
 Value Percent:  
 Continuous Index:  
 Within 8" of Joint: **YES**  
 Remarks:

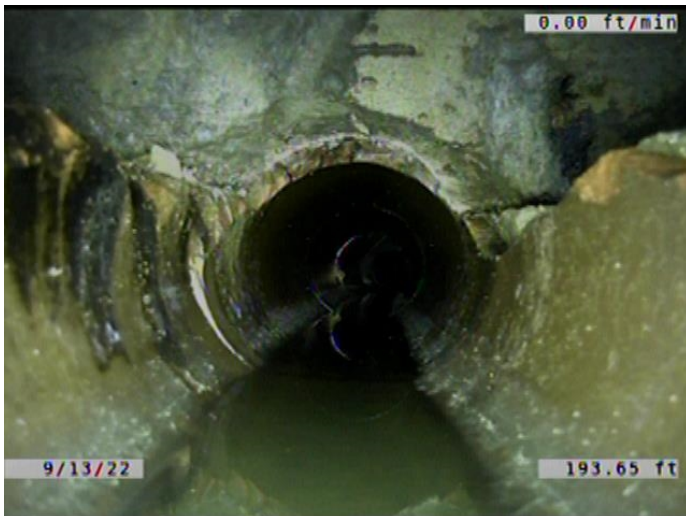
Code: **DSF**  
 Description: **Deposits Settled Fine**

Distance (ft): **193.7**  
 Structural Grade: **0**  
 O&M Grade: **2**  
 Clock Start/From: **5**  
 Clock To: **7**  
 1st Value:  
 2nd Value:  
 Value Percent: **5.000**  
 Continuous Index: **F01**  
 Within 8" of Joint: **YES**  
 Remarks:

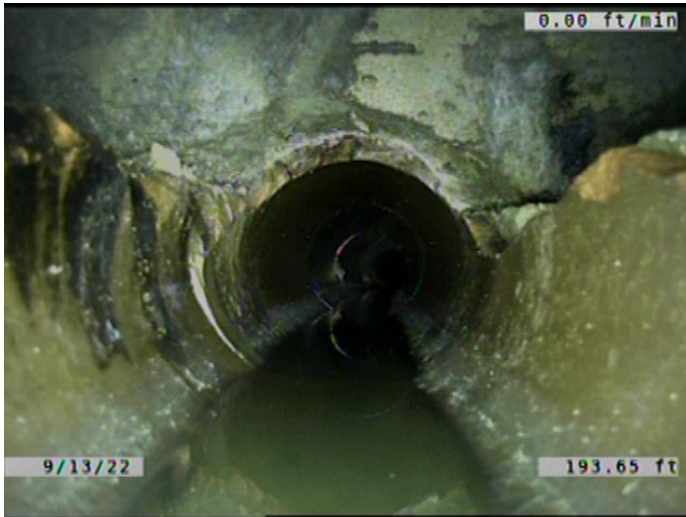
Code: **RFJ**  
 Description: **Roots Fine Joint**

Distance (ft): **193.7**  
 Structural Grade: **0**  
 O&M Grade: **1**  
 Clock Start/From: **8**  
 Clock To: **4**  
 1st Value:  
 2nd Value:  
 Value Percent:  
 Continuous Index: **F05**  
 Within 8" of Joint: **YES**  
 Remarks:
