## Profile/Photo Observation Report

Street:	<b>ALLEY BETWEEN S LIBERTY ST &amp; S LI</b>	Flow Control:	<b>Not Controlled</b>
City:	<b>Hobart, IN</b>	Year Renewed:	
Location:	<b>Alley</b>	Tape/Media #:	
Purpose:	<b>Maintenance Related</b>	Dia/Height:	<b>10"</b>
Use:	<b>Sanitary</b>	Material:	<b>VCP</b>
Drain Area:	<b>NA</b>	Lining:	<b>Cured in Place</b>
Category:	<b>NA</b>		
Comment:	<b>flow incorrect. Roots at 5'.</b>		
Location Details:		Direction of Survey:	<b>Upstream</b>
US MH:	<b>M-805-015</b>	DS MH:	<b>M-805-016</b>
		Total Length Surveyed (ft):	<b>6.5</b>

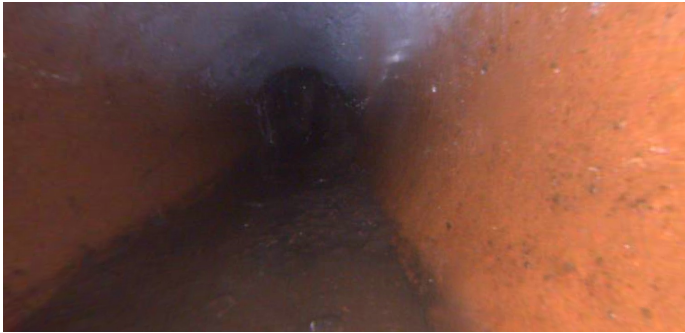
Code:	<b>MWL</b>
Description:	<b>Water Level</b>

Distance (ft):	<b>.0</b>
Structural Grade:	<b>0</b>
O&M Grade:	<b>0</b>
Clock Start/From:	
Clock To:	
1st Value:	
2nd Value:	
Value Percent:	<b>20.000</b>
Continuous Index:	
Within 8" of Joint:	<b>NO</b>
Remarks:

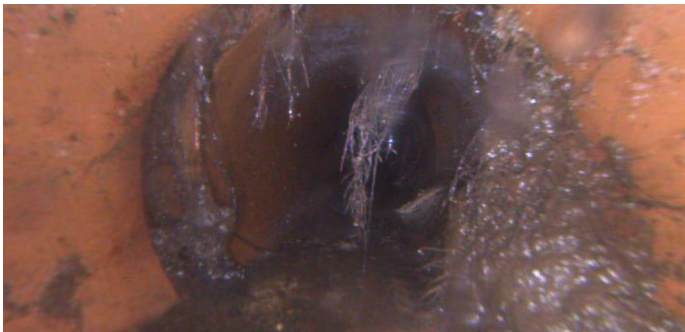
Code:	<b>RMJ</b>
Description:	<b>Roots Medium Joint</b>

Distance (ft):	<b>3.3</b>
Structural Grade:	<b>0</b>
O&M Grade:	<b>3</b>
Clock Start/From:	<b>8</b>
Clock To:	<b>4</b>
1st Value:	
2nd Value:	
Value Percent:	<b>20.000</b>
Continuous Index:	
Within 8" of Joint:	<b>YES</b>
Remarks:

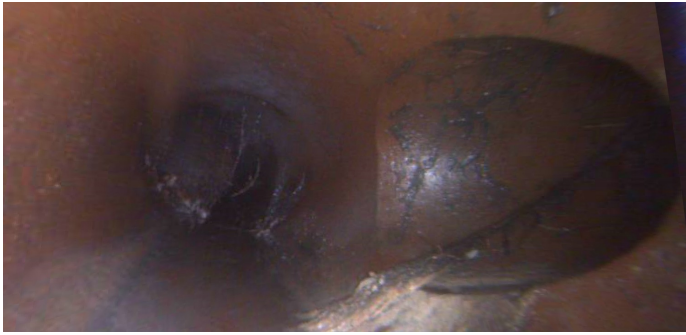
Code: **TFD**  
Description: **Tap Factory Defective**

Distance (ft): **4.2**  
Structural Grade: **0**  
O&M Grade: **2**  
Clock Start/From: **3**  
Clock To:  
1st Value: **4.000**  
2nd Value:  
Value Percent:  
Continuous Index:  
Within 8" of Joint:  
Remarks: **rfl**

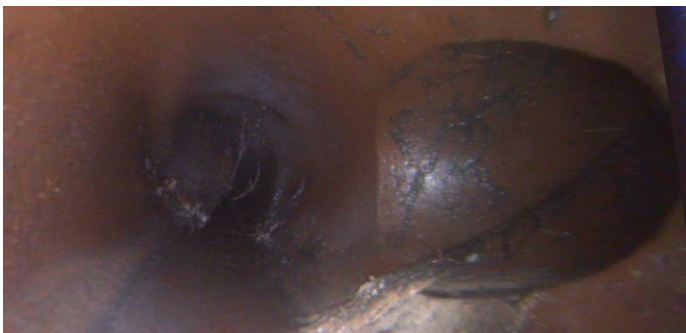
Code: **RFL**  
Description: **Roots Fine Lateral**

Distance (ft): **4.2**  
Structural Grade: **0**  
O&M Grade: **1**  
Clock Start/From: **3**  
Clock To:  
1st Value:  
2nd Value:  
Value Percent:  
Continuous Index:  
Within 8" of Joint: **NO**  
Remarks:

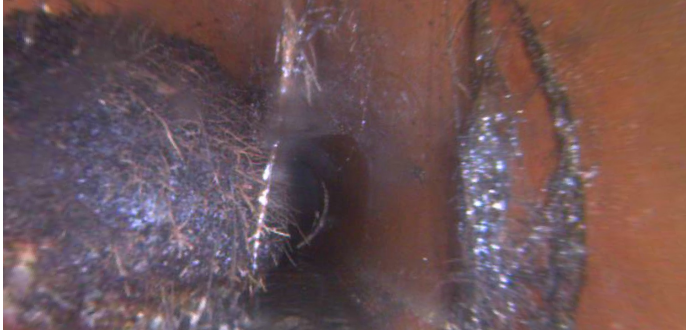
Code: **RMJ**  
Description: **Roots Medium Joint**

Distance (ft): **5.6**  
Structural Grade: **0**  
O&M Grade: **3**  
Clock Start/From: **8**  
Clock To: **4**  
1st Value:  
2nd Value:  
Value Percent: **40.000**  
Continuous Index:  
Within 8" of Joint: **YES**  
Remarks:

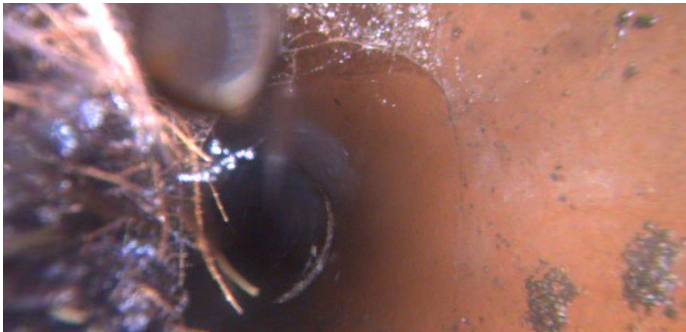
Code: **MSA**  
Description: **Abandoned Survey**

Distance (ft): **6.5**  
Structural Grade: **0**  
O&M Grade: **0**  
Clock Start/From:  
Clock To:  
1st Value:  
2nd Value:  
Value Percent:  
Continuous Index:  
Within 8" of Joint: **NO**  
Remarks: **rmj**
