## Profile/Photo Observation Report

Date:	<b>04/22/2018</b>	Weather:		Coding:	<b>PACP 6.0</b>
Pipe Length (ft):	<b>202.3</b>	Owner:	<b>NA</b>	Pre Clean:	<b>Not Known</b>
P.O.#:		Surveyor:	<b>Jen Costello</b>	PSR:	<b>P-805-016-015</b>
Customer:		Clean Date:	<b>01/01/1900</b>	Shape:	<b>C</b>

Street:	<b>Capitol</b>	Flow Control:	<b>Not Controlled</b>
City:	<b>Hobart, IN</b>	Year Renewed:	
Location:	<b>Alley</b>	Tape/Media #:	
Purpose:	<b>Maintenance Related</b>	Dia/Height:	<b>10"</b>
Use:	<b>Sanitary</b>	Material:	<b>VCP</b>
Drain Area:	<b>NA</b>	Lining:	<b>Cured in Place</b>
Category:	<b>NA</b>		
Comment:	<b>flow incorrect. Roots at 5'.</b>		
Location Details:		Direction of Survey:	<b>Upstream</b>
US MH:	<b>M-805-015</b>	DS MH:	<b>M-805-016</b>
		Total Length Surveyed (ft):	<b>6.5</b>

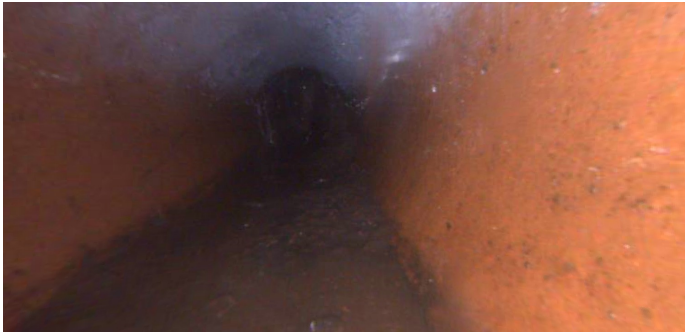
Code:	<b>MWL</b>
Description:	<b>Water Level</b>

Distance (ft):	<b>.0</b>
Structural Grade:	<b>0</b>
O&M Grade:	<b>0</b>
Clock Start/From:	
Clock To:	
1st Value:	
2nd Value:	
Value Percent:	<b>20.000</b>
Continuous Index:	
Within 8" of Joint:	<b>NO</b>
Remarks:

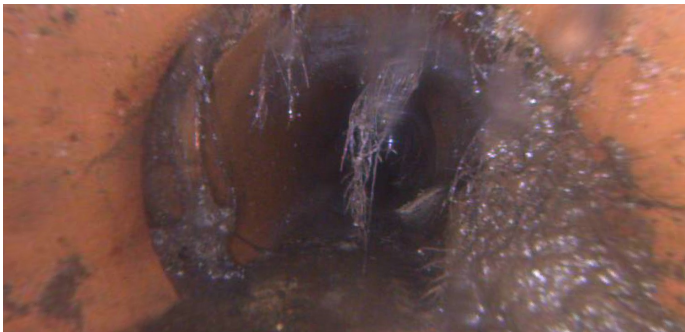
Code:	<b>RMJ</b>
Description:	<b>Roots Medium Joint</b>

Distance (ft):	<b>3.3</b>
Structural Grade:	<b>0</b>
O&M Grade:	<b>3</b>
Clock Start/From:	<b>8</b>
Clock To:	<b>4</b>
1st Value:	
2nd Value:	
Value Percent:	<b>20.000</b>
Continuous Index:	
Within 8" of Joint:	<b>YES</b>
Remarks:

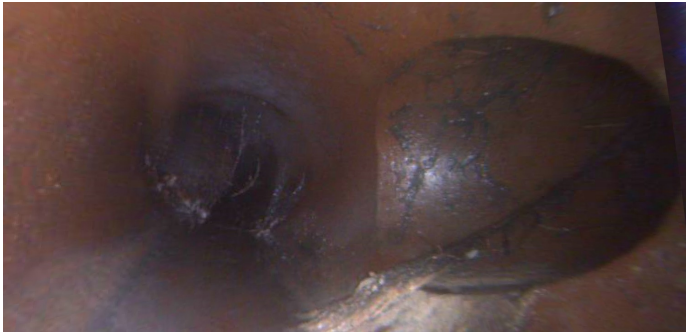
Code: **TFD**  
Description: **Tap Factory Defective**

Distance (ft): **4.2**  
Structural Grade: **0**  
O&M Grade: **2**  
Clock Start/From: **3**  
Clock To:  
1st Value: **4.000**  
2nd Value:  
Value Percent:  
Continuous Index:  
Within 8" of Joint:  
Remarks: **rfl**

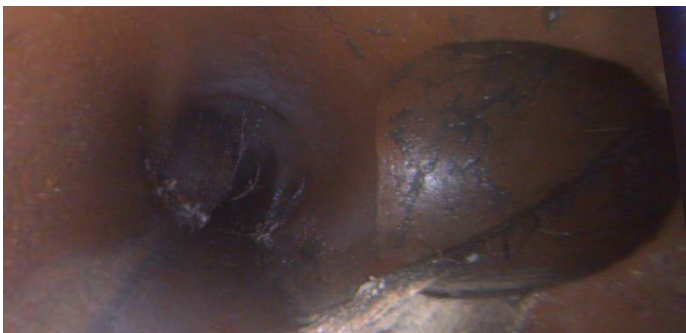
Code: **RFL**  
Description: **Roots Fine Lateral**

Distance (ft): **4.2**  
Structural Grade: **0**  
O&M Grade: **1**  
Clock Start/From: **3**  
Clock To:  
1st Value:  
2nd Value:  
Value Percent:  
Continuous Index:  
Within 8" of Joint: **NO**  
Remarks:

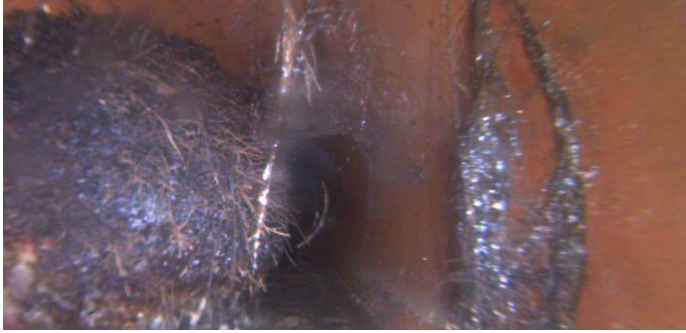
Code: **RMJ**  
Description: **Roots Medium Joint**

Distance (ft): **5.6**  
Structural Grade: **0**  
O&M Grade: **3**  
Clock Start/From: **8**  
Clock To: **4**  
1st Value:  
2nd Value:  
Value Percent: **40.000**  
Continuous Index:  
Within 8" of Joint: **YES**  
Remarks:

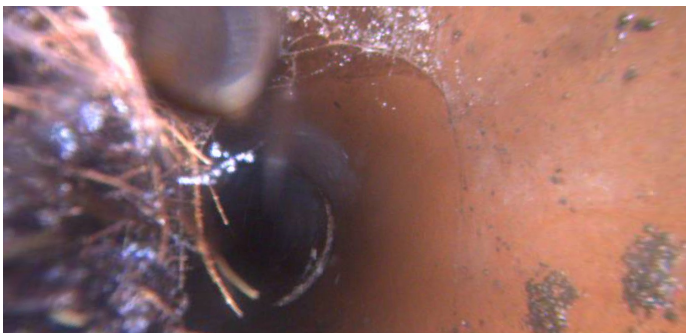
Code: **MSA**  
Description: **Abandoned Survey**

Distance (ft): **6.5**  
Structural Grade: **0**  
O&M Grade: **0**  
Clock Start/From:  
Clock To:  
1st Value:  
2nd Value:  
Value Percent:  
Continuous Index:  
Within 8" of Joint: **NO**  
Remarks: **rmj**
