Profile/Photo Observation Report

Date:	05/05/2018	Weather:		Coding:	PACP 6.0
Pipe Length (ft):		Owner:	City of Hobart	Pre Clean:	No Pre-Cleaning
P.O.#:	191	Surveyor:	M. Pielacha	PSR:	P-805-013-018
Customer:	City of Hobart	Clean Date:		Shape:	C

Street:	5th Street	Flow Control:	Not Controlled
City:	Hobart, IN	Year Renewed:	
Location:	Light Highway	Tape/Media #:	DEP 191
Purpose:	Routine Assessment	Dia/Height:	20"
Use:	Sanitary	Material:	VCP
Drain Area:		Lining:	
Category:	NA		
Comment:	5-21-2018		
Location Details:		Direction of Survey:	Upstream
US MH:	M-805-013	DS MH:	M-805-018
		Total Length Surveyed (ft):	.1

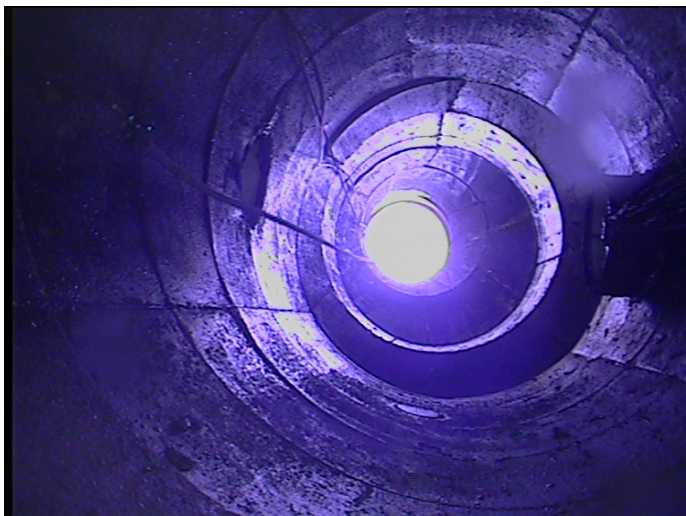
Code:	AMH
Description:	Manhole
Distance (ft):	.0
Structural Grade:	0
O&M Grade:	0
Clock Start/From:	
Clock To:	
1st Value:	
2nd Value:	
Value Percent:	
Continuous Index:	
Within 8" of Joint:	NO
Remarks:	M-805-018

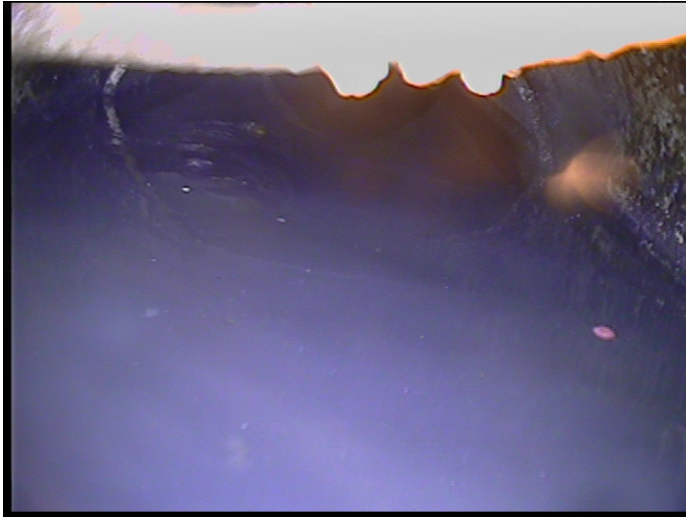
Code: **MWL**
Description: **Water Level**

Distance (ft): **.0**
Structural Grade: **0**
O&M Grade: **0**
Clock Start/From:
Clock To:
1st Value:
2nd Value:
Value Percent: **15.000**
Continuous Index:
Within 8" of Joint: **NO**
Remarks:

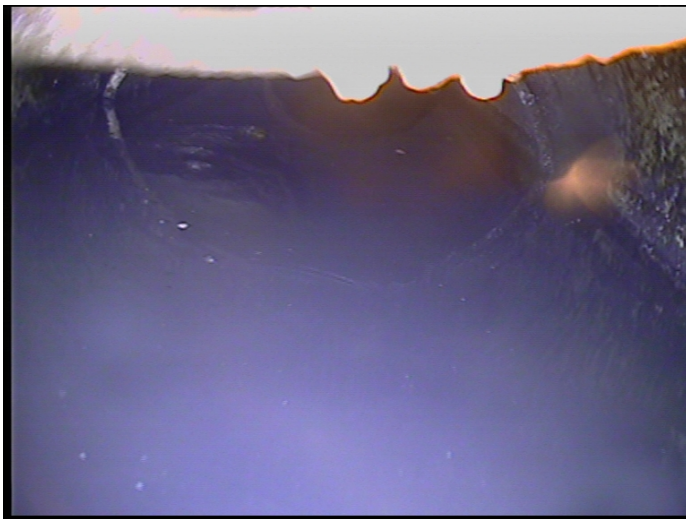
Code: **DSF**
Description: **Deposits Settled Fine**

Distance (ft): **.0**
Structural Grade: **0**
O&M Grade: **3**
Clock Start/From: **4**
Clock To: **8**
1st Value:
2nd Value:
Value Percent: **20.000**
Continuous Index:
Within 8" of Joint: **NO**
Remarks:

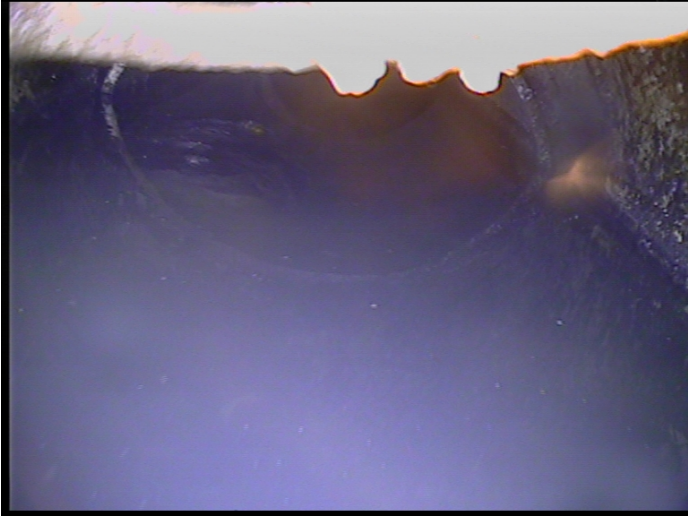
Code:	MSA
Description:	Abandoned Survey
Distance (ft):	.0
Structural Grade:	0
O&M Grade:	0
Clock Start/From:	
Clock To:	
1st Value:	
2nd Value:	
Value Percent:	
Continuous Index:	
Within 8" of Joint:	NO
Remarks:	deep sediment
