Profile/Photo Observation Report

Street:	5th Street	Flow Control:	Not Controlled
City:	Hobart, IN	Year Renewed:	
Location:	Light Highway	Tape/Media #:	DEP 192
Purpose:	Routine Assessment	Dia/Height:	18"
Use:	Sanitary	Material:	VCP
Drain Area:		Lining:	
Category:	NA		
Comment:	5-21-2018		
Location Details:		Direction of Survey:	Downstream
US MH:	M-805-013	DS MH:	M-805-018
		Total Length Surveyed (ft):	13.0

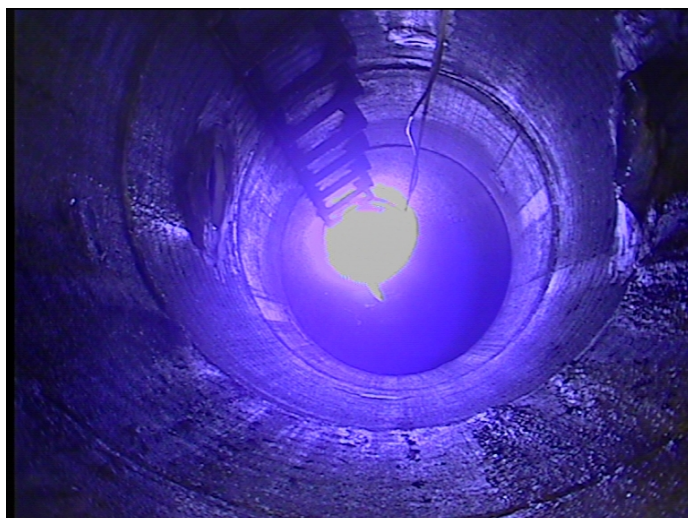
Code: **AMH**
Description: **Manhole**

Distance (ft): **.0**
Structural Grade: **0**
O&M Grade: **0**
Clock Start/From:
Clock To:
1st Value:
2nd Value:
Value Percent:
Continuous Index:
Within 8" of Joint: **NO**
Remarks: **M-805-013**

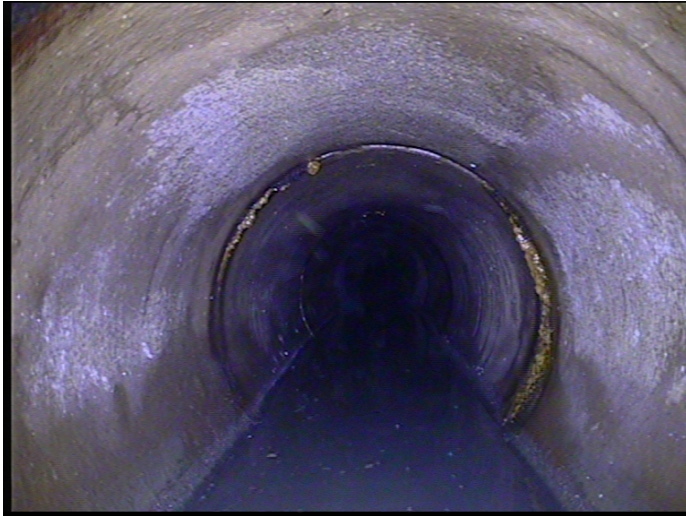
Code:	MWL
Description:	Water Level
Distance (ft):	.0
Structural Grade:	0
O&M Grade:	0
Clock Start/From:	
Clock To:	
1st Value:	
2nd Value:	
Value Percent:	10.000
Continuous Index:	
Within 8" of Joint:	NO
Remarks:

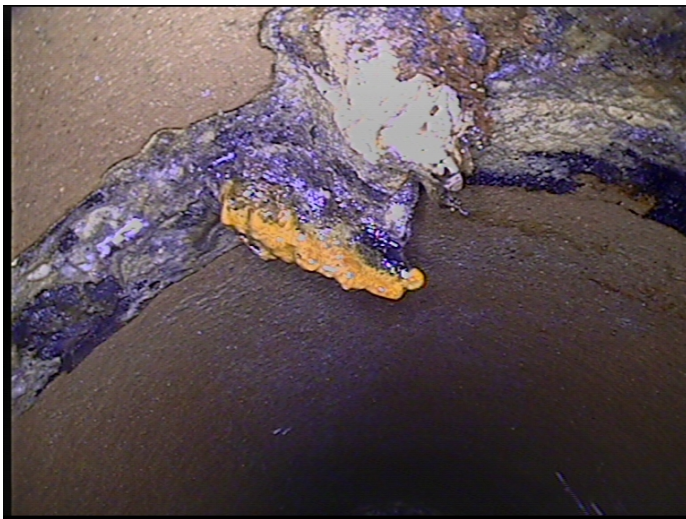
Code:	ID
Description:	Infil Dripper
Distance (ft):	6.8
Structural Grade:	0
O&M Grade:	3
Clock Start/From:	1
Clock To:	
1st Value:	
2nd Value:	
Value Percent:	
Continuous Index:	
Within 8" of Joint:	YES
Remarks:

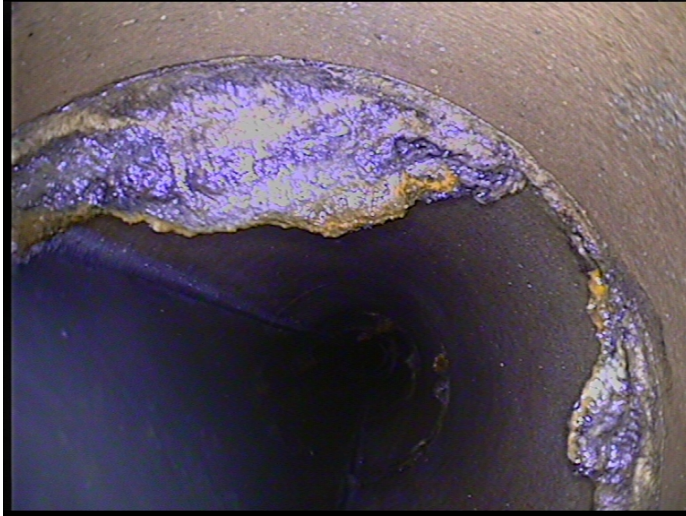
Code: **DAE**
Description: **Deposits Attached Encrustation**

Distance (ft): **11.1**
Structural Grade: **0**
O&M Grade: **3**
Clock Start/From: **7**
Clock To: **5**
1st Value:
2nd Value:
Value Percent: **15.000**
Continuous Index:
Within 8" of Joint: **YES**
Remarks:

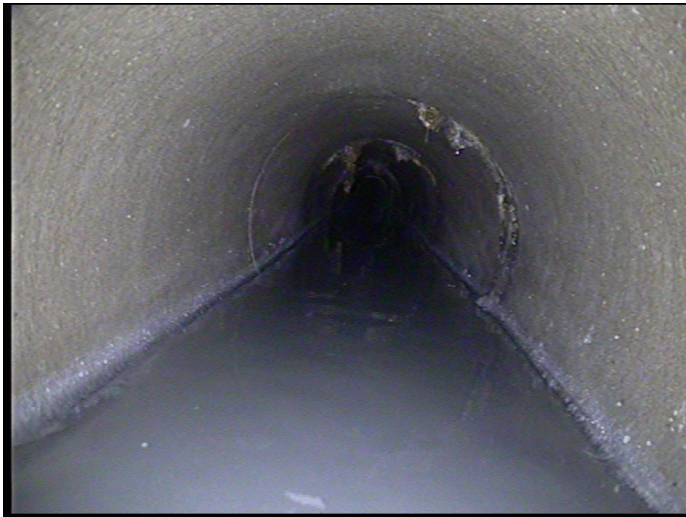
Code: **MSA**
Description: **Abandoned Survey**

Distance (ft): **13.0**
Structural Grade: **0**
O&M Grade: **0**
Clock Start/From:
Clock To:
1st Value:
2nd Value:
Value Percent:
Continuous Index:
Within 8" of Joint: **NO**
Remarks: **encrustation**
