# Profile/Photo Observation Report

| Customer: | <b>City of Hobart</b> | Clean Date: | <b>09/01/2022</b> | Shape: | <b>C</b> |

| Street: | <b>E 5TH ST</b> | Flow Control: | <b>Not Controlled</b> |
| US MH: | <b>M-805-018</b> | DS MH: | <b>M-805-013</b> |

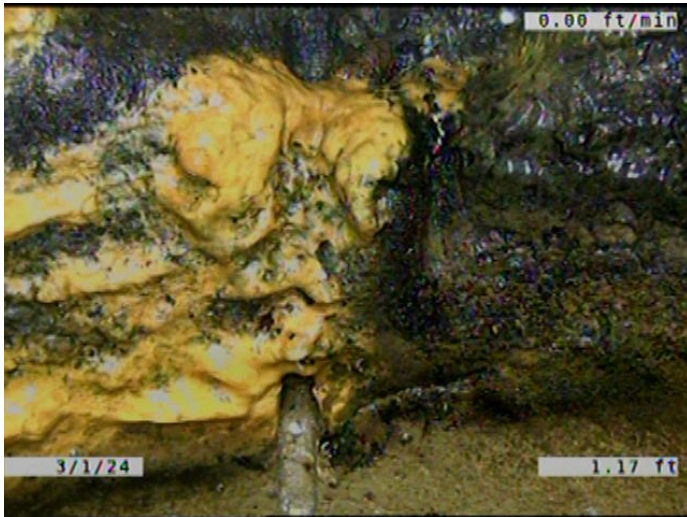
Code: **IDJ**  
Description: **Infiltration Dripper Joint**

Distance (ft): **1.2**  
Structural Grade: **0**  
O&M Grade: **3**  
Clock Start/From: **11**  
Clock To: **1**  
1st Value:  
2nd Value:  
Value Percent:  
Continuous Index:  
Within 8" of Joint: **YES**  
Remarks:

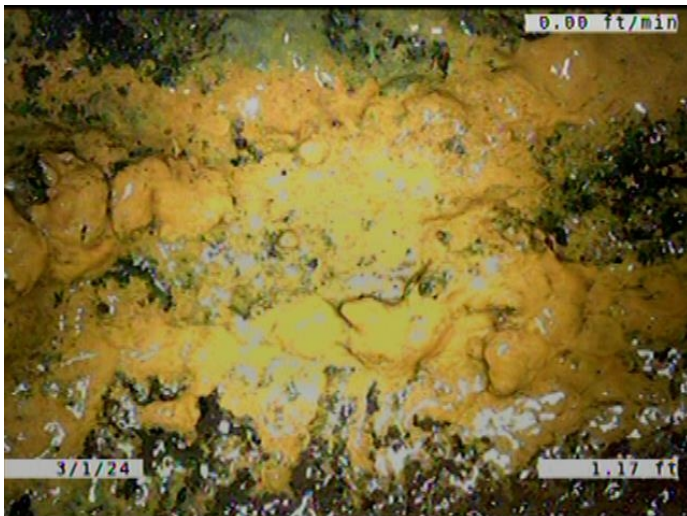
Code: **DAE**  
Description: **Deposits Attached Encrustation**

Distance (ft): **1.2**  
Structural Grade: **0**  
O&M Grade: **2**  
Clock Start/From: **7**  
Clock To: **5**  
1st Value:  
2nd Value:  
Value Percent: **5.000**  
Continuous Index: **S01**  
Within 8" of Joint: **YES**  
Remarks:

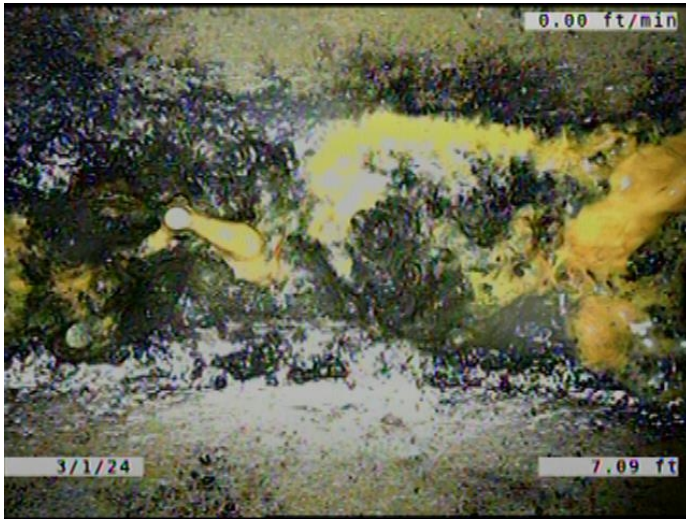
Code: IDJ  
Description: Infiltration Dripper Joint

Distance (ft): 7.1  
Structural Grade: 0  
O&M Grade: 3  
Clock Start/From: 11  
Clock To: 1  
1st Value:  
2nd Value:  
Value Percent:  
Continuous Index:  
Within 8" of Joint: YES  
Remarks:

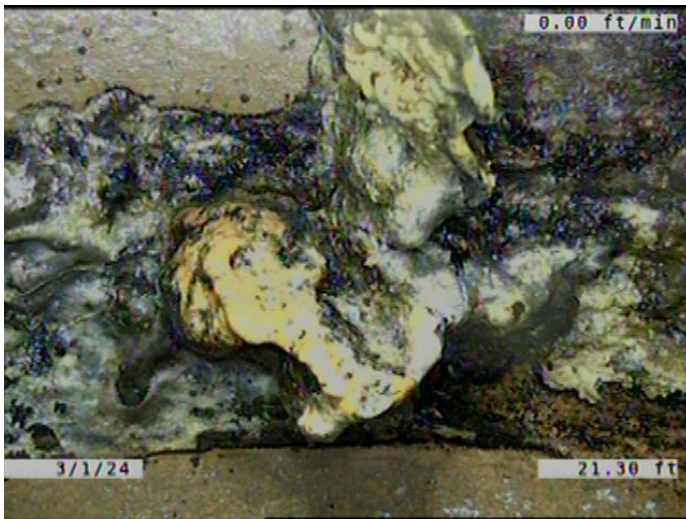
Code: IDJ  
Description: Infiltration Dripper Joint

Distance (ft): 21.3  
Structural Grade: 0  
O&M Grade: 3  
Clock Start/From: 11  
Clock To: 1  
1st Value:  
2nd Value:  
Value Percent:  
Continuous Index: S02  
Within 8" of Joint: YES  
Remarks:

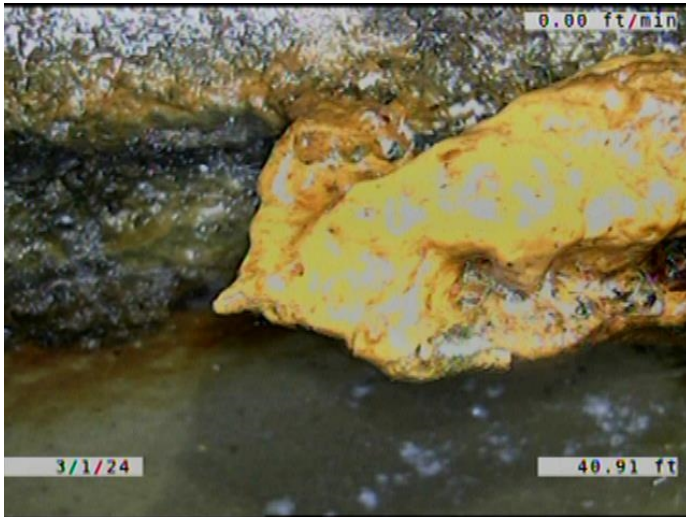
Code: **IDJ**  
Description: **Infiltration Dripper Joint**

Distance (ft): **40.9**  
Structural Grade: **0**  
O&M Grade: **3**  
Clock Start/From: **10**  
Clock To:  
1st Value:  
2nd Value:  
Value Percent:  
Continuous Index:  
Within 8" of Joint: **YES**  
Remarks:

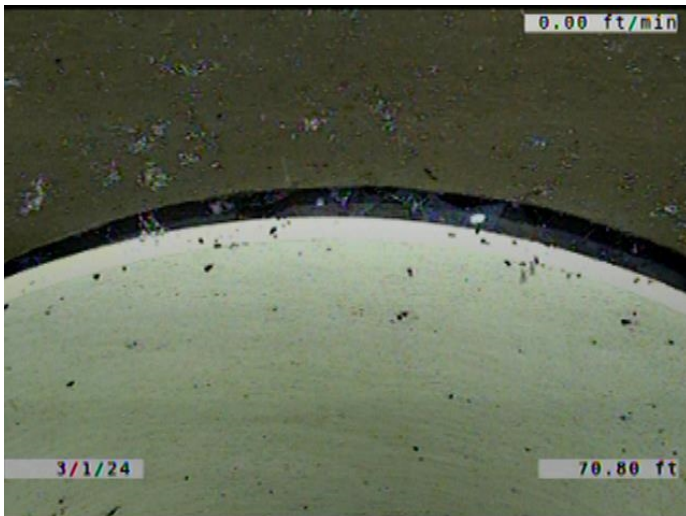
Code: **JOM**  
Description: **Joint Offset Medium**

Distance (ft): **70.8**  
Structural Grade: **3**  
O&M Grade: **0**  
Clock Start/From:  
Clock To:  
1st Value:  
2nd Value:  
Value Percent:  
Continuous Index:  
Within 8" of Joint: **NO**  
Remarks:

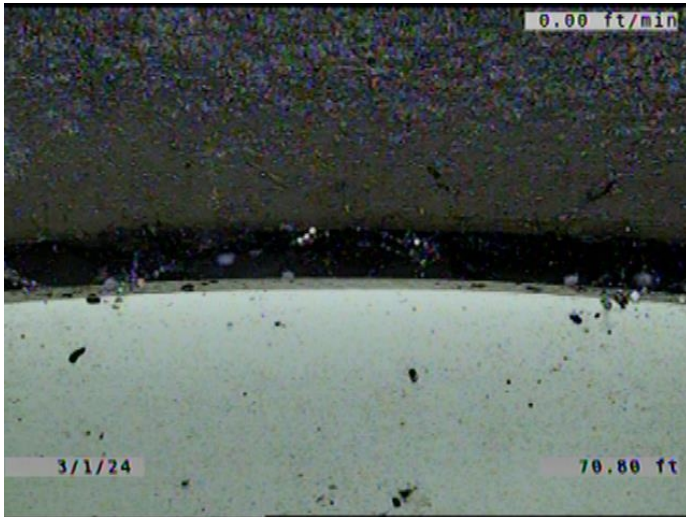
Code: **RPR**  
Description: **Point Repair Replacement**

Distance (ft): **70.8**  
Structural Grade: **0**  
O&M Grade: **0**  
Clock Start/From:  
Clock To:  
1st Value:  
2nd Value:  
Value Percent:  
Continuous Index: **S03**  
Within 8" of Joint: **YES**  
Remarks: **REPLACED WITH PVC.**

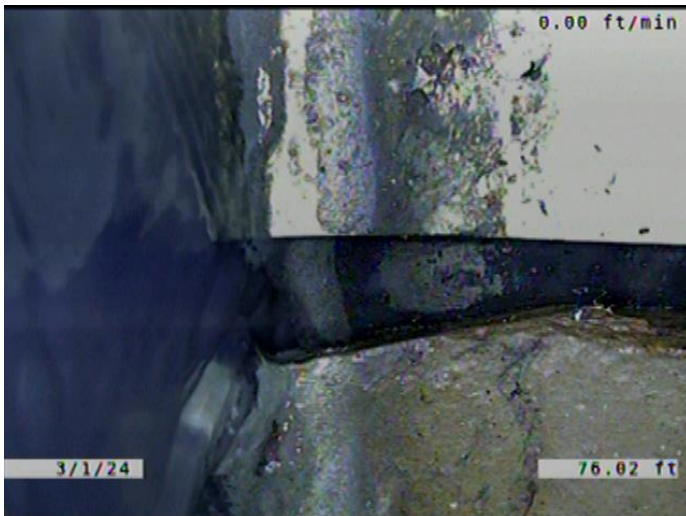
Code: **JAM**  
Description: **Joint Angular Medium**

Distance (ft): **76.0**  
Structural Grade: **3**  
O&M Grade: **0**  
Clock Start/From:  
Clock To:  
1st Value:  
2nd Value:  
Value Percent:  
Continuous Index:  
Within 8" of Joint: **NO**  
Remarks:

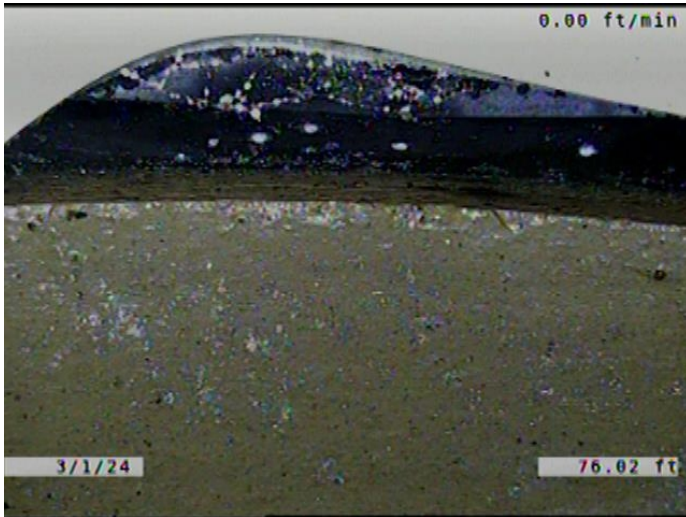
Code: **RPR**  
Description: **Point Repair Replacement**

Distance (ft): **76.0**  
Structural Grade: **0**  
O&M Grade: **0**  
Clock Start/From:  
Clock To:  
1st Value:  
2nd Value:  
Value Percent:  
Continuous Index: **F03**  
Within 8" of Joint: **YES**  
Remarks: **REPLACED WITH PVC.**

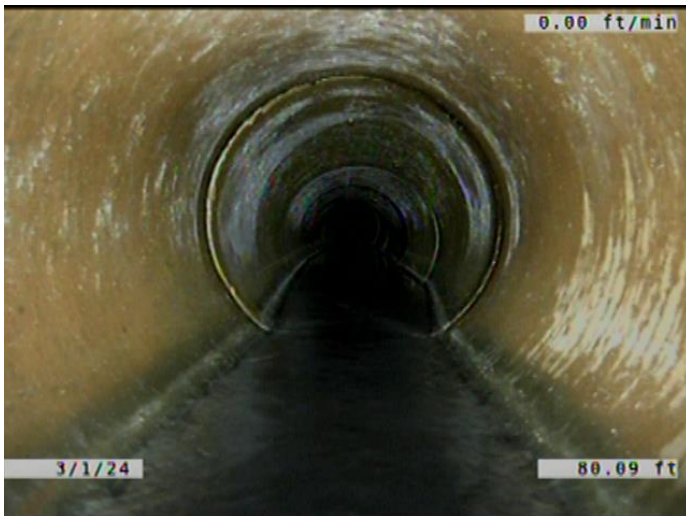
Code: **IDJ**  
Description: **Infiltration Dripper Joint**

Distance (ft): **80.1**  
Structural Grade: **0**  
O&M Grade: **3**  
Clock Start/From: **11**  
Clock To: **1**  
1st Value:  
2nd Value:  
Value Percent:  
Continuous Index: **F02**  
Within 8" of Joint: **YES**  
Remarks:

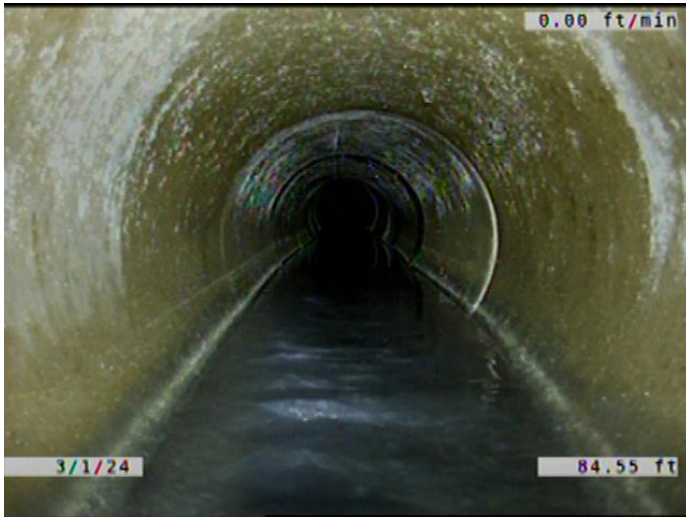
Code: **MWLS**  
Description: **Miscellaneous Water Level Sag**

Distance (ft): **84.6**  
Structural Grade: **2**  
O&M Grade: **0**  
Clock Start/From:  
Clock To:  
1st Value:  
2nd Value:  
Value Percent: **15.000**  
Continuous Index: **S04**  
Within 8" of Joint: **NO**  
Remarks:

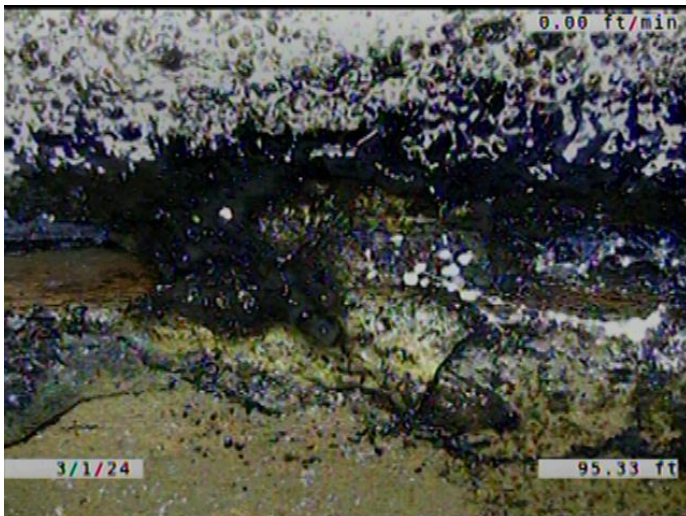
Code: **IWJ**  
Description: **Infiltration Weeper Joint**

Distance (ft): **95.3**  
Structural Grade: **0**  
O&M Grade: **2**  
Clock Start/From: **12**  
Clock To: **1**  
1st Value:  
2nd Value:  
Value Percent:  
Continuous Index:  
Within 8" of Joint: **YES**  
Remarks:

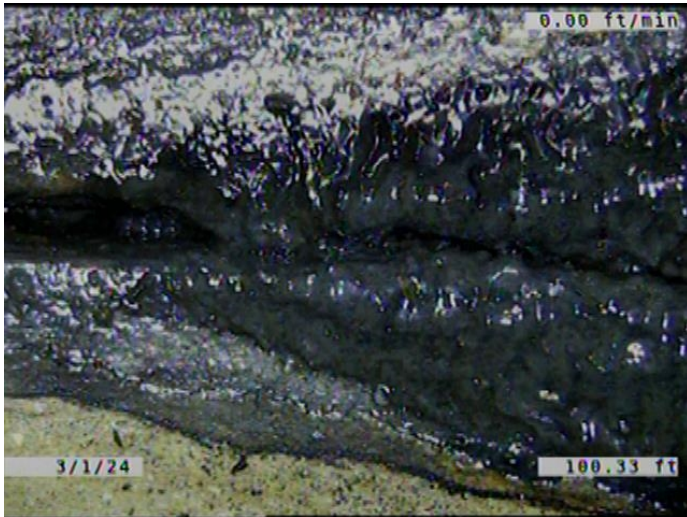
Code: **IDJ**  
 Description: **Infiltration Dripper Joint**

Distance (ft): **100.3**  
 Structural Grade: **0**  
 O&M Grade: **3**  
 Clock Start/From: **2**  
 Clock To:  
 1st Value:  
 2nd Value:  
 Value Percent:  
 Continuous Index:  
 Within 8" of Joint: **YES**  
 Remarks:

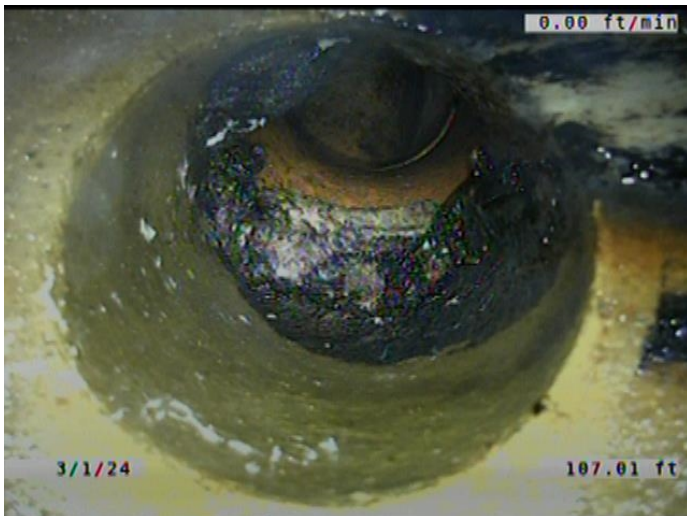
Code: **IDC**  
 Description: **Infiltration Dripper Connection**

Distance (ft): **107.0**  
 Structural Grade: **0**  
 O&M Grade: **3**  
 Clock Start/From: **1**  
 Clock To:  
 1st Value:  
 2nd Value:  
 Value Percent:  
 Continuous Index:  
 Within 8" of Joint: **YES**  
 Remarks:

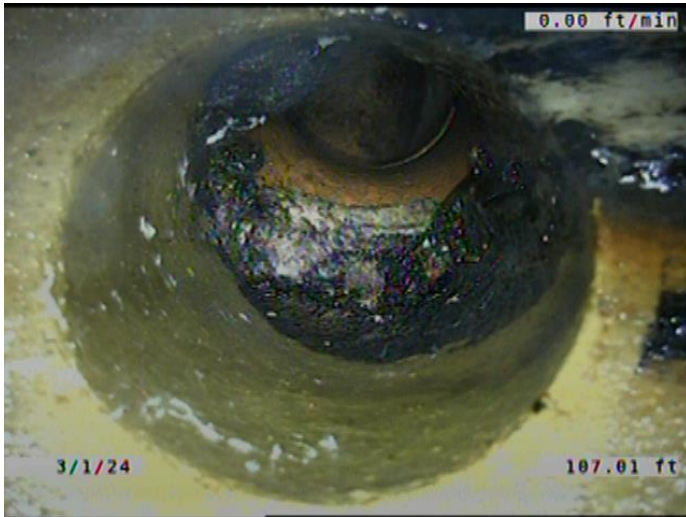
| Code: | <b>TFD</b> |
| Description: | <b>Tap Factory Defective</b> |
| O&M Grade: | <b>3</b> |
| Remarks: | <b>SERVICE OFFSET. ENCRUSTATION<br/>COMING FROM THE SERVICE TO MA</b> |

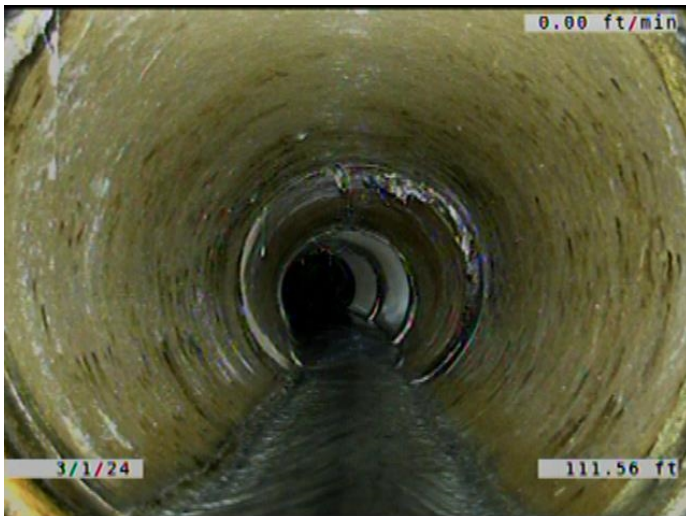
| Code: | <b>MWLS</b> |
| Description: | <b>Miscellaneous Water Level Sag</b> |
| Structural Grade: | <b>2</b> |
| Value Percent: | <b>15.000</b> |

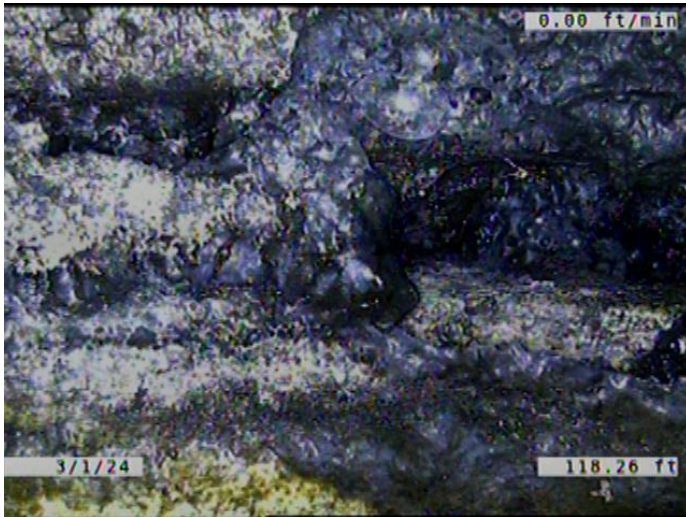
Code: **IDJ**  
 Description: **Infiltration Dripper Joint**

Distance (ft): **118.3**  
 Structural Grade: **0**  
 O&M Grade: **3**  
 Clock Start/From: **3**  
 Clock To:  
 1st Value:  
 2nd Value:  
 Value Percent:  
 Continuous Index:  
 Within 8" of Joint: **YES**  
 Remarks:

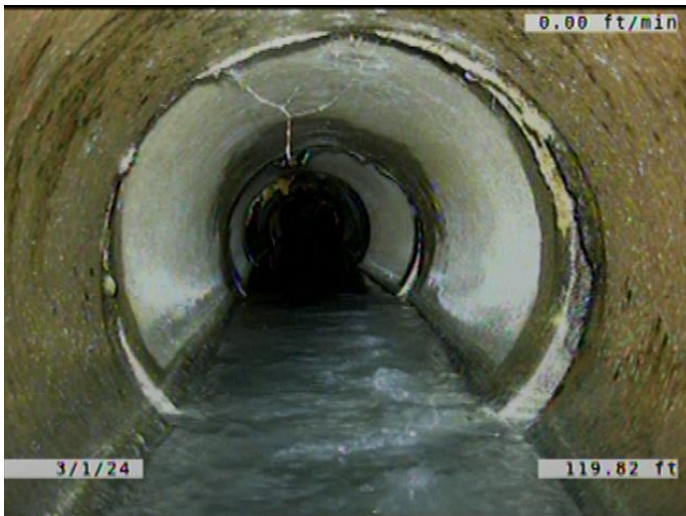
Code: **MWLS**  
 Description: **Miscellaneous Water Level Sag**

Distance (ft): **119.8**  
 Structural Grade: **2**  
 O&M Grade: **0**  
 Clock Start/From:  
 Clock To:  
 1st Value:  
 2nd Value:  
 Value Percent: **15.000**  
 Continuous Index: **S05**  
 Within 8" of Joint: **NO**  
 Remarks:

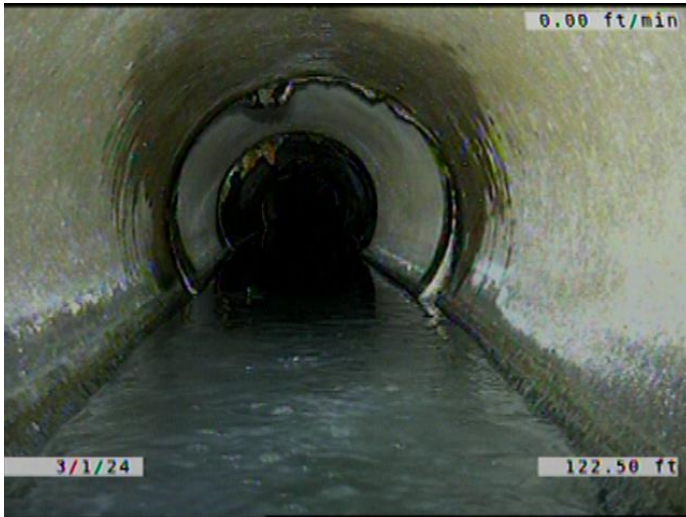
Code: **LL**  
 Description: **Line Left**

Distance (ft): **122.5**  
 Structural Grade: **0**  
 O&M Grade: **1**  
 Clock Start/From:  
 Clock To:  
 1st Value:  
 2nd Value:  
 Value Percent: **5.000**  
 Continuous Index:  
 Within 8" of Joint: **NO**  
 Remarks:

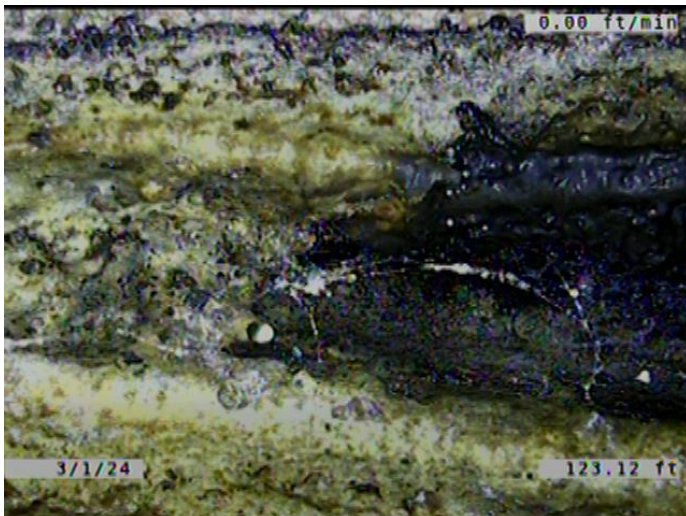
Code: **IDJ**  
 Description: **Infiltration Dripper Joint**

Distance (ft): **123.1**  
 Structural Grade: **0**  
 O&M Grade: **3**  
 Clock Start/From: **10**  
 Clock To: **2**  
 1st Value:  
 2nd Value:  
 Value Percent:  
 Continuous Index: **S06**  
 Within 8" of Joint: **YES**  
 Remarks:

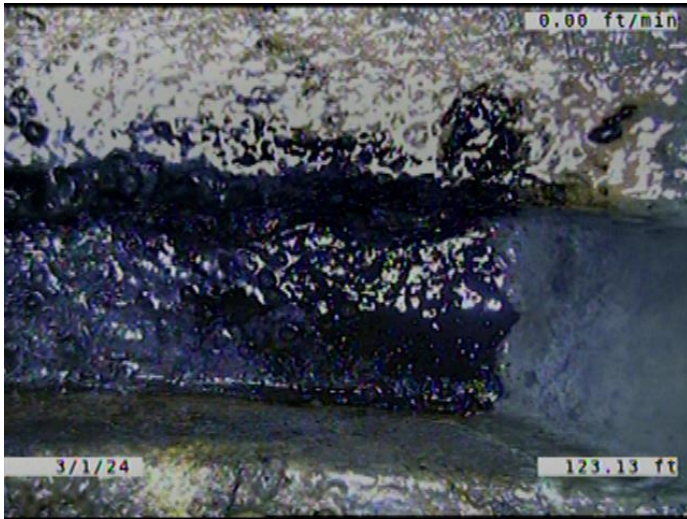
Code: **JAM**  
Description: **Joint Angular Medium**

Distance (ft): **123.1**  
Structural Grade: **3**  
O&M Grade: **0**  
Clock Start/From:  
Clock To:  
1st Value:  
2nd Value:  
Value Percent:  
Continuous Index:  
Within 8" of Joint: **NO**  
Remarks:

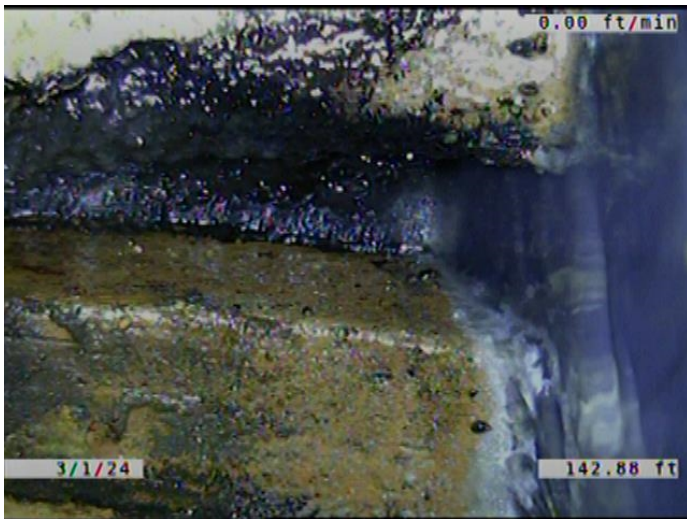
Code: **JAM**  
Description: **Joint Angular Medium**

Distance (ft): **142.9**  
Structural Grade: **3**  
O&M Grade: **0**  
Clock Start/From:  
Clock To:  
1st Value:  
2nd Value:  
Value Percent:  
Continuous Index:  
Within 8" of Joint: **NO**  
Remarks:

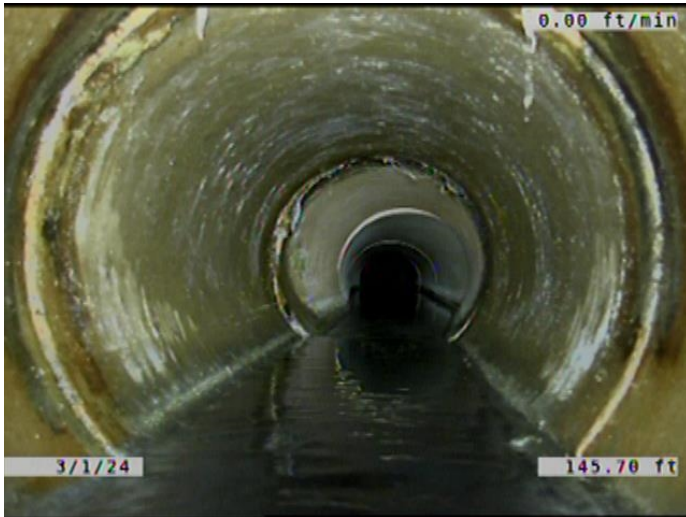
Code: **MWLS**  
Description: **Miscellaneous Water Level Sag**

Distance (ft): **145.7**  
Structural Grade: **2**  
O&M Grade: **0**  
Clock Start/From:  
Clock To:  
1st Value:  
2nd Value:  
Value Percent: **15.000**  
Continuous Index: **F05**  
Within 8" of Joint: **NO**  
Remarks:

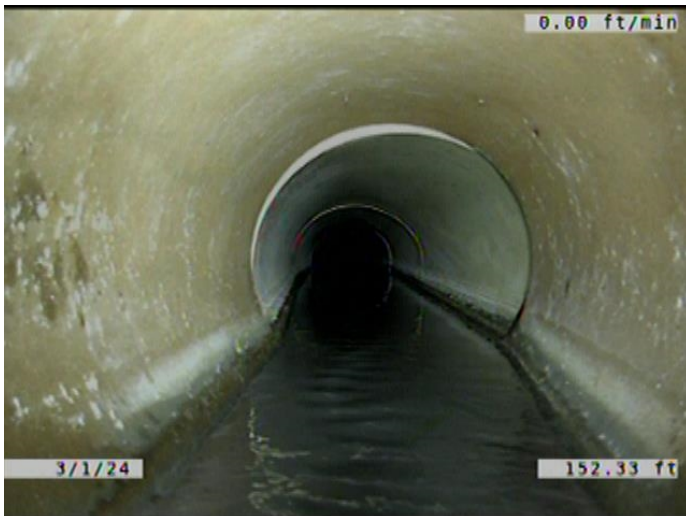
Code: **MWLS**  
Description: **Miscellaneous Water Level Sag**

Distance (ft): **152.3**  
Structural Grade: **2**  
O&M Grade: **0**  
Clock Start/From:  
Clock To:  
1st Value:  
2nd Value:  
Value Percent: **20.000**  
Continuous Index: **S07**  
Within 8" of Joint: **NO**  
Remarks:

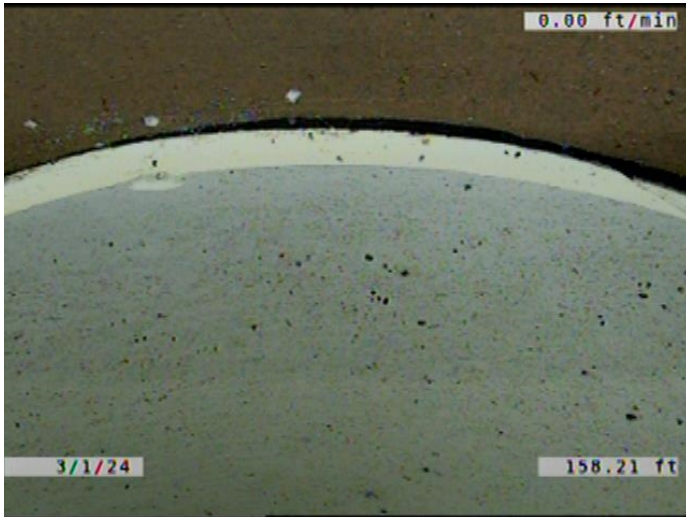
Code: **JOMD**  
Description: **Joint Offset Medium Defective**

Distance (ft): **158.2**  
Structural Grade: **3**  
O&M Grade: **0**  
Clock Start/From:  
Clock To:  
1st Value:  
2nd Value:  
Value Percent:  
Continuous Index:  
Within 8" of Joint: **NO**  
Remarks:

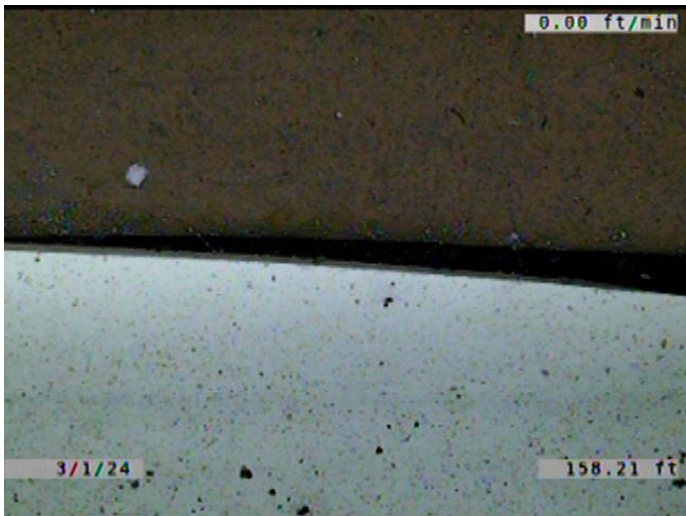
Code: **RPR**  
Description: **Point Repair Replacement**

Distance (ft): **158.2**  
Structural Grade: **0**  
O&M Grade: **0**  
Clock Start/From:  
Clock To:  
1st Value:  
2nd Value:  
Value Percent:  
Continuous Index: **S08**  
Within 8" of Joint: **YES**  
Remarks: **REPLACED WITH PVC.**

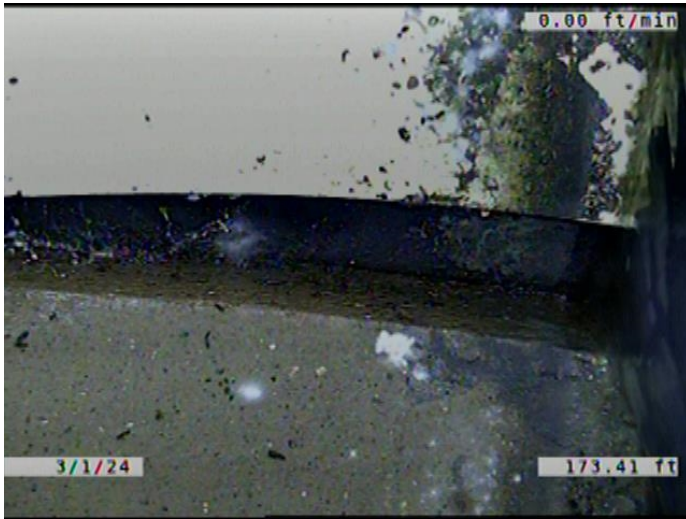
Code: **JAM**  
 Description: **Joint Angular Medium**

Distance (ft): **173.4**  
 Structural Grade: **3**  
 O&M Grade: **0**  
 Clock Start/From:  
 Clock To:  
 1st Value:  
 2nd Value:  
 Value Percent:  
 Continuous Index:  
 Within 8" of Joint: **NO**  
 Remarks:

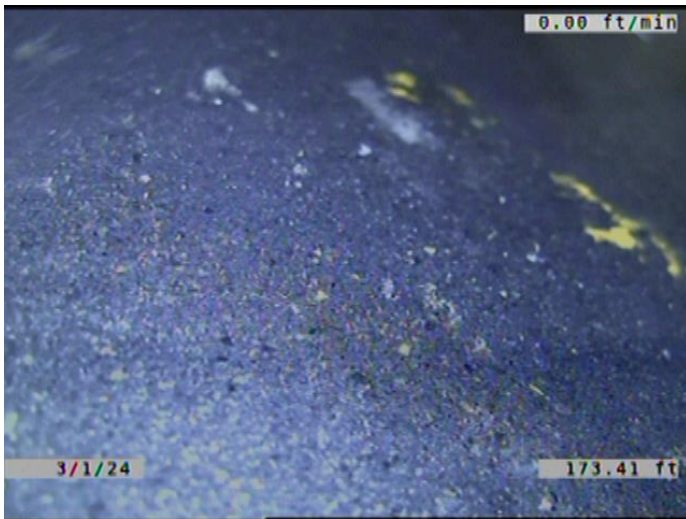
Code: **DSF**  
 Description: **Deposits Settled Fine**

Distance (ft): **173.4**  
 Structural Grade: **0**  
 O&M Grade: **2**  
 Clock Start/From: **5**  
 Clock To: **7**  
 1st Value:  
 2nd Value:  
 Value Percent: **5.000**  
 Continuous Index:  
 Within 8" of Joint: **YES**  
 Remarks:

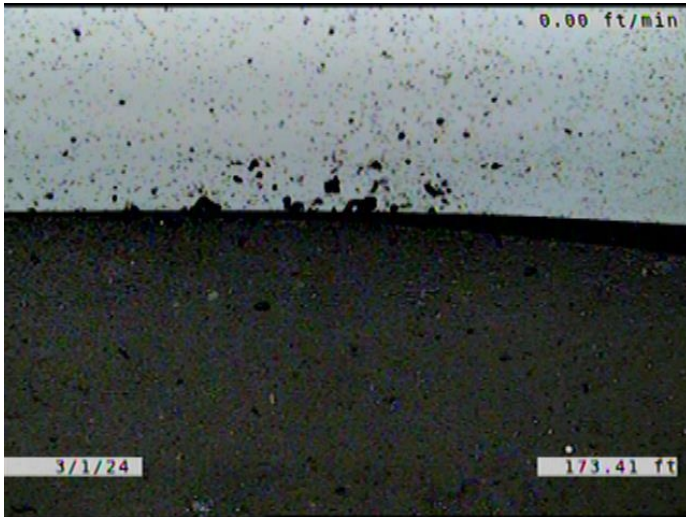
Code: **RPR**  
Description: **Point Repair Replacement**

Distance (ft): **173.4**  
Structural Grade: **0**  
O&M Grade: **0**  
Clock Start/From:  
Clock To:  
1st Value:  
2nd Value:  
Value Percent:  
Continuous Index: **F08**  
Within 8" of Joint: **YES**  
Remarks: **REPLACED WITH PVC.**

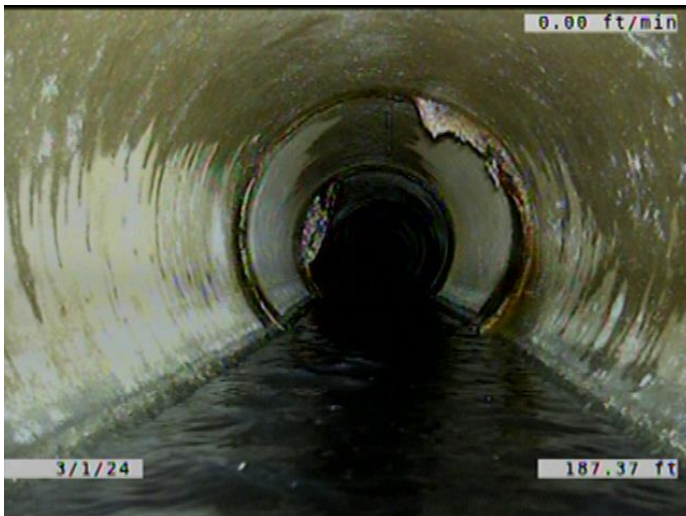
Code: **MWLS**  
Description: **Miscellaneous Water Level Sag**

Distance (ft): **187.4**  
Structural Grade: **2**  
O&M Grade: **0**  
Clock Start/From:  
Clock To:  
1st Value:  
2nd Value:  
Value Percent: **20.000**  
Continuous Index: **F07**  
Within 8" of Joint: **NO**  
Remarks:

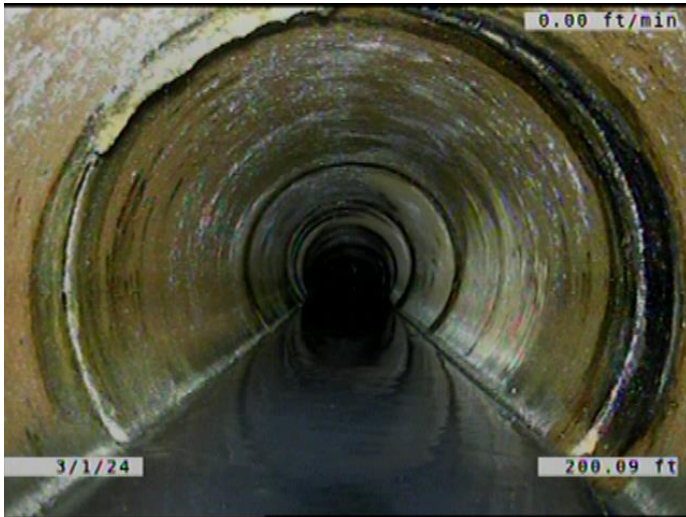
Code: **MWLS**  
Description: **Miscellaneous Water Level Sag**

Distance (ft): **200.1**  
Structural Grade: **3**  
O&M Grade: **0**  
Clock Start/From:  
Clock To:  
1st Value:  
2nd Value:  
Value Percent: **40.000**  
Continuous Index: **S09**  
Within 8" of Joint: **NO**  
Remarks:

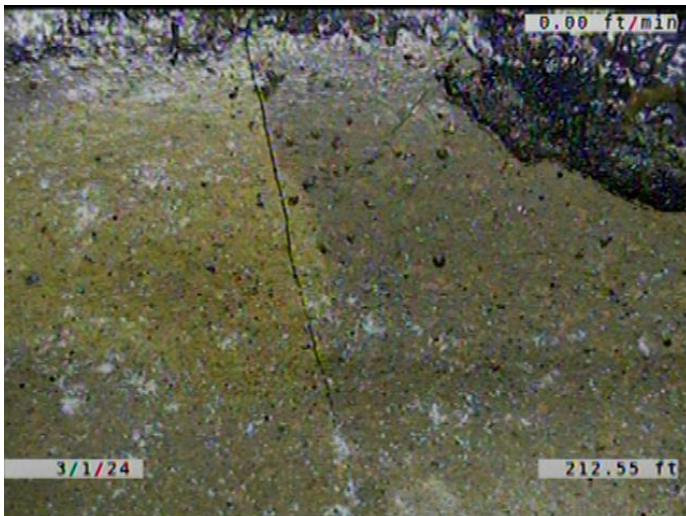
Code: **CS**  
Description: **Crack Spiral**

Distance (ft): **212.6**  
Structural Grade: **2**  
O&M Grade: **0**  
Clock Start/From: **11**  
Clock To: **12**  
1st Value:  
2nd Value:  
Value Percent:  
Continuous Index: **S10**  
Within 8" of Joint: **YES**  
Remarks:

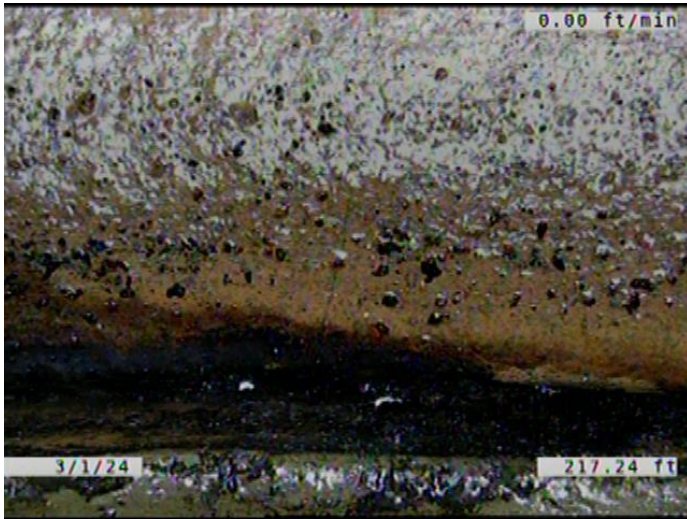
Code: **CS**  
Description: **Crack Spiral**

Distance (ft): **217.2**  
Structural Grade: **2**  
O&M Grade: **0**  
Clock Start/From: **11**  
Clock To: **12**  
1st Value:  
2nd Value:  
Value Percent:  
Continuous Index: **F10**  
Within 8" of Joint: **YES**  
Remarks:

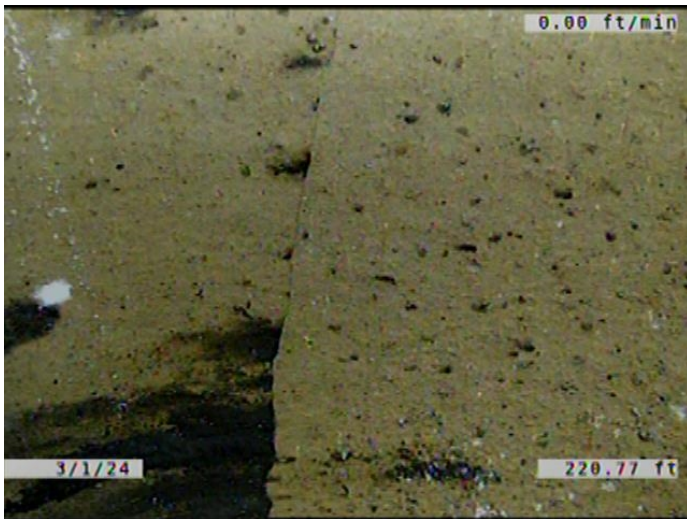
Code: **CS**  
Description: **Crack Spiral**

Distance (ft): **220.8**  
Structural Grade: **2**  
O&M Grade: **0**  
Clock Start/From: **9**  
Clock To: **10**  
1st Value:  
2nd Value:  
Value Percent:  
Continuous Index:  
Within 8" of Joint: **YES**  
Remarks:

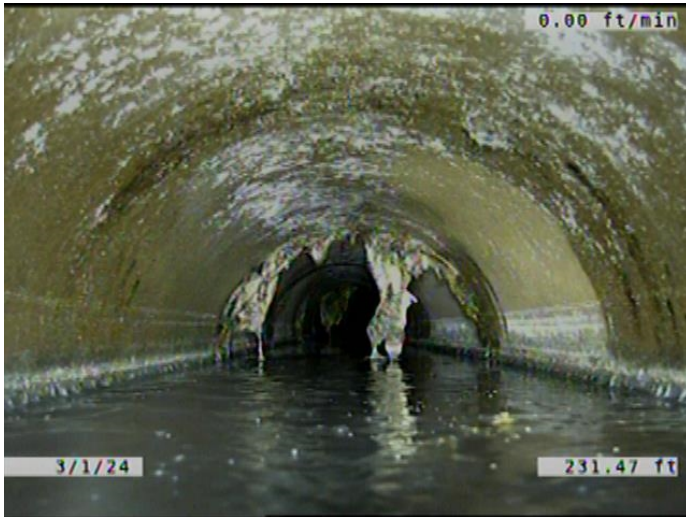
Code: **DSF**  
Description: **Deposits Settled Fine**

Distance (ft): **231.5**  
Structural Grade: **0**  
O&M Grade: **2**  
Clock Start/From: **4**  
Clock To: **8**  
1st Value:  
2nd Value:  
Value Percent: **5.000**  
Continuous Index: **S11**  
Within 8" of Joint: **YES**  
Remarks:

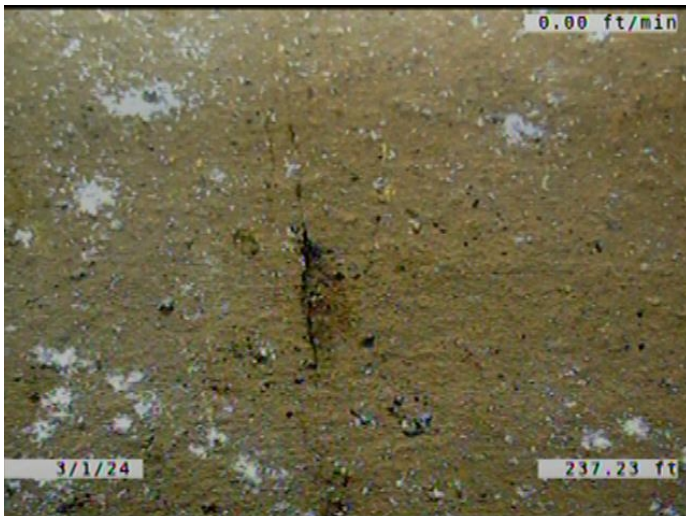
Code: **CL**  
Description: **Crack Longitudinal**

Distance (ft): **237.2**  
Structural Grade: **2**  
O&M Grade: **0**  
Clock Start/From: **12**  
Clock To:  
1st Value:  
2nd Value:  
Value Percent:  
Continuous Index:  
Within 8" of Joint: **YES**  
Remarks:

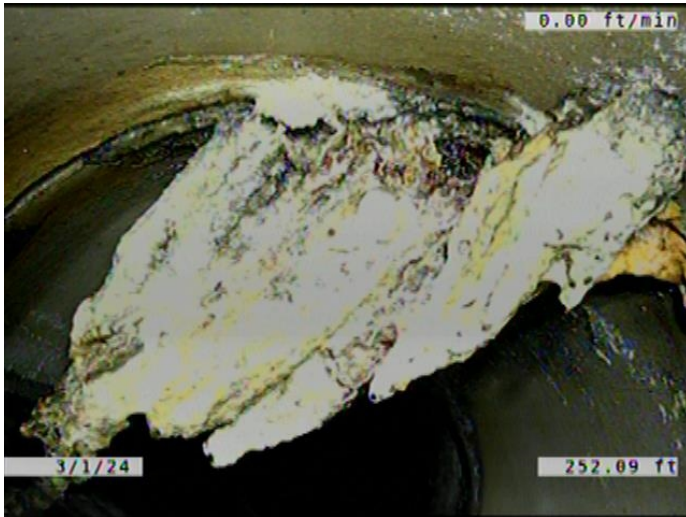
Code: **DAE**  
Description: **Deposits Attached Encrustation**

Distance (ft): **252.1**  
Structural Grade: **0**  
O&M Grade: **3**  
Clock Start/From: **8**  
Clock To: **4**  
1st Value:  
2nd Value:  
Value Percent: **15.000**  
Continuous Index:  
Within 8" of Joint: **YES**  
Remarks:

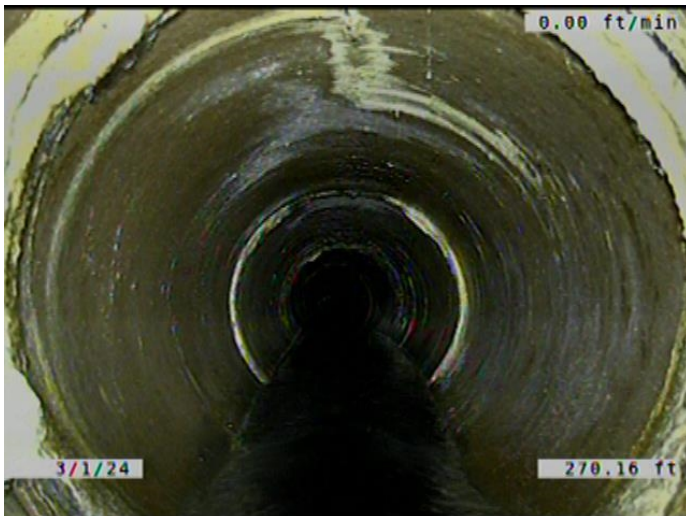
Code: **MWLS**  
Description: **Miscellaneous Water Level Sag**

Distance (ft): **270.2**  
Structural Grade: **3**  
O&M Grade: **0**  
Clock Start/From:  
Clock To:  
1st Value:  
2nd Value:  
Value Percent: **40.000**  
Continuous Index: **F09**  
Within 8" of Joint: **NO**  
Remarks:

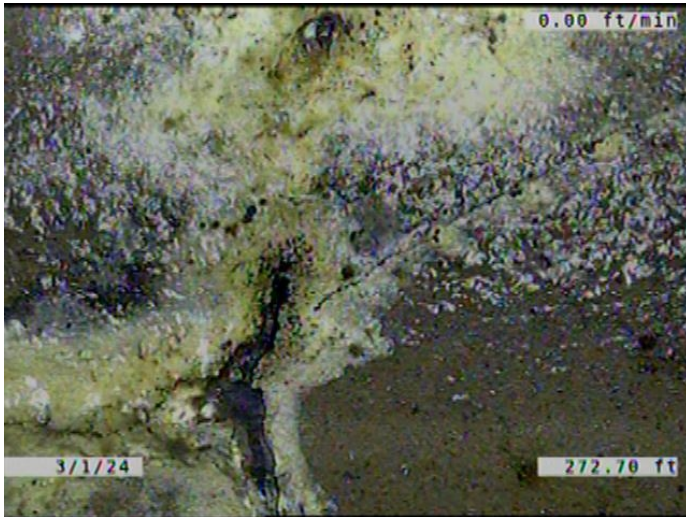
Code: **CM**  
 Description: **Crack Multiple**

Distance (ft): **272.7**  
 Structural Grade: **3**  
 O&M Grade: **0**  
 Clock Start/From: **12**  
 Clock To: **1**  
 1st Value:  
 2nd Value:  
 Value Percent:  
 Continuous Index:  
 Within 8" of Joint: **YES**  
 Remarks:

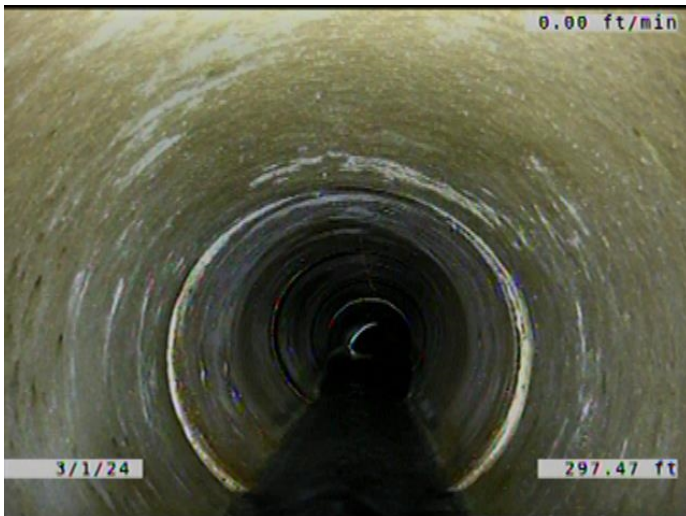
Code: **LD**  
 Description: **Line Down**

Distance (ft): **297.5**  
 Structural Grade: **0**  
 O&M Grade: **1**  
 Clock Start/From:  
 Clock To:  
 1st Value:  
 2nd Value:  
 Value Percent: **5.000**  
 Continuous Index:  
 Within 8" of Joint: **NO**  
 Remarks:

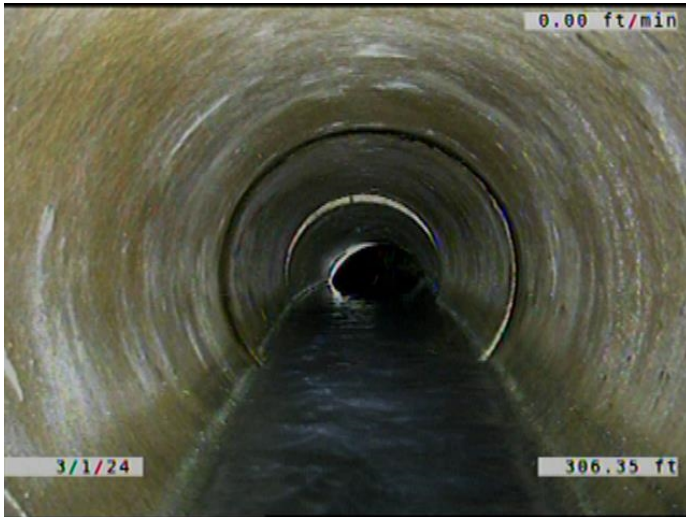
Code: **MWLS**  
Description: **Miscellaneous Water Level Sag**

Distance (ft): **306.3**  
Structural Grade: **4**  
O&M Grade: **0**  
Clock Start/From:  
Clock To:  
1st Value:  
2nd Value:  
Value Percent: **75.000**  
Continuous Index: **S12**  
Within 8" of Joint: **NO**  
Remarks:

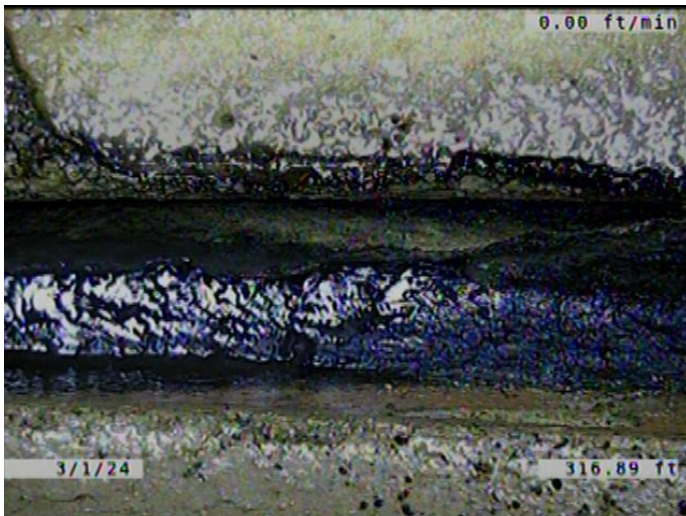
Code: **IRJ**  
Description: **Infiltration Runner Joint**

Distance (ft): **316.9**  
Structural Grade: **0**  
O&M Grade: **4**  
Clock Start/From: **10**  
Clock To:  
1st Value:  
2nd Value:  
Value Percent:  
Continuous Index:  
Within 8" of Joint: **YES**  
Remarks:

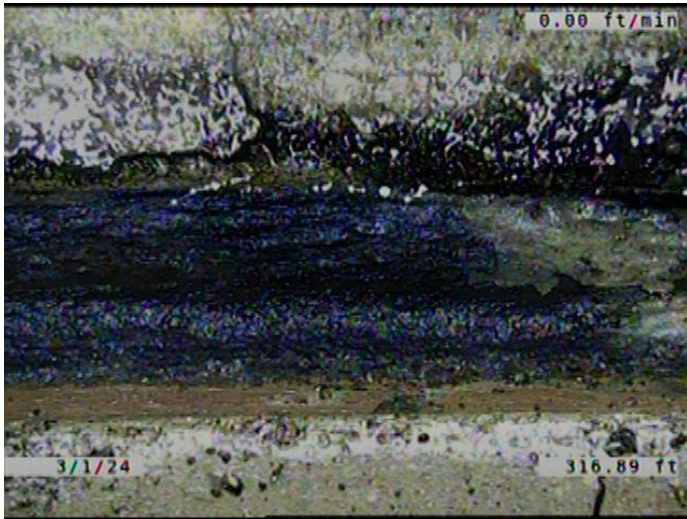
Code: **JAM**  
Description: **Joint Angular Medium**

Distance (ft): **316.9**  
Structural Grade: **3**  
O&M Grade: **0**  
Clock Start/From:  
Clock To:  
1st Value:  
2nd Value:  
Value Percent:  
Continuous Index:  
Within 8" of Joint: **NO**  
Remarks:

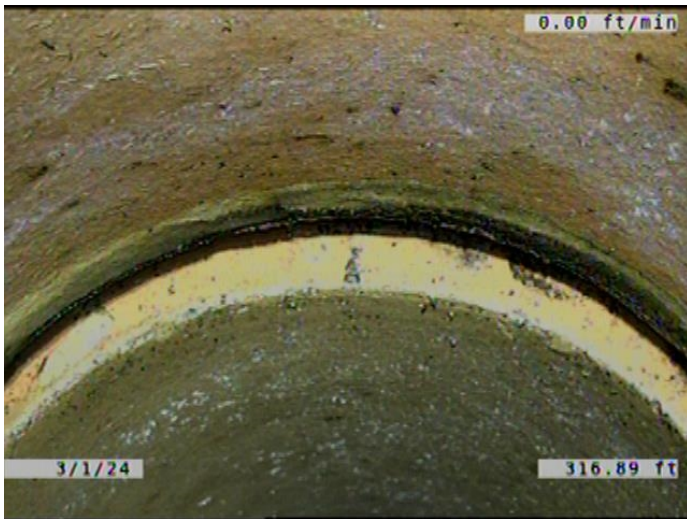
Code: **JOMD**  
Description: **Joint Offset Medium Defective**

Distance (ft): **316.9**  
Structural Grade: **3**  
O&M Grade: **0**  
Clock Start/From:  
Clock To:  
1st Value:  
2nd Value:  
Value Percent:  
Continuous Index:  
Within 8" of Joint: **NO**  
Remarks:

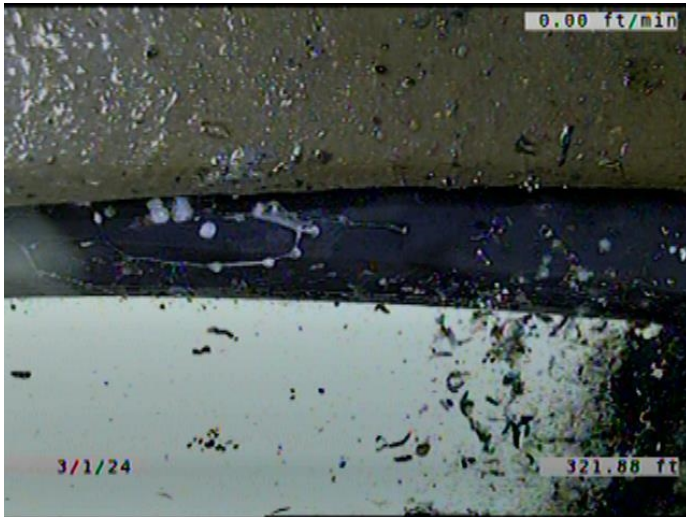
Code: **JAM**  
 Description: **Joint Angular Medium**

Distance (ft): **321.9**  
 Structural Grade: **3**  
 O&M Grade: **0**  
 Clock Start/From:  
 Clock To:  
 1st Value:  
 2nd Value:  
 Value Percent:  
 Continuous Index:  
 Within 8" of Joint: **NO**  
 Remarks:

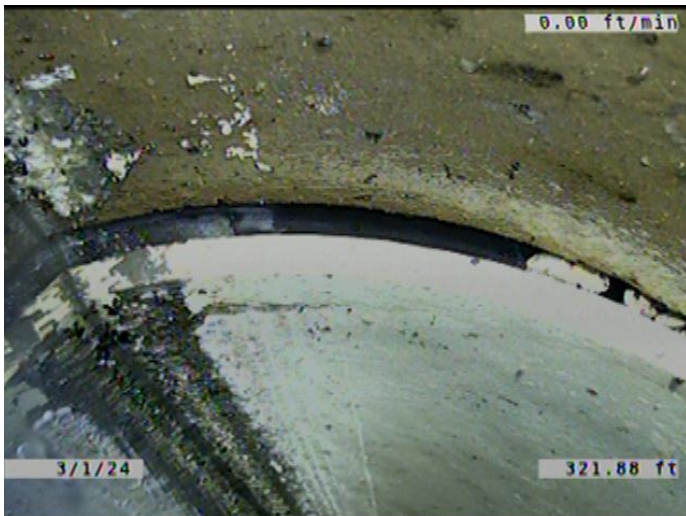
Code: **JOMD**  
 Description: **Joint Offset Medium Defective**

Distance (ft): **321.9**  
 Structural Grade: **3**  
 O&M Grade: **0**  
 Clock Start/From:  
 Clock To:  
 1st Value:  
 2nd Value:  
 Value Percent:  
 Continuous Index:  
 Within 8" of Joint: **NO**  
 Remarks:

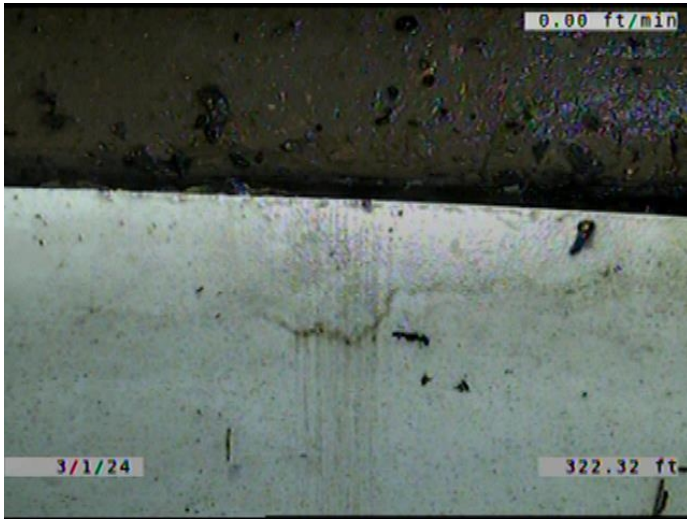
Code: **RPRD**  
Description: **Point Repair Replacement Defective**

Distance (ft): **322.3**  
Structural Grade: **4**  
O&M Grade: **0**  
Clock Start/From:  
Clock To:  
1st Value:  
2nd Value:  
Value Percent:  
Continuous Index:  
Within 8" of Joint: **YES**  
Remarks: **REPLACED WITH PVC. JOINTS HAVE FAILED AND PIPE HAS DROPPED.**

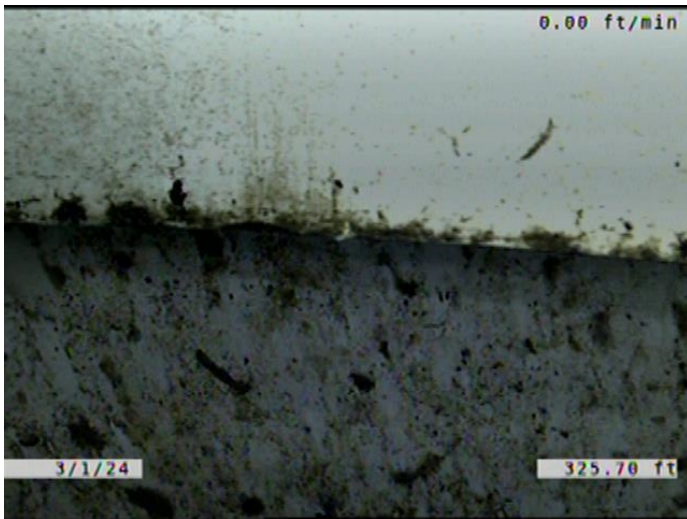
Code: **JOM**  
Description: **Joint Offset Medium**

Distance (ft): **325.7**  
Structural Grade: **3**  
O&M Grade: **0**  
Clock Start/From:  
Clock To:  
1st Value:  
2nd Value:  
Value Percent:  
Continuous Index:  
Within 8" of Joint: **NO**  
Remarks:

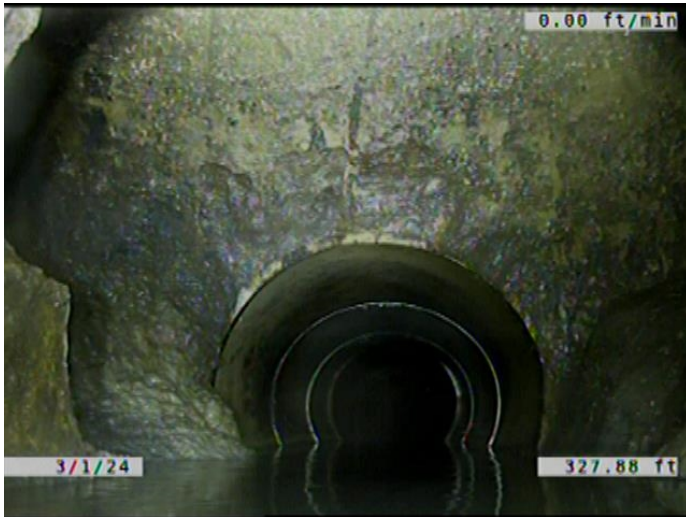
Code: **DAE**  
Description: **Deposits Attached Encrustation**

Distance (ft): **327.9**  
Structural Grade: **0**  
O&M Grade: **2**  
Clock Start/From: **7**  
Clock To: **5**  
1st Value:  
2nd Value:  
Value Percent: **5.000**  
Continuous Index: **F01**  
Within 8" of Joint: **YES**  
Remarks:

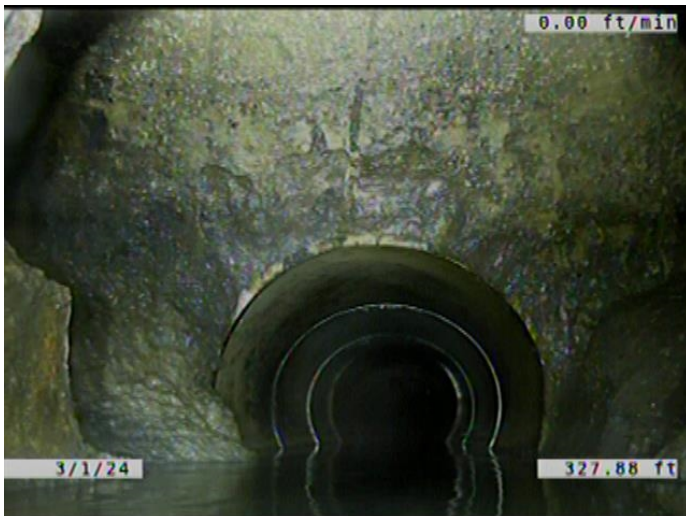
Code: **IDJ**  
Description: **Infiltration Dripper Joint**

Distance (ft): **327.9**  
Structural Grade: **0**  
O&M Grade: **3**  
Clock Start/From: **10**  
Clock To: **2**  
1st Value:  
2nd Value:  
Value Percent:  
Continuous Index: **F06**  
Within 8" of Joint: **YES**  
Remarks:

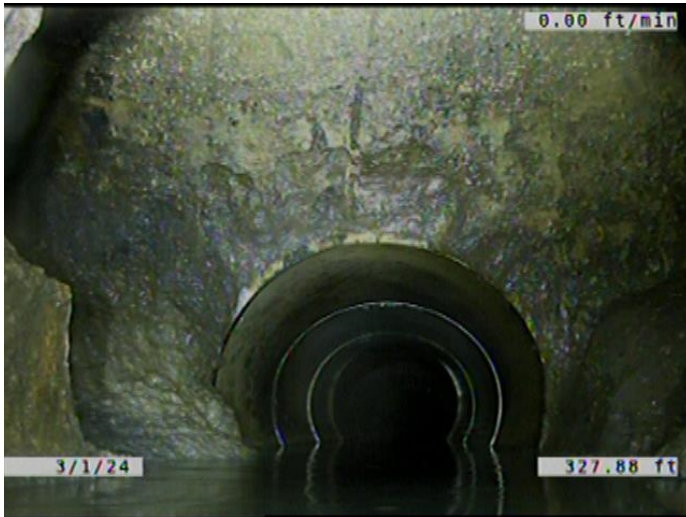
Code: **DSF**  
Description: **Deposits Settled Fine**

Distance (ft): **327.9**  
Structural Grade: **0**  
O&M Grade: **2**  
Clock Start/From: **4**  
Clock To: **8**  
1st Value:  
2nd Value:  
Value Percent: **5.000**  
Continuous Index: **F11**  
Within 8" of Joint: **YES**  
Remarks:

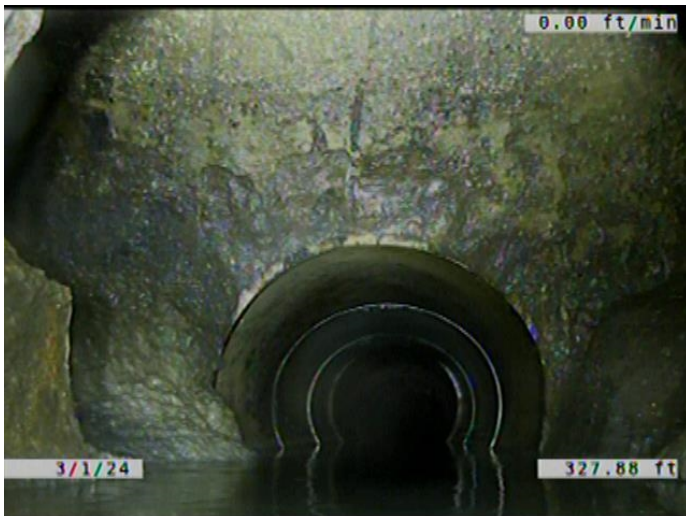
Code: **MWLS**  
Description: **Miscellaneous Water Level Sag**

Distance (ft): **327.9**  
Structural Grade: **4**  
O&M Grade: **0**  
Clock Start/From:  
Clock To:  
1st Value:  
2nd Value:  
Value Percent: **75.000**  
Continuous Index: **F12**  
Within 8" of Joint: **NO**  
Remarks:

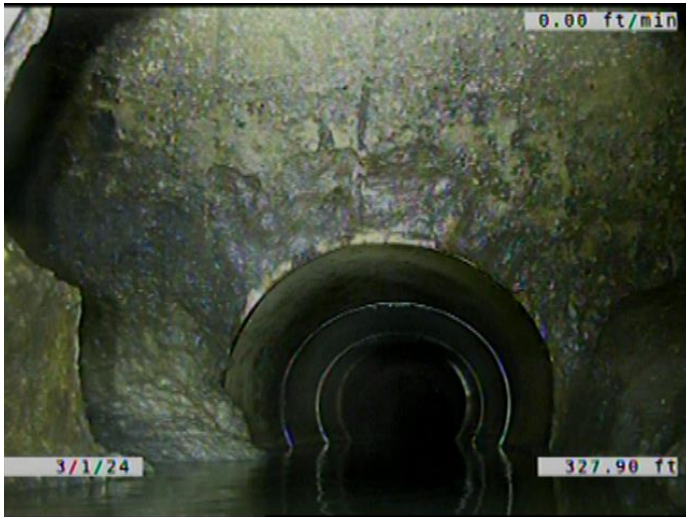
| Code: | MSA |
| Description: | Miscellaneous Survey Abandoned |
| Remarks: | CAMERA CANT MAKE IT PAST LARGE DEFECTIVE OFFSET JOINT. |
