Profile/Photo Observation Report

Date:	09/12/2022	Weather:		Coding:	PACP 7.0
Pipe Length (ft):	223.0	Owner:	City of Hobart	Pre Clean:	Heavy Cleaning
P.O.#:	YES502259	Surveyor:	S. Bucklin	PSR:	P-805-017-018
Customer:	City of Hobart	Clean Date:	08/26/2022	Shape:	C

Street:	South Liberty Place	Flow Control:	Not Controlled
City:	Hobart, IN	Year Renewed:	
Location:	Alley	Tape/Media #:	
Purpose:	Routine Assessment	Dia/Height:	10"
Use:	Sanitary Sewage Pipe	Material:	VCP
Drain Area:		Lining:	None
Category:	NA		
Comment:

Location Details:		Direction of Survey:	Downstream
US MH:	M-805-018	DS MH:	M-805-017
		Total Length Surveyed (ft):	202.9

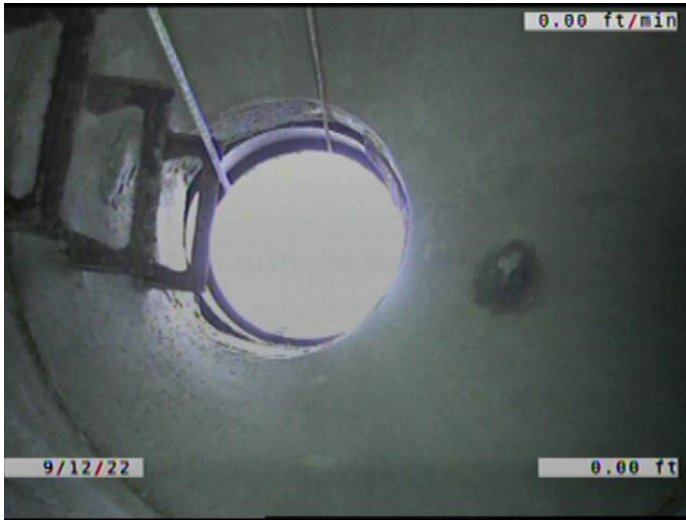
Code: **AMH**
Description: **Manhole**

Distance (ft): **.0**
Structural Grade: **0**
O&M Grade: **0**
Clock Start/From:
Clock To:
1st Value:
2nd Value:
Value Percent:
Continuous Index:
Within 8" of Joint: **NO**
Remarks: **M-805-018**

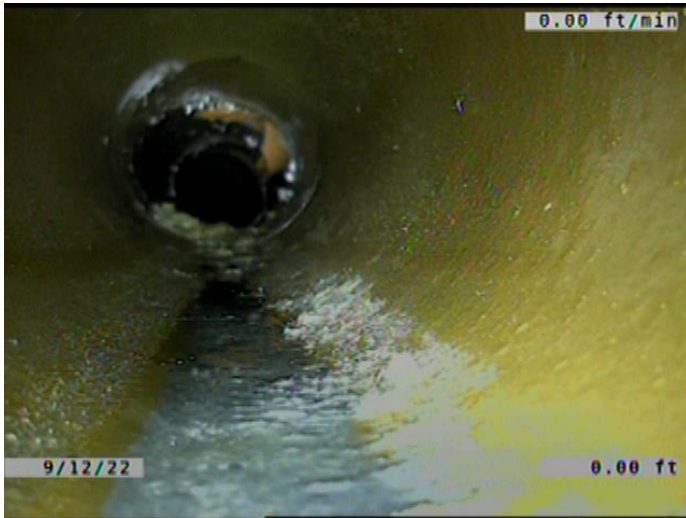
Code: **MWL**
Description: **Miscellaneous Water Level**

Distance (ft): **.0**
Structural Grade: **0**
O&M Grade: **0**
Clock Start/From:
Clock To:
1st Value:
2nd Value:
Value Percent: **5.000**
Continuous Index:
Within 8" of Joint: **NO**
Remarks:

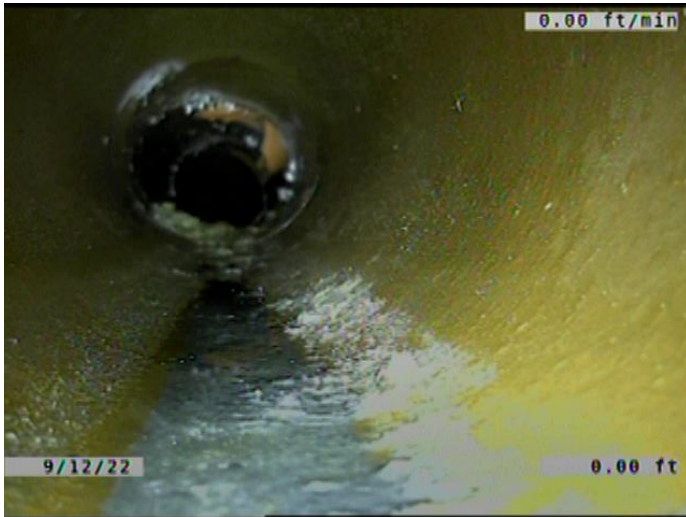
Code: **DSF**
 Description: **Deposits Settled Fine**

Distance (ft): **.0**
 Structural Grade: **0**
 O&M Grade: **2**
 Clock Start/From: **5**
 Clock To: **7**
 1st Value:
 2nd Value:
 Value Percent: **5.000**
 Continuous Index: **S01**
 Within 8" of Joint: **YES**
 Remarks:

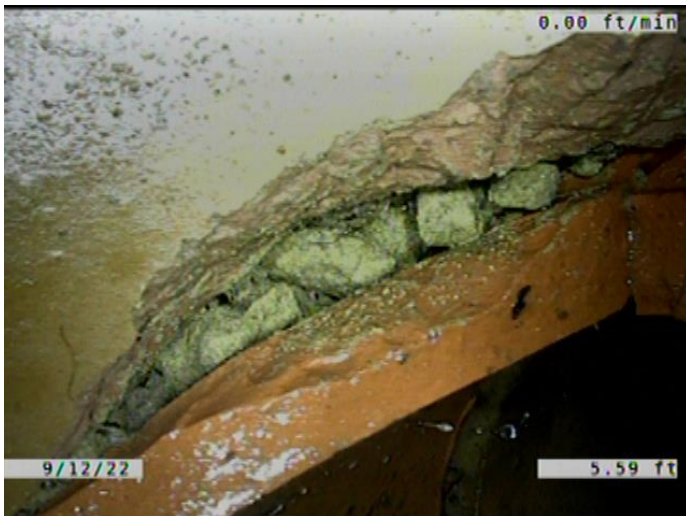
Code: **BSV**
 Description: **Broken Soil Visible**

Distance (ft): **5.6**
 Structural Grade: **5**
 O&M Grade: **0**
 Clock Start/From: **12**
 Clock To: **3**
 1st Value:
 2nd Value:
 Value Percent:
 Continuous Index:
 Within 8" of Joint: **YES**
 Remarks:

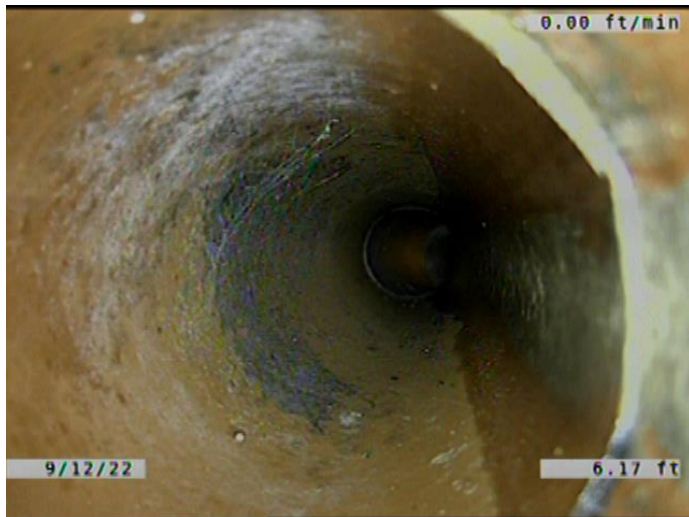
Code: **TBI**
 Description: **Tap Break-in Intruding**

Distance (ft): **6.2**
 Structural Grade: **0**
 O&M Grade: **2**
 Clock Start/From: **1**
 Clock To:
 1st Value: **6.000**
 2nd Value: **2.000**
 Value Percent:
 Continuous Index:
 Within 8" of Joint: **YES**
 Remarks: **ACTIVITY.**

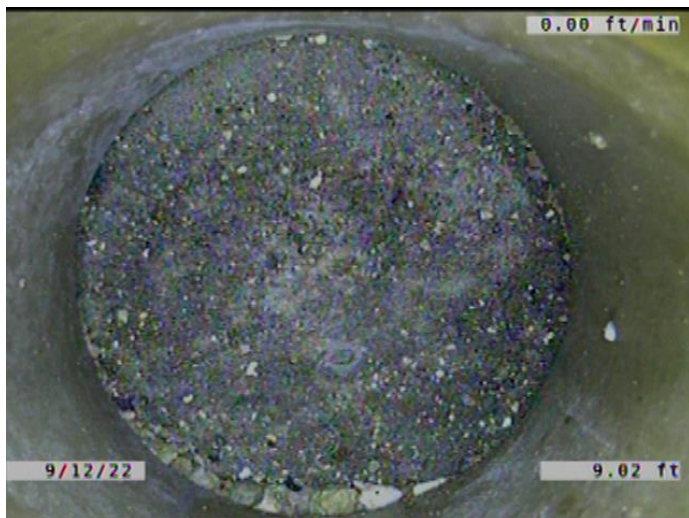
Code: **TFC**
 Description: **Tap Factory Capped**

Distance (ft): **9.0**
 Structural Grade: **0**
 O&M Grade: **0**
 Clock Start/From: **1**
 Clock To:
 1st Value: **6.000**
 2nd Value:
 Value Percent:
 Continuous Index:
 Within 8" of Joint: **YES**
 Remarks:

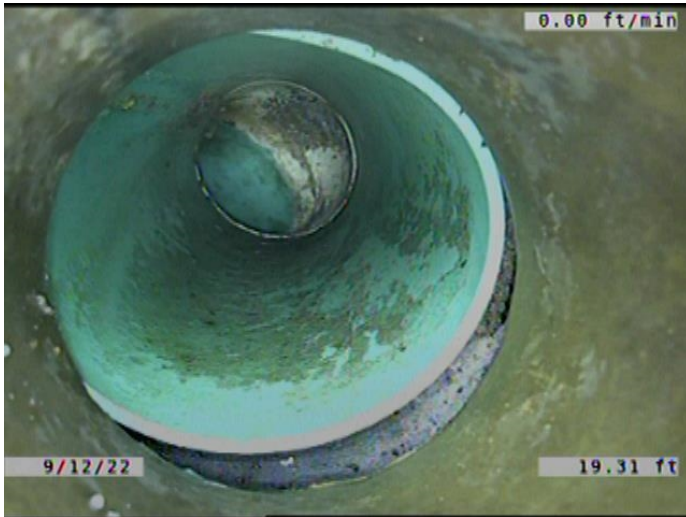
Code: **TF**
Description: **Tap Factory**

Distance (ft): **19.3**
Structural Grade: **0**
O&M Grade: **0**
Clock Start/From: **11**
Clock To:
1st Value: **6.000**
2nd Value:
Value Percent:
Continuous Index:
Within 8" of Joint: **YES**
Remarks:

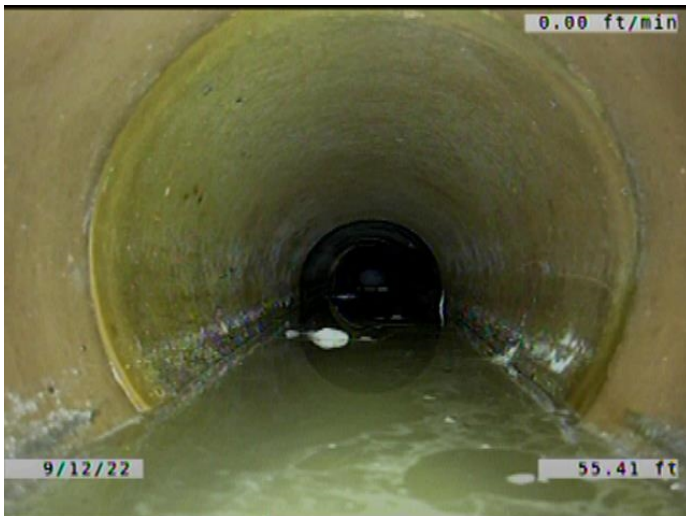
Code: **MWL**
Description: **Miscellaneous Water Level**

Distance (ft): **55.4**
Structural Grade: **0**
O&M Grade: **0**
Clock Start/From:
Clock To:
1st Value:
2nd Value:
Value Percent: **25.000**
Continuous Index:
Within 8" of Joint: **NO**
Remarks:

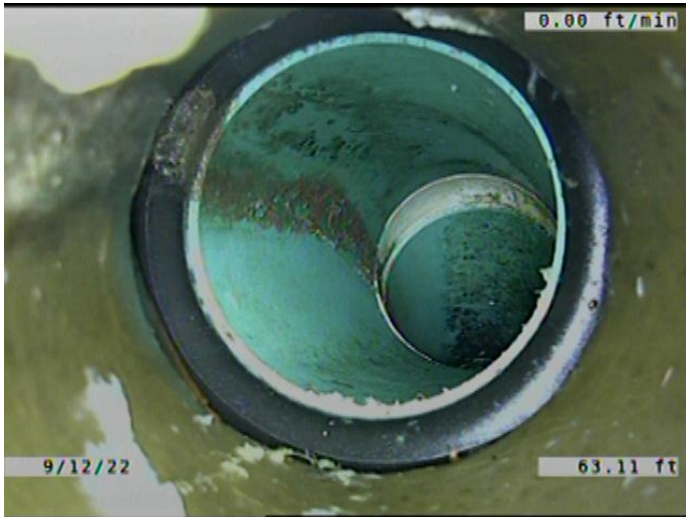
Code: **TF**
 Description: **Tap Factory**

Distance (ft): **63.1**
 Structural Grade: **0**
 O&M Grade: **0**
 Clock Start/From: **11**
 Clock To:
 1st Value: **6.000**
 2nd Value:
 Value Percent:
 Continuous Index:
 Within 8" of Joint: **YES**
 Remarks:

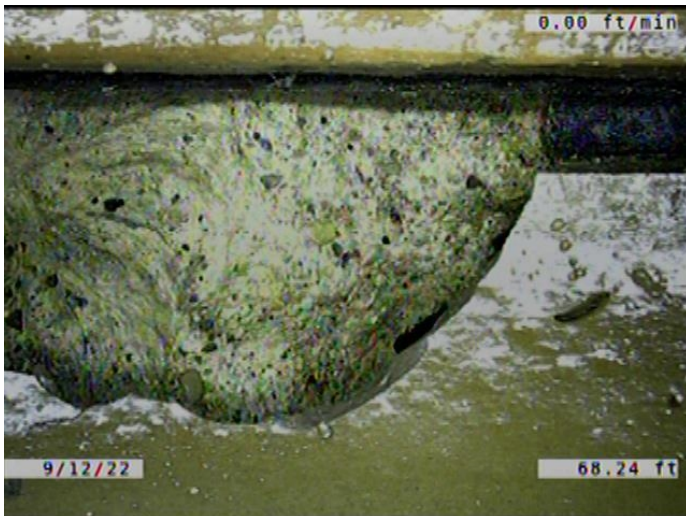
Code: **BSV**
 Description: **Broken Soil Visible**

Distance (ft): **68.2**
 Structural Grade: **5**
 O&M Grade: **0**
 Clock Start/From: **8**
 Clock To: **1**
 1st Value:
 2nd Value:
 Value Percent:
 Continuous Index:
 Within 8" of Joint: **YES**
 Remarks:

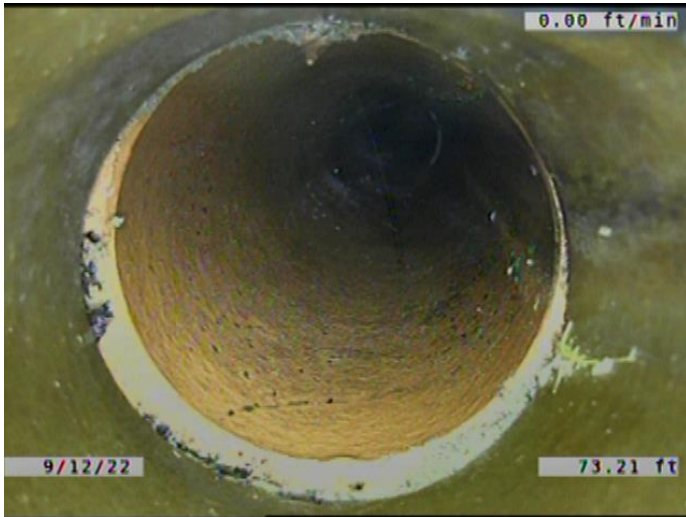
Code: **TF**
 Description: **Tap Factory**

Distance (ft): **73.2**
 Structural Grade: **0**
 O&M Grade: **0**
 Clock Start/From: **2**
 Clock To:
 1st Value: **6.000**
 2nd Value:
 Value Percent:
 Continuous Index:
 Within 8" of Joint: **YES**
 Remarks:

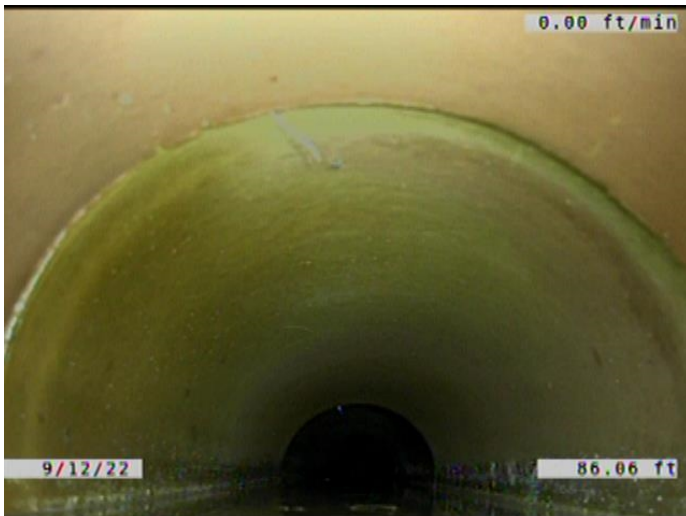
Code: **MWL**
 Description: **Miscellaneous Water Level**

Distance (ft): **86.1**
 Structural Grade: **0**
 O&M Grade: **0**
 Clock Start/From:
 Clock To:
 1st Value:
 2nd Value:
 Value Percent: **35.000**
 Continuous Index:
 Within 8" of Joint: **NO**
 Remarks:

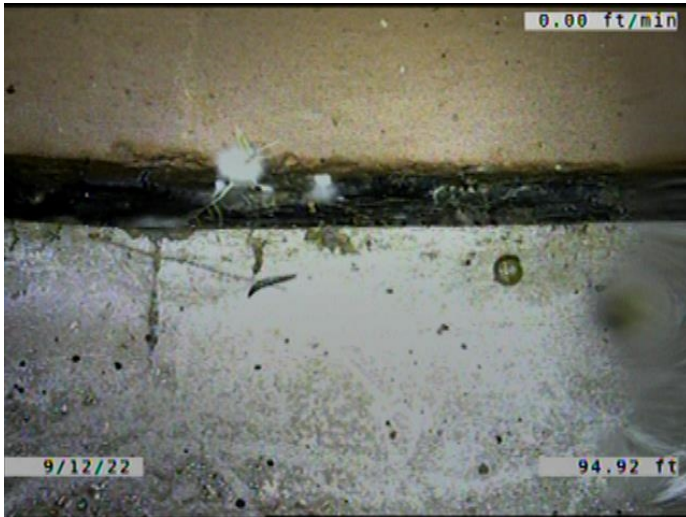
Code: **RFJ**
 Description: **Roots Fine Joint**

Distance (ft): **94.9**
 Structural Grade: **0**
 O&M Grade: **1**
 Clock Start/From: **10**
 Clock To: **2**
 1st Value:
 2nd Value:
 Value Percent:
 Continuous Index:
 Within 8" of Joint: **YES**
 Remarks:

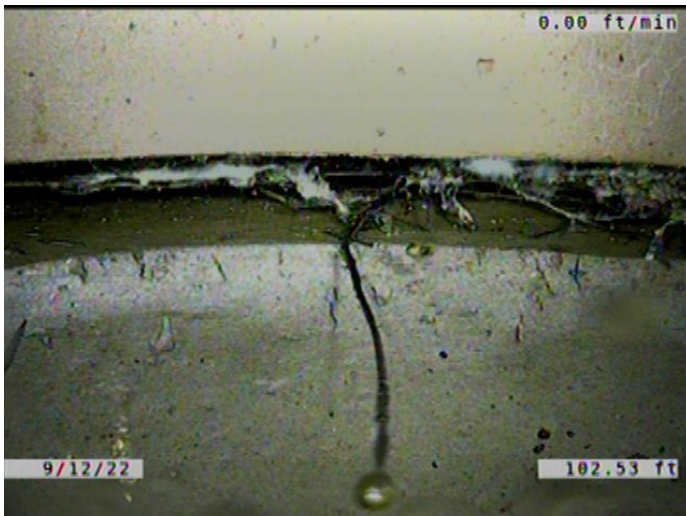
Code: **RFJ**
 Description: **Roots Fine Joint**

Distance (ft): **102.5**
 Structural Grade: **0**
 O&M Grade: **1**
 Clock Start/From: **9**
 Clock To: **3**
 1st Value:
 2nd Value:
 Value Percent:
 Continuous Index: **S02**
 Within 8" of Joint: **YES**
 Remarks:

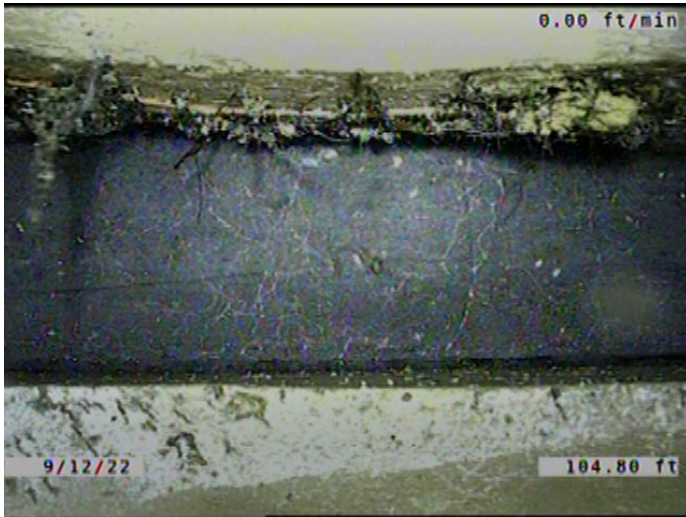
Code: **JSM**
Description: **Joint Separated Medium**

Distance (ft): **104.8**
Structural Grade: **3**
O&M Grade: **0**
Clock Start/From:
Clock To:
1st Value:
2nd Value:
Value Percent:
Continuous Index:
Within 8" of Joint: **NO**
Remarks:

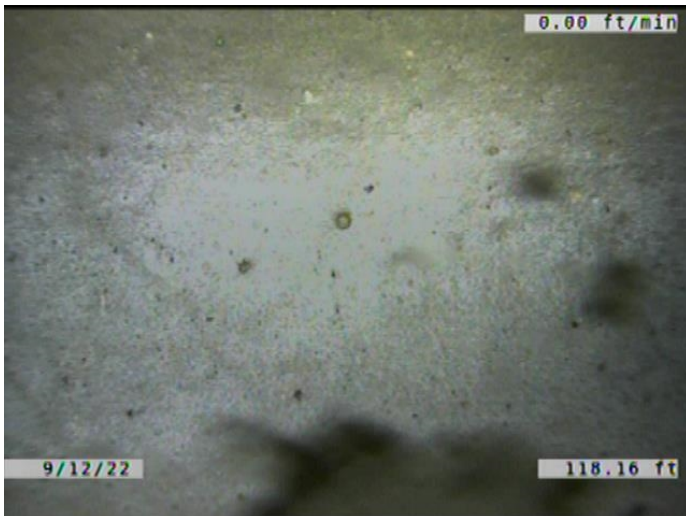
Code: **MWL**
Description: **Miscellaneous Water Level**

Distance (ft): **118.2**
Structural Grade: **0**
O&M Grade: **0**
Clock Start/From:
Clock To:
1st Value:
2nd Value:
Value Percent: **50.000**
Continuous Index:
Within 8" of Joint: **NO**
Remarks:

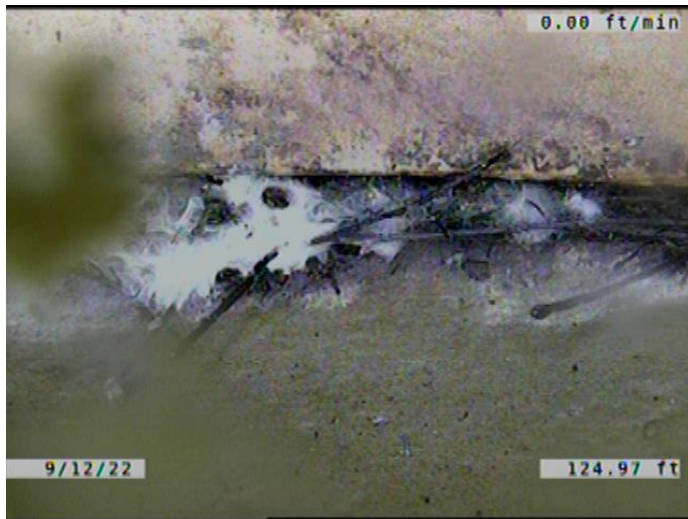
Code: **ISJ**
Description: **Infiltration Stain Joint**

Distance (ft): **125.0**
Structural Grade: **0**
O&M Grade: **1**
Clock Start/From: **10**
Clock To: **2**
1st Value:
2nd Value:
Value Percent:
Continuous Index:
Within 8" of Joint: **YES**
Remarks:

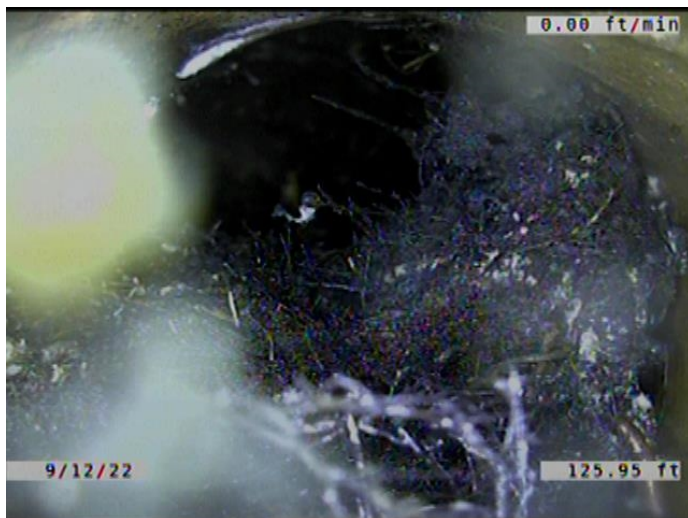
Code: **TF**
Description: **Tap Factory**

Distance (ft): **126.0**
Structural Grade: **0**
O&M Grade: **0**
Clock Start/From: **10**
Clock To:
1st Value: **6.000**
2nd Value:
Value Percent:
Continuous Index:
Within 8" of Joint: **YES**
Remarks: **80% PLUGGED WITH ROOTS.**

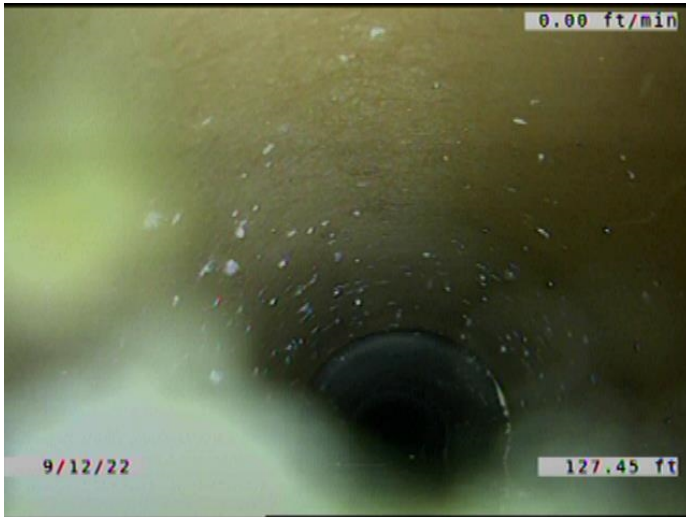
Code: **MWL**
Description: **Miscellaneous Water Level**

Distance (ft): **127.5**
Structural Grade: **0**
O&M Grade: **0**
Clock Start/From:
Clock To:
1st Value:
2nd Value:
Value Percent: **35.000**
Continuous Index:
Within 8" of Joint: **NO**
Remarks:

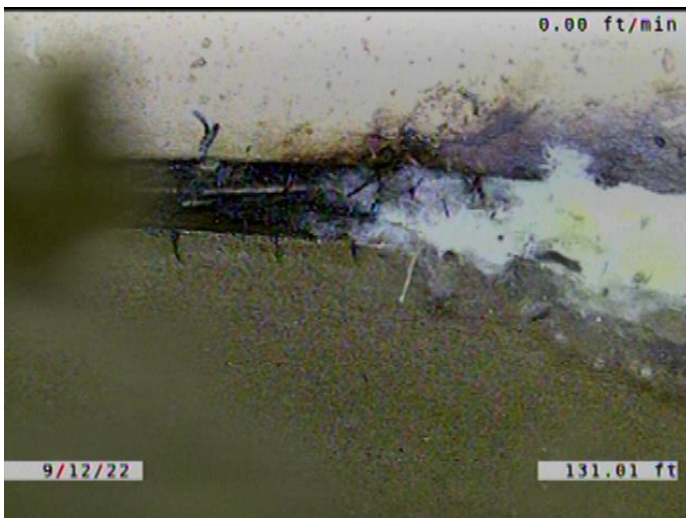
Code: **ISJ**
Description: **Infiltration Stain Joint**

Distance (ft): **131.0**
Structural Grade: **0**
O&M Grade: **1**
Clock Start/From: **1**
Clock To: **2**
1st Value:
2nd Value:
Value Percent:
Continuous Index:
Within 8" of Joint: **YES**
Remarks:

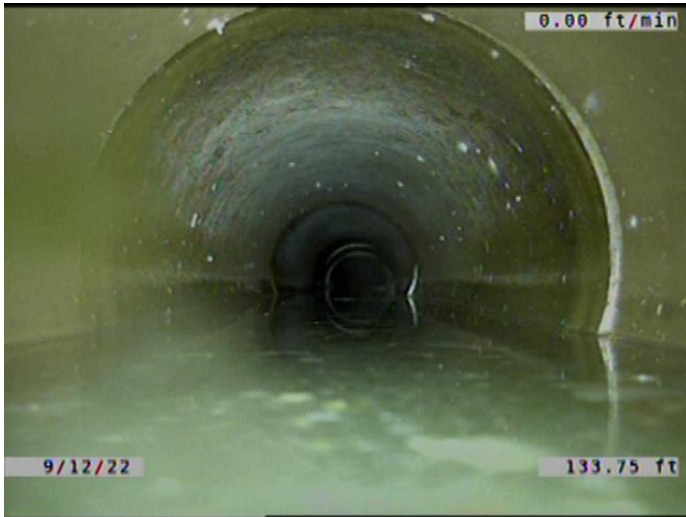
Code: **MWL**
 Description: **Miscellaneous Water Level**

Distance (ft): **133.7**
 Structural Grade: **0**
 O&M Grade: **0**
 Clock Start/From:
 Clock To:
 1st Value:
 2nd Value:
 Value Percent: **20.000**
 Continuous Index:
 Within 8" of Joint: **NO**
 Remarks:

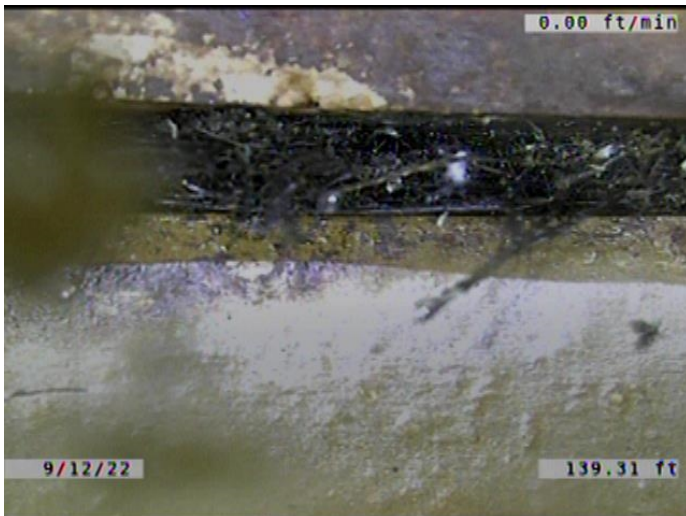
Code: **ISJ**
 Description: **Infiltration Stain Joint**

Distance (ft): **139.3**
 Structural Grade: **0**
 O&M Grade: **1**
 Clock Start/From: **9**
 Clock To: **3**
 1st Value:
 2nd Value:
 Value Percent:
 Continuous Index:
 Within 8" of Joint: **YES**
 Remarks:

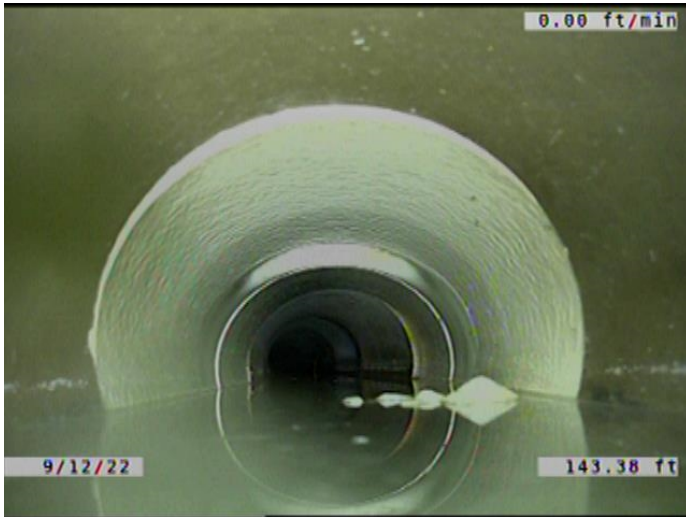
Code: **MWL**
Description: **Miscellaneous Water Level**

Distance (ft): **143.4**
Structural Grade: **0**
O&M Grade: **0**
Clock Start/From:
Clock To:
1st Value:
2nd Value:
Value Percent: **35.000**
Continuous Index:
Within 8" of Joint: **NO**
Remarks:

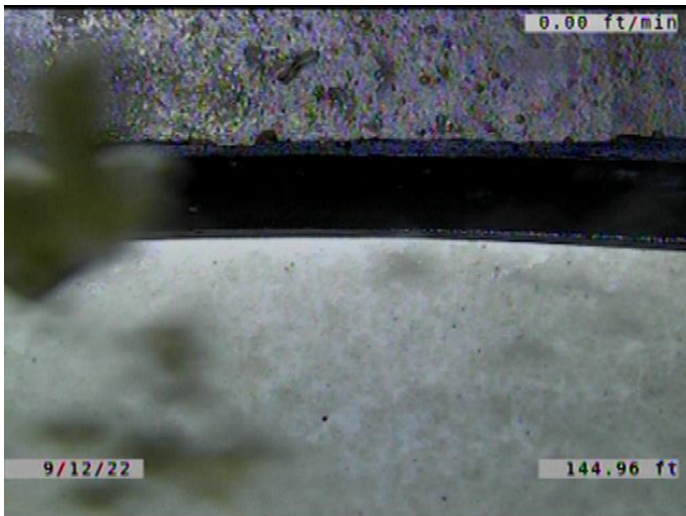
Code: **MMC**
Description: **Miscellaneous Material Change**

Distance (ft): **145.0**
Structural Grade: **0**
O&M Grade: **0**
Clock Start/From:
Clock To:
1st Value:
2nd Value:
Value Percent:
Continuous Index:
Within 8" of Joint: **NO**
Remarks: **VCP TO PVC**

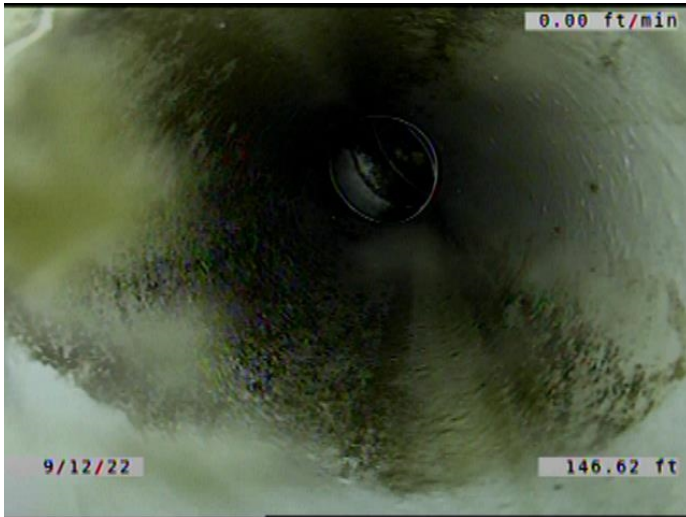
Code: **TF**
 Description: **Tap Factory**

Distance (ft): **146.6**
 Structural Grade: **0**
 O&M Grade: **0**
 Clock Start/From: **12**
 Clock To:
 1st Value: **6.000**
 2nd Value:
 Value Percent:
 Continuous Index:
 Within 8" of Joint: **YES**
 Remarks:

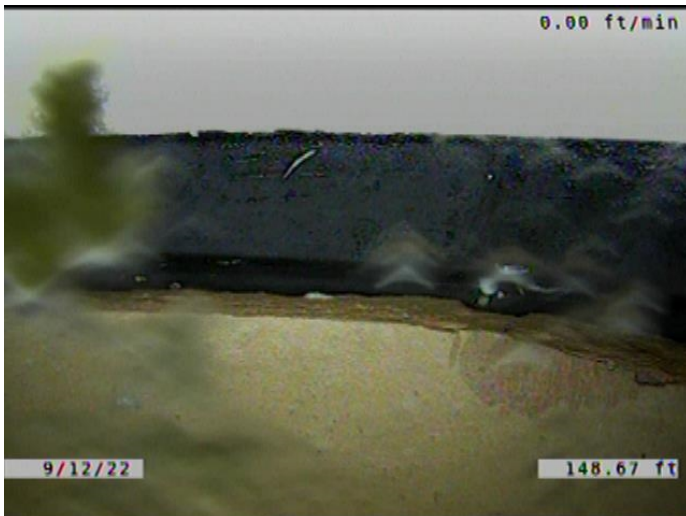
Code: **MMC**
 Description: **Miscellaneous Material Change**

Distance (ft): **148.7**
 Structural Grade: **0**
 O&M Grade: **0**
 Clock Start/From:
 Clock To:
 1st Value:
 2nd Value:
 Value Percent:
 Continuous Index:
 Within 8" of Joint: **NO**
 Remarks: **PVC TO VCP**

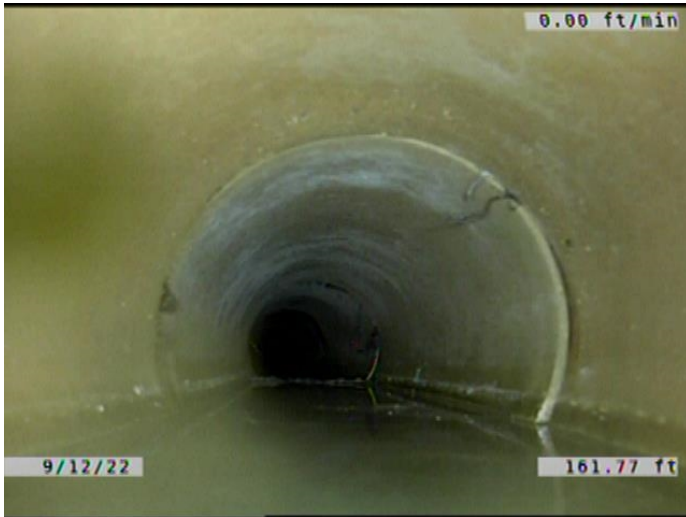
Code: **MWL**
Description: **Miscellaneous Water Level**

Distance (ft): **161.8**
Structural Grade: **0**
O&M Grade: **0**
Clock Start/From:
Clock To:
1st Value:
2nd Value:
Value Percent: **20.000**
Continuous Index:
Within 8" of Joint: **NO**
Remarks:

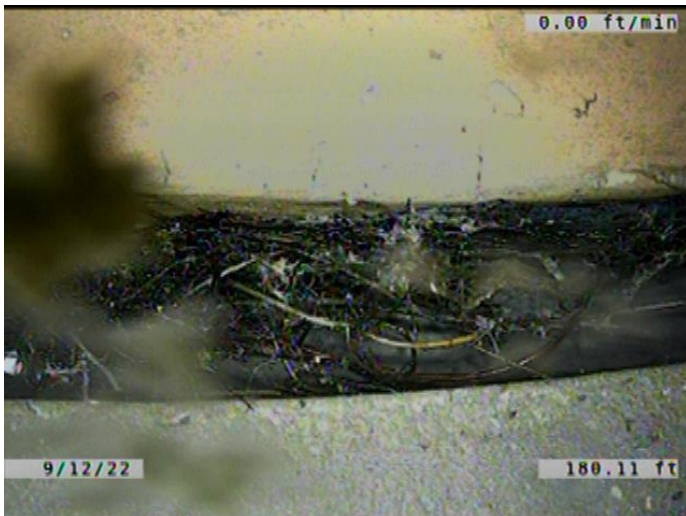
Code: **JAM**
Description: **Joint Angular Medium**

Distance (ft): **180.1**
Structural Grade: **3**
O&M Grade: **0**
Clock Start/From:
Clock To:
1st Value:
2nd Value:
Value Percent:
Continuous Index:
Within 8" of Joint: **NO**
Remarks:

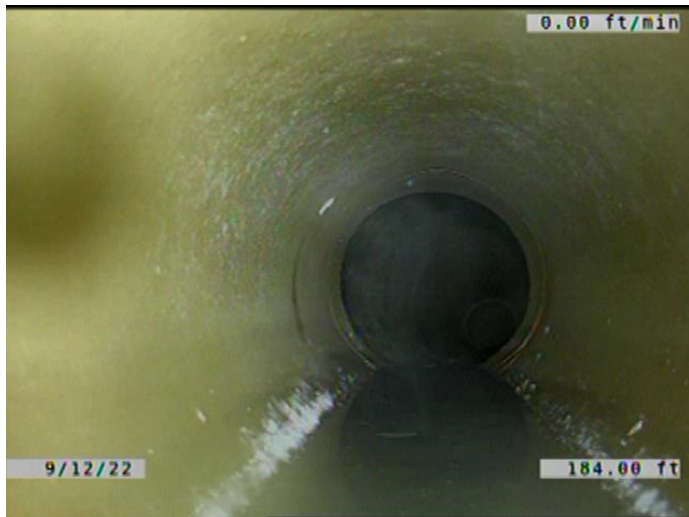
Code: **MWL**
 Description: **Miscellaneous Water Level**

Distance (ft): **184.0**
 Structural Grade: **0**
 O&M Grade: **0**
 Clock Start/From:
 Clock To:
 1st Value:
 2nd Value:
 Value Percent: **5.000**
 Continuous Index:
 Within 8" of Joint: **NO**
 Remarks:

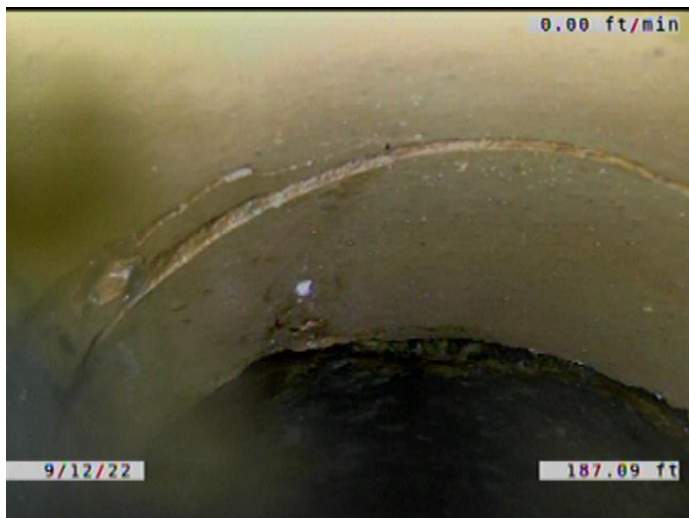
Code: **B**
 Description: **Broken**

Distance (ft): **187.1**
 Structural Grade: **4**
 O&M Grade: **0**
 Clock Start/From: **7**
 Clock To: **8**
 1st Value:
 2nd Value:
 Value Percent:
 Continuous Index:
 Within 8" of Joint: **YES**
 Remarks:

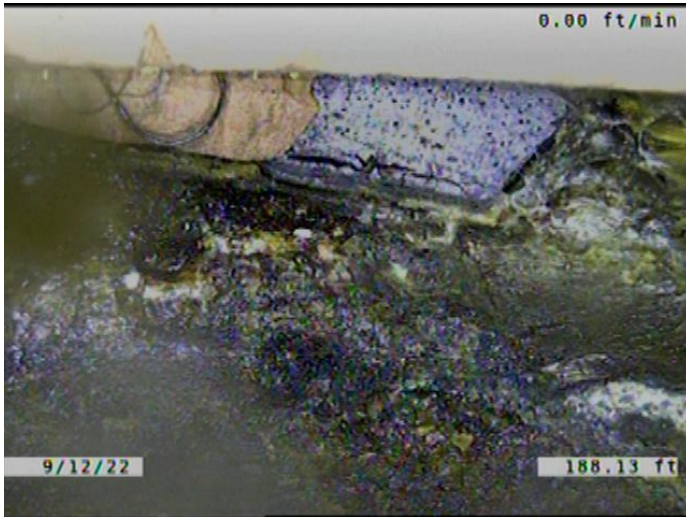
Code: **MMC**
 Description: **Miscellaneous Material Change**

Distance (ft): **188.1**
 Structural Grade: **0**
 O&M Grade: **0**
 Clock Start/From:
 Clock To:
 1st Value:
 2nd Value:
 Value Percent:
 Continuous Index:
 Within 8" of Joint: **NO**
 Remarks: **VCP TO CIP**

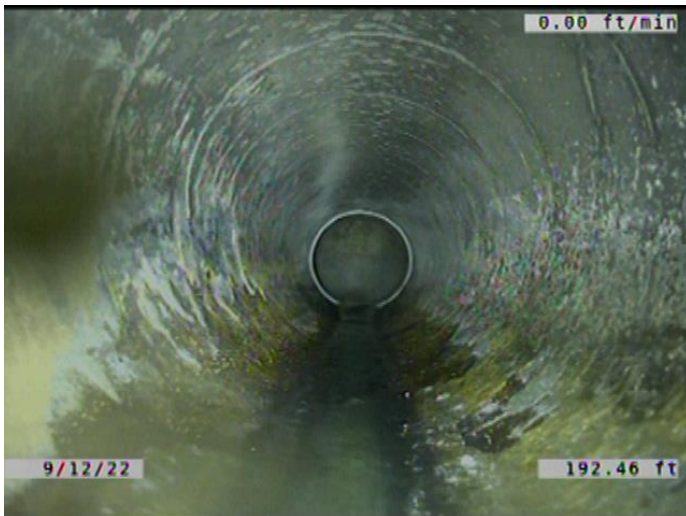
Code: **SSC**
 Description: **Surface Spalling of Damage Coating**

Distance (ft): **192.5**
 Structural Grade: **1**
 O&M Grade: **0**
 Clock Start/From: **4**
 Clock To: **8**
 1st Value:
 2nd Value:
 Value Percent:
 Continuous Index: **S03**
 Within 8" of Joint: **YES**
 Remarks:

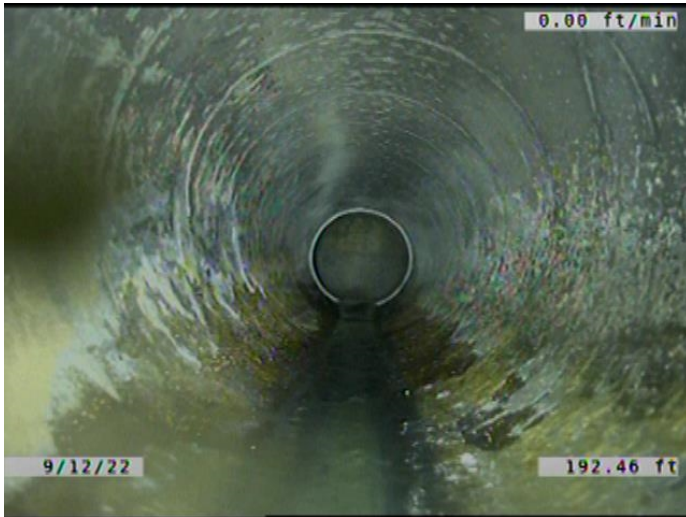
Code: **RFJ**
Description: **Roots Fine Joint**

Distance (ft): **192.5**
Structural Grade: **0**
O&M Grade: **1**
Clock Start/From: **9**
Clock To: **3**
1st Value:
2nd Value:
Value Percent:
Continuous Index: **F02**
Within 8" of Joint: **YES**
Remarks:

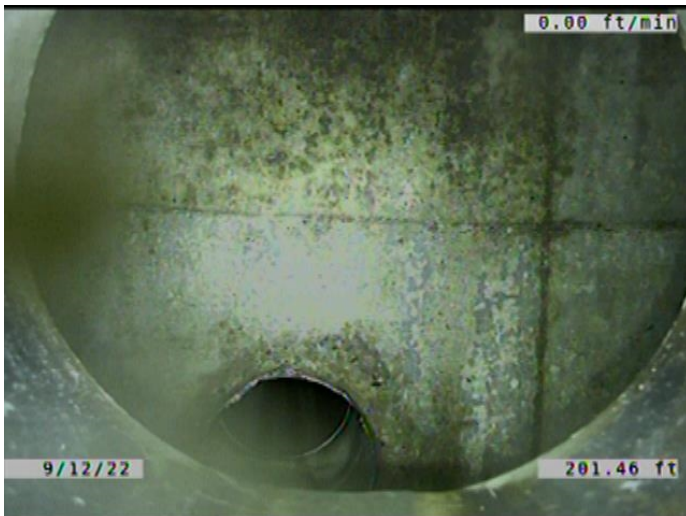
Code: **SSC**
Description: **Surface Spalling of Damage Coating**

Distance (ft): **201.5**
Structural Grade: **1**
O&M Grade: **0**
Clock Start/From: **4**
Clock To: **8**
1st Value:
2nd Value:
Value Percent:
Continuous Index: **F03**
Within 8" of Joint: **YES**
Remarks:

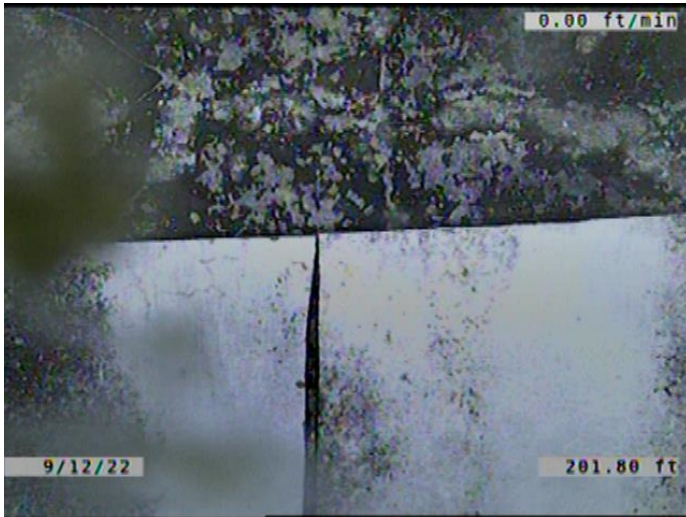
Code: **MMC**
Description: **Miscellaneous Material Change**

Distance (ft): **201.8**
Structural Grade: **0**
O&M Grade: **0**
Clock Start/From:
Clock To:
1st Value:
2nd Value:
Value Percent:
Continuous Index:
Within 8" of Joint: **NO**
Remarks: **CIP TO VCP**

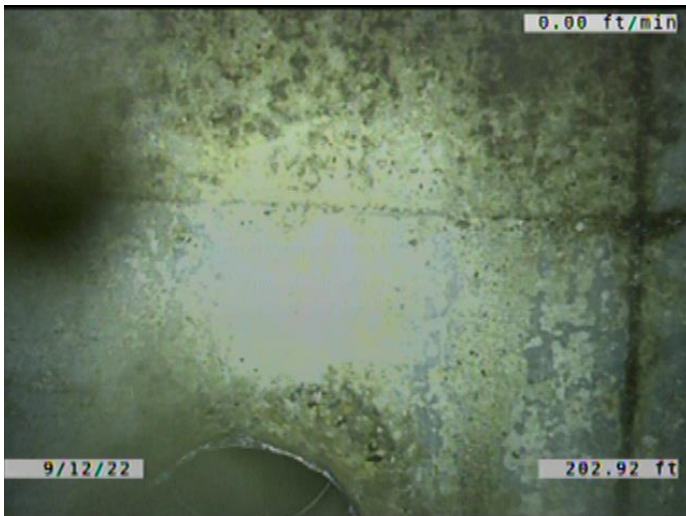
Code: **DSF**
Description: **Deposits Settled Fine**

Distance (ft): **202.9**
Structural Grade: **0**
O&M Grade: **2**
Clock Start/From: **5**
Clock To: **7**
1st Value:
2nd Value:
Value Percent: **5.000**
Continuous Index: **F01**
Within 8" of Joint: **YES**
Remarks:

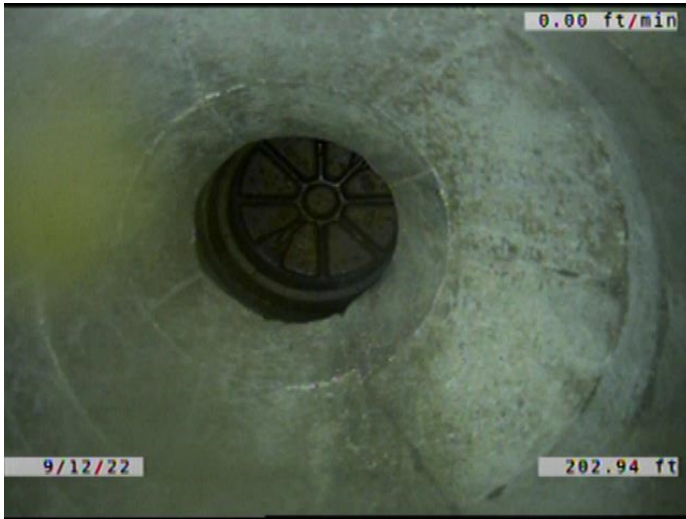
Code:	AMH
Description:	Manhole
Distance (ft):	202.9
Structural Grade:	0
O&M Grade:	0
Clock Start/From:	
Clock To:	
1st Value:	
2nd Value:	
Value Percent:	
Continuous Index:	
Within 8" of Joint:	NO
Remarks:	M-805-017
