## Profile/Photo Observation Report

Street:	<b>E 5TH ST</b>	Flow Control:	<b>Not Controlled</b>
City:	<b>Hobart, IN</b>	Year Renewed:	
Location:	<b>Alley</b>	Tape/Media #:	
Purpose:	<b>Maintenance Related</b>	Dia/Height:	<b>10"</b>
Use:	<b>Sanitary</b>	Material:	<b>VCP</b>
Drain Area:	<b>NA</b>	Lining:	<b>Cured in Place</b>
Category:	<b>NA</b>		
Comment:	<b>robot issue at 8'.</b>

Location Details:		Direction of Survey:	<b>Upstream</b>
US MH:	<b>M-805-018</b>	DS MH:	<b>M-805-019</b>
		Total Length Surveyed (ft):	<b>9.7</b>

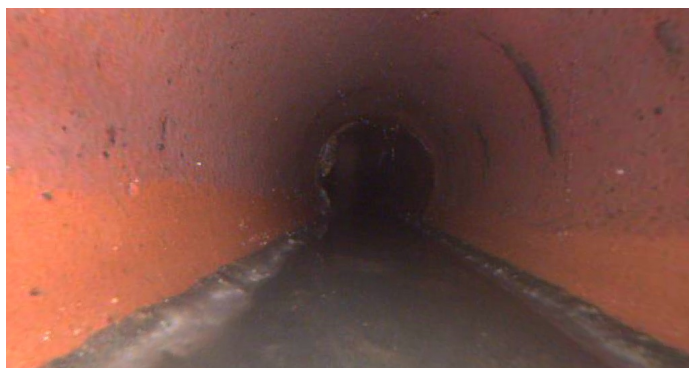
Code: **AMH**  
Description: **Manhole**

Distance (ft): **.0**  
Structural Grade: **0**  
O&M Grade: **0**  
Clock Start/From:  
Clock To:  
1st Value:  
2nd Value:  
Value Percent:  
Continuous Index:  
Within 8" of Joint: **NO**  
Remarks:

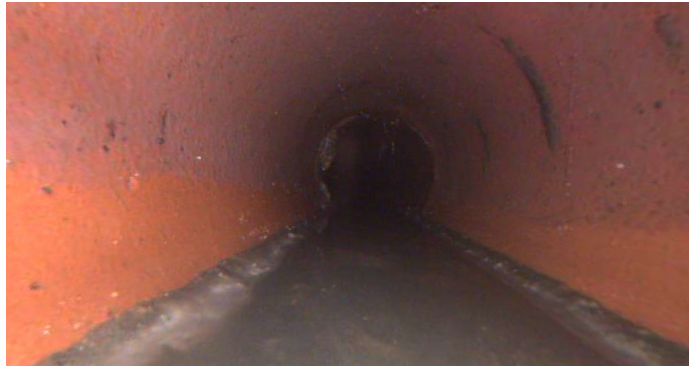
Code: **MWL**  
Description: **Water Level**

Distance (ft): **.0**  
Structural Grade: **0**  
O&M Grade: **0**  
Clock Start/From:  
Clock To:  
1st Value:  
2nd Value:  
Value Percent: **10.000**  
Continuous Index:  
Within 8" of Joint: **NO**  
Remarks:

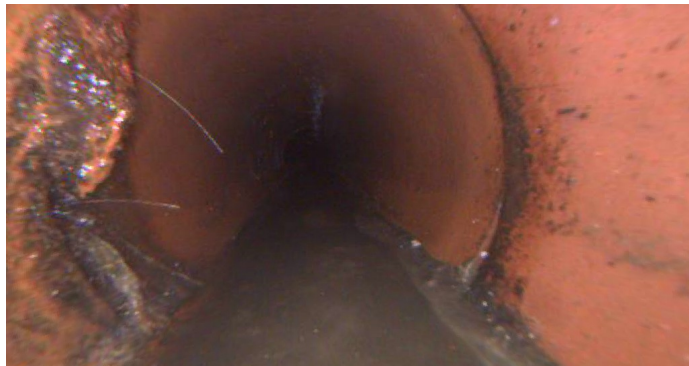
Code: **RFJ**  
Description: **Roots Fine Joint**

Distance (ft): **2.8**  
Structural Grade: **0**  
O&M Grade: **1**  
Clock Start/From: **7**  
Clock To: **12**  
1st Value:  
2nd Value:  
Value Percent:  
Continuous Index:  
Within 8" of Joint: **YES**  
Remarks:
