Profile/Photo Observation Report

Date:	04/22/2018	Weather:		Coding:	PACP 6.0
Pipe Length (ft):	200.2	Owner:	NA	Pre Clean:	Not Known
P.O.#:		Surveyor:	Mark Ruby	PSR:	P-805-019-018
Customer:		Clean Date:	01/01/1900	Shape:	C

Street:	E 5TH ST	Flow Control:	Not Controlled
City:	Hobart, IN	Year Renewed:	
Location:	Alley	Tape/Media #:	
Purpose:	Maintenance Related	Dia/Height:	10"
Use:	Sanitary	Material:	VCP
Drain Area:	NA	Lining:	Cured in Place
Category:	NA		
Comment:	2nd attempt. user set max-flow incorrect.		
Location Details:		Direction of Survey:	Downstream
US MH:	M-805-018	DS MH:	M-805-019
		Total Length Surveyed (ft):	184.6

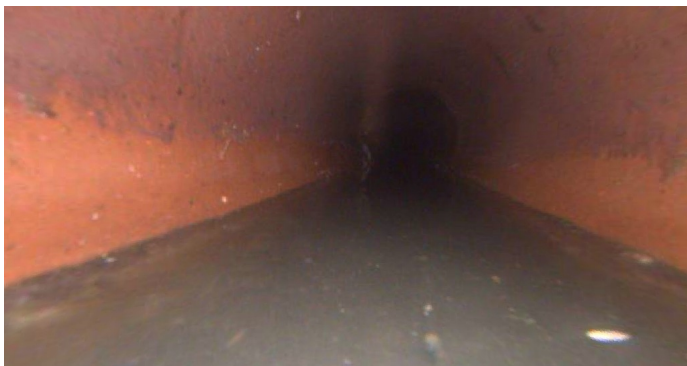
Code: **AMH**
 Description: **Manhole**

Distance (ft): **.0**
 Structural Grade: **0**
 O&M Grade: **0**
 Clock Start/From:
 Clock To:
 1st Value:
 2nd Value:
 Value Percent:
 Continuous Index:
 Within 8" of Joint: **NO**
 Remarks: **M-805-019**

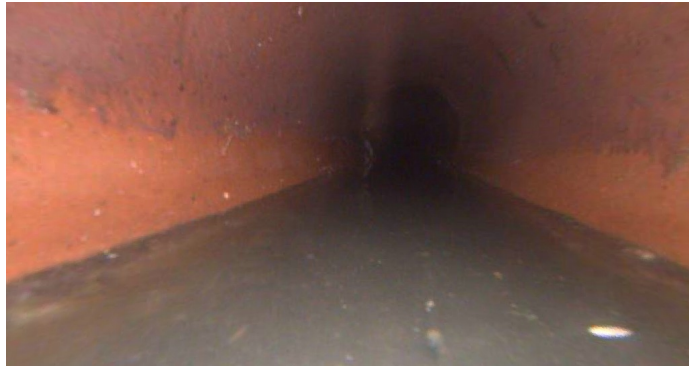
Code: **MWL**
Description: **Water Level**

Distance (ft): **.0**
Structural Grade: **0**
O&M Grade: **0**
Clock Start/From:
Clock To:
1st Value:
2nd Value:
Value Percent: **10.000**
Continuous Index:
Within 8" of Joint: **NO**
Remarks:

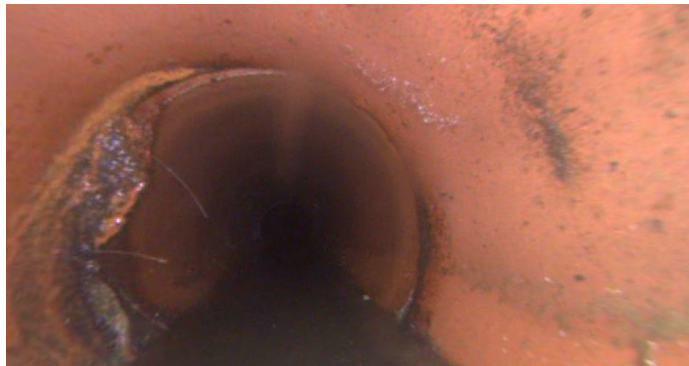
Code: **DAZ**
Description: **Deposits Attached Other**

Distance (ft): **2.9**
Structural Grade: **0**
O&M Grade: **2**
Clock Start/From: **7**
Clock To: **11**
1st Value:
2nd Value:
Value Percent: **5.000**
Continuous Index:
Within 8" of Joint: **YES**
Remarks:

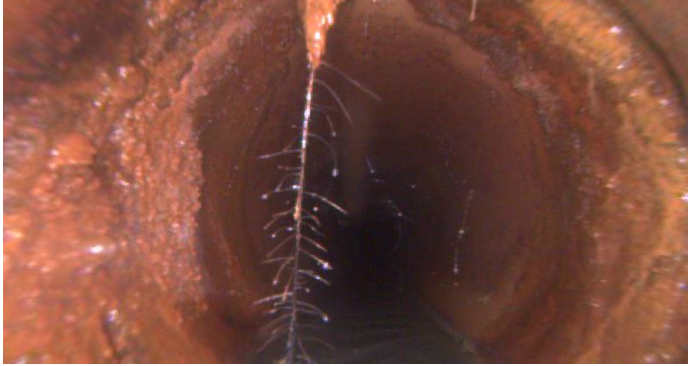
Code:	DAZ
Description:	Deposits Attached Other
Distance (ft):	19.1
Structural Grade:	0
O&M Grade:	2
Clock Start/From:	7
Clock To:	5
1st Value:	
2nd Value:	
Value Percent:	5.000
Continuous Index:	
Within 8" of Joint:	YES
Remarks:

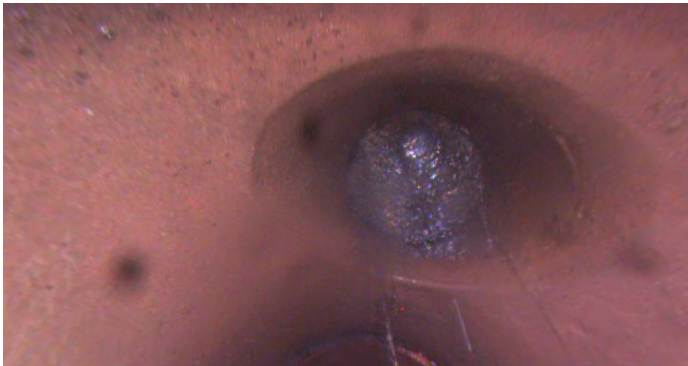
Code:	TFC
Description:	Tap Factory Capped
Distance (ft):	32.8
Structural Grade:	0
O&M Grade:	0
Clock Start/From:	11
Clock To:	
1st Value:	4.000
2nd Value:	
Value Percent:	
Continuous Index:	
Within 8" of Joint:	
Remarks:

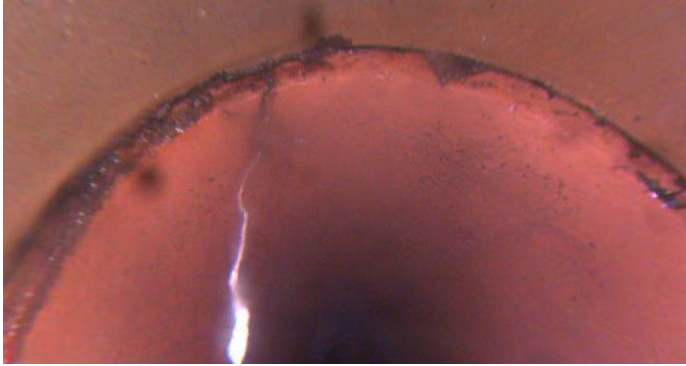
Code: **RFJ**
Description: **Roots Fine Joint**

Distance (ft): **37.9**
Structural Grade: **0**
O&M Grade: **1**
Clock Start/From: **1**
Clock To:
1st Value:
2nd Value:
Value Percent:
Continuous Index:
Within 8" of Joint: **YES**
Remarks:

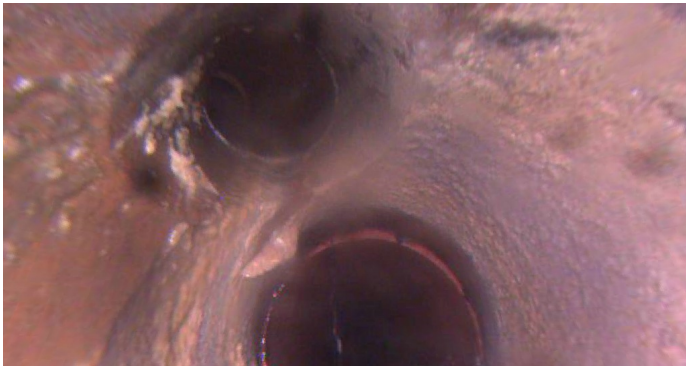
Code: **TF**
Description: **Tap Factory**

Distance (ft): **38.9**
Structural Grade: **0**
O&M Grade: **0**
Clock Start/From: **1**
Clock To:
1st Value: **4.000**
2nd Value:
Value Percent:
Continuous Index:
Within 8" of Joint:
Remarks:

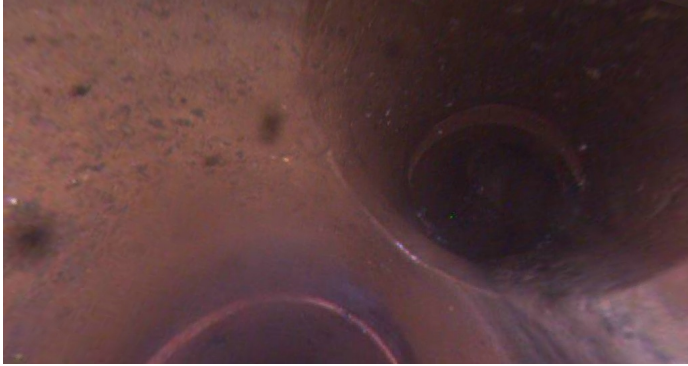
Code: **TF**
Description: **Tap Factory**

Distance (ft): **81.2**
Structural Grade: **0**
O&M Grade: **0**
Clock Start/From: **10**
Clock To:
1st Value: **4.000**
2nd Value:
Value Percent:
Continuous Index:
Within 8" of Joint:
Remarks:

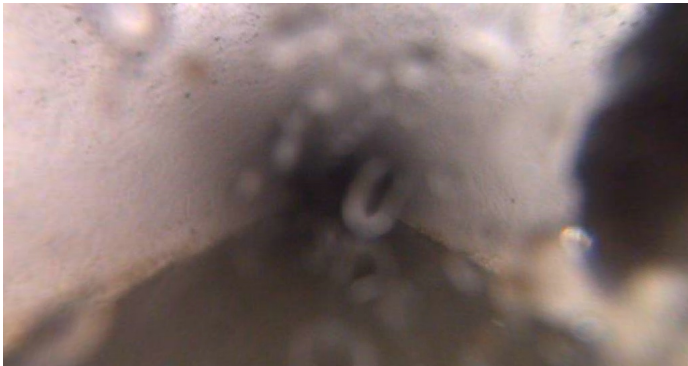
Code: **MMC**
Description: **Material Change**

Distance (ft): **98.4**
Structural Grade: **0**
O&M Grade: **0**
Clock Start/From:
Clock To:
1st Value:
2nd Value:
Value Percent:
Continuous Index:
Within 8" of Joint: **NO**
Remarks: **PVC**

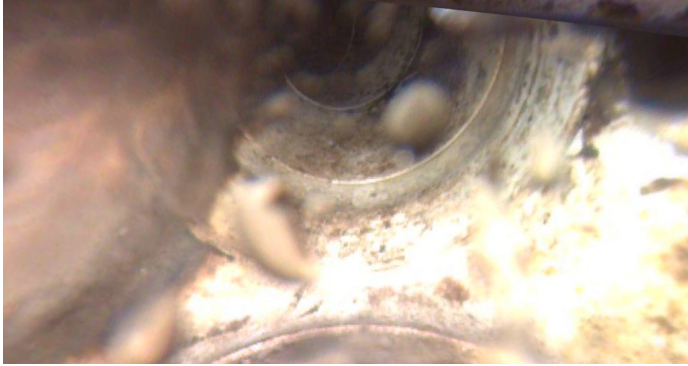
Code: **TF**
Description: **Tap Factory**

Distance (ft): **102.5**
Structural Grade: **0**
O&M Grade: **0**
Clock Start/From: **12**
Clock To:
1st Value: **4.000**
2nd Value:
Value Percent:
Continuous Index:
Within 8" of Joint:
Remarks:

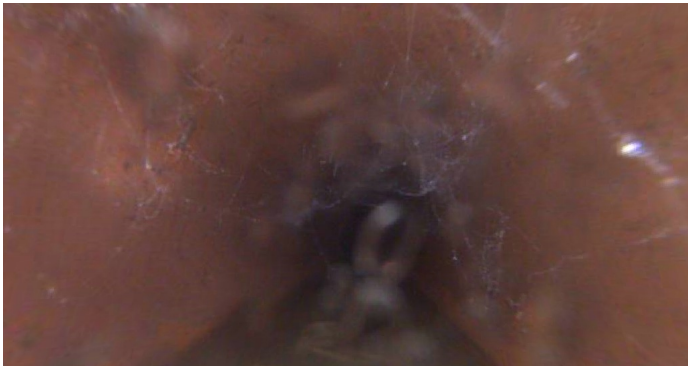
Code: **MMC**
Description: **Material Change**

Distance (ft): **104.6**
Structural Grade: **0**
O&M Grade: **0**
Clock Start/From:
Clock To:
1st Value:
2nd Value:
Value Percent:
Continuous Index:
Within 8" of Joint: **NO**
Remarks: **VCP**

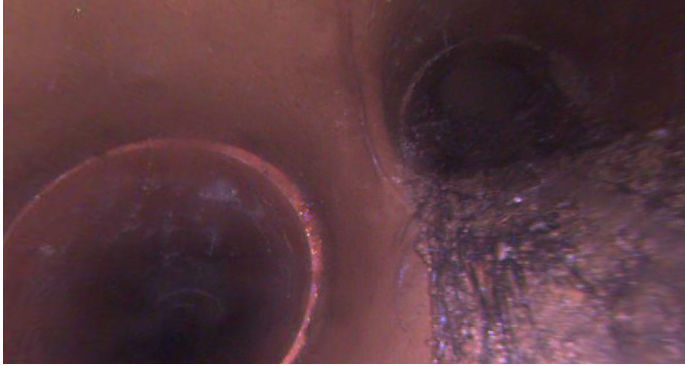
Code: **TFD**
Description: **Tap Factory Defective**

Distance (ft): **109.7**
Structural Grade: **0**
O&M Grade: **2**
Clock Start/From: **10**
Clock To:
1st Value: **4.000**
2nd Value:
Value Percent:
Continuous Index:
Within 8" of Joint:
Remarks: **RFL**

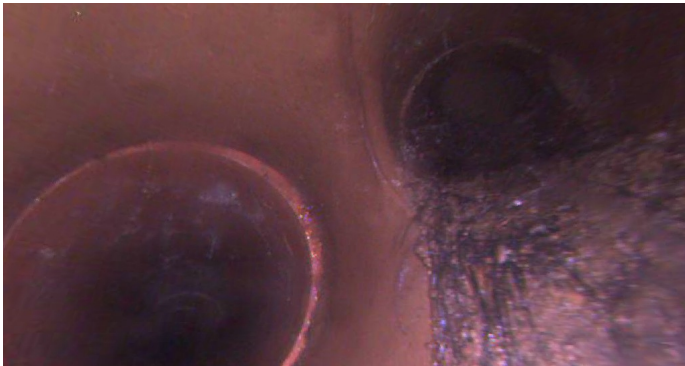
Code: **RFL**
Description: **Roots Fine Lateral**

Distance (ft): **109.7**
Structural Grade: **0**
O&M Grade: **1**
Clock Start/From: **10**
Clock To:
1st Value:
2nd Value:
Value Percent:
Continuous Index:
Within 8" of Joint: **NO**
Remarks:

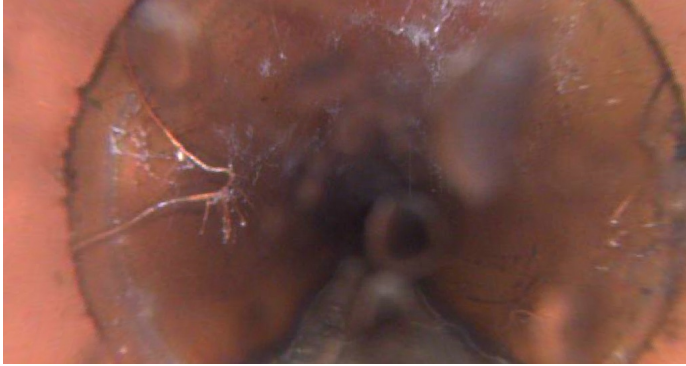
Code: **RFJ**
Description: **Roots Fine Joint**

Distance (ft): **122.4**
Structural Grade: **0**
O&M Grade: **1**
Clock Start/From: **7**
Clock To: **5**
1st Value:
2nd Value:
Value Percent:
Continuous Index:
Within 8" of Joint: **YES**
Remarks:

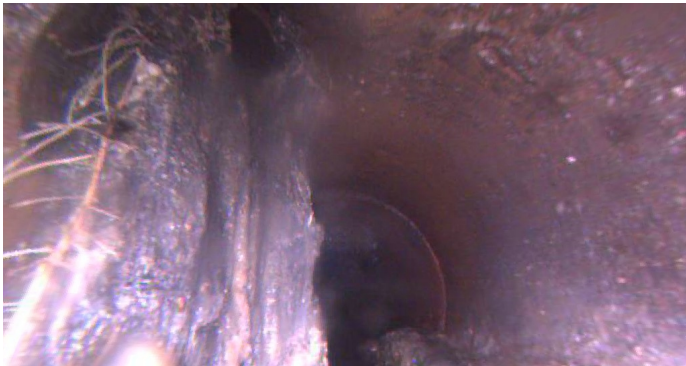
Code: **TFD**
Description: **Tap Factory Defective**

Distance (ft): **136.4**
Structural Grade: **0**
O&M Grade: **2**
Clock Start/From: **1**
Clock To:
1st Value: **4.000**
2nd Value:
Value Percent:
Continuous Index:
Within 8" of Joint:
Remarks: **RFL**

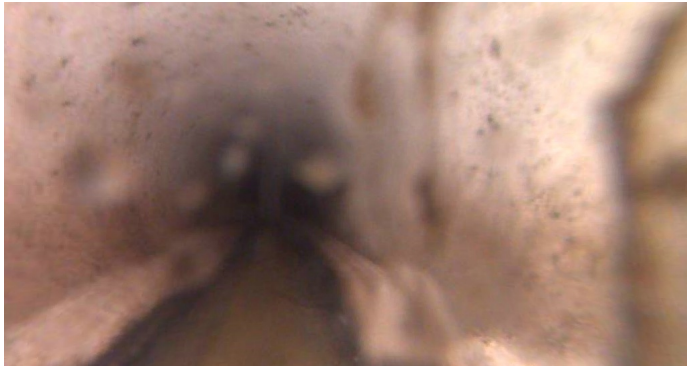
Code: **MMC**
Description: **Material Change**

Distance (ft): **177.8**
Structural Grade: **0**
O&M Grade: **0**
Clock Start/From:
Clock To:
1st Value:
2nd Value:
Value Percent:
Continuous Index:
Within 8" of Joint: **NO**
Remarks: **PVC**

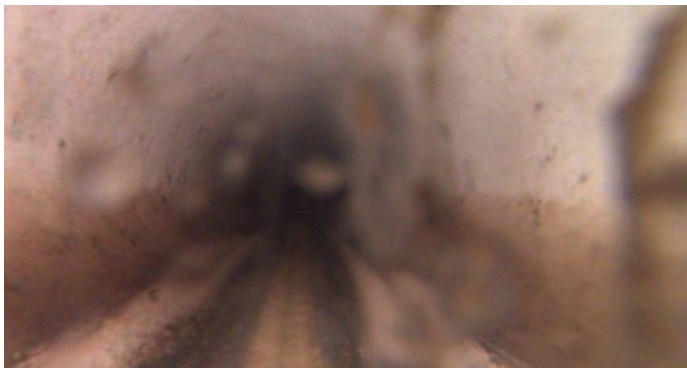
Code: **MSA**
Description: **Abandoned Survey**

Distance (ft): **184.6**
Structural Grade: **0**
O&M Grade: **0**
Clock Start/From:
Clock To:
1st Value:
2nd Value:
Value Percent:
Continuous Index:
Within 8" of Joint: **NO**
Remarks: **No blockage**
