Profile/Photo Observation Report

Date:	04/22/2018	Weather:		Coding:	PACP 6.0
Pipe Length (ft):	200.2	Owner:	NA	Pre Clean:	Not Known
P.O.#:		Surveyor:	Mark Ruby	PSR:	P-805-019-018
Customer:		Clean Date:	01/01/1900	Shape:	C

Street:	Capitol	Flow Control:	Not Controlled
City:	Hobart, IN	Year Renewed:	
Location:	Alley	Tape/Media #:	
Purpose:	Maintenance Related	Dia/Height:	10"
Use:	Sanitary	Material:	VCP
Drain Area:	NA	Lining:	Cured in Place
Category:	NA		
Comment:	2nd attempt. user set max-flow incorrect.		
Location Details:		Direction of Survey:	Downstream
US MH:	M-805-018	DS MH:	M-805-019
		Total Length Surveyed (ft):	184.6

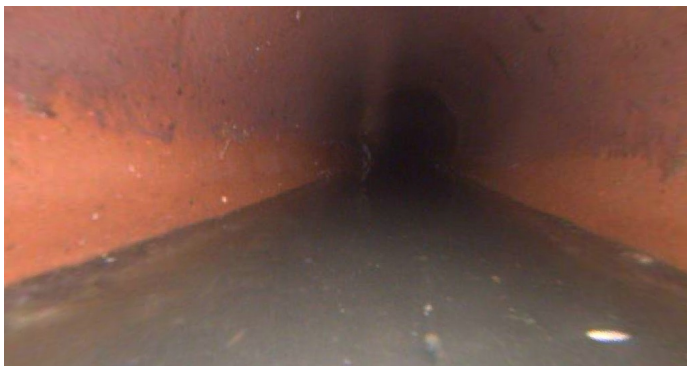
Code: **AMH**
 Description: **Manhole**

Distance (ft): **.0**
 Structural Grade: **0**
 O&M Grade: **0**
 Clock Start/From:
 Clock To:
 1st Value:
 2nd Value:
 Value Percent:
 Continuous Index:
 Within 8" of Joint: **NO**
 Remarks: **M-805-019**

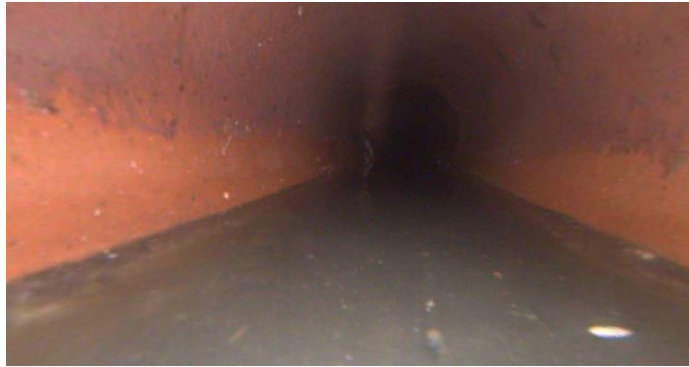
Code: **MWL**
Description: **Water Level**

Distance (ft): **.0**
Structural Grade: **0**
O&M Grade: **0**
Clock Start/From:
Clock To:
1st Value:
2nd Value:
Value Percent: **10.000**
Continuous Index:
Within 8" of Joint: **NO**
Remarks:

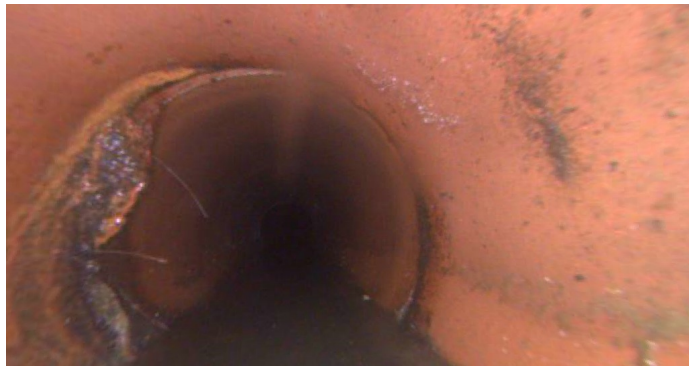
Code: **DAZ**
Description: **Deposits Attached Other**

Distance (ft): **2.9**
Structural Grade: **0**
O&M Grade: **2**
Clock Start/From: **7**
Clock To: **11**
1st Value:
2nd Value:
Value Percent: **5.000**
Continuous Index:
Within 8" of Joint: **YES**
Remarks:

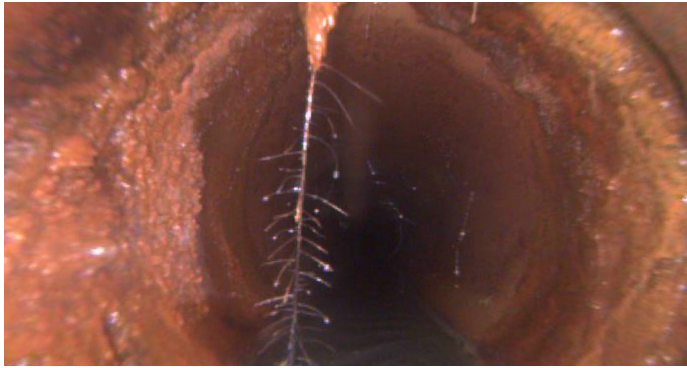
Code:	DAZ
Description:	Deposits Attached Other
Distance (ft):	19.1
Structural Grade:	0
O&M Grade:	2
Clock Start/From:	7
Clock To:	5
1st Value:	
2nd Value:	
Value Percent:	5.000
Continuous Index:	
Within 8" of Joint:	YES
Remarks:

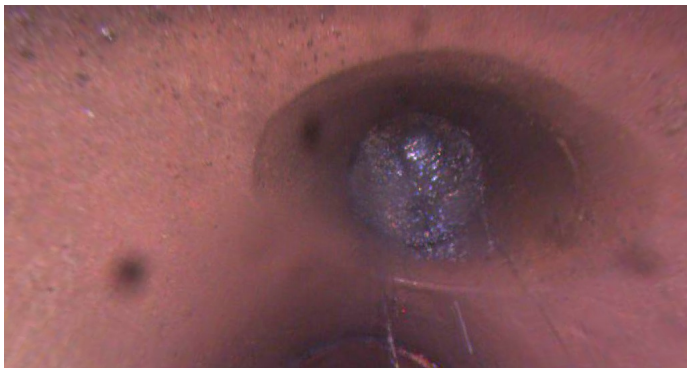
Code:	TFC
Description:	Tap Factory Capped
Distance (ft):	32.8
Structural Grade:	0
O&M Grade:	0
Clock Start/From:	11
Clock To:	
1st Value:	4.000
2nd Value:	
Value Percent:	
Continuous Index:	
Within 8" of Joint:	
Remarks:

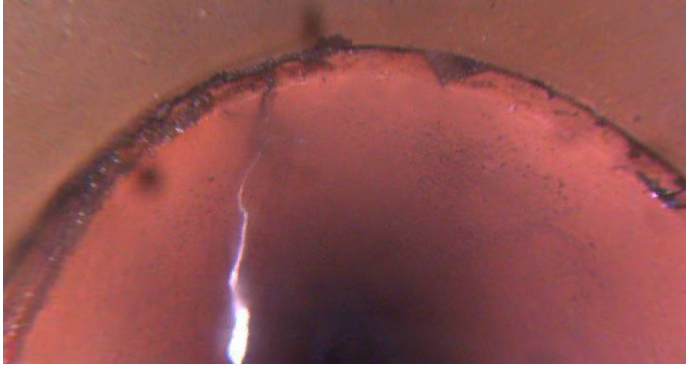
Code: **RFJ**
Description: **Roots Fine Joint**

Distance (ft): **37.9**
Structural Grade: **0**
O&M Grade: **1**
Clock Start/From: **1**
Clock To:
1st Value:
2nd Value:
Value Percent:
Continuous Index:
Within 8" of Joint: **YES**
Remarks:

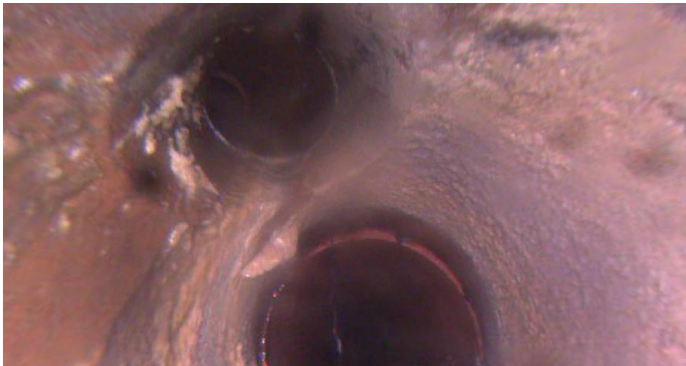
Code: **TF**
Description: **Tap Factory**

Distance (ft): **38.9**
Structural Grade: **0**
O&M Grade: **0**
Clock Start/From: **1**
Clock To:
1st Value: **4.000**
2nd Value:
Value Percent:
Continuous Index:
Within 8" of Joint:
Remarks:

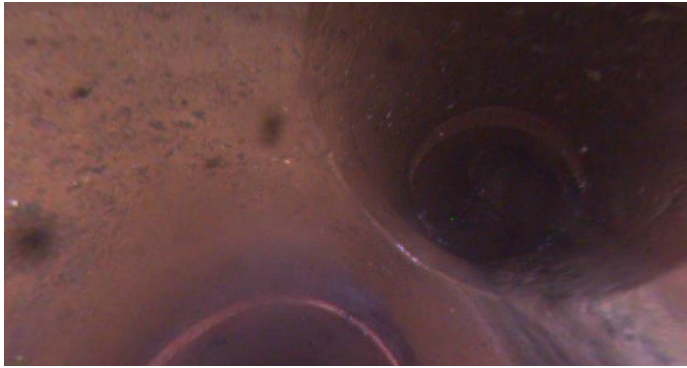
Code: **TF**
Description: **Tap Factory**

Distance (ft): **81.2**
Structural Grade: **0**
O&M Grade: **0**
Clock Start/From: **10**
Clock To:
1st Value: **4.000**
2nd Value:
Value Percent:
Continuous Index:
Within 8" of Joint:
Remarks:

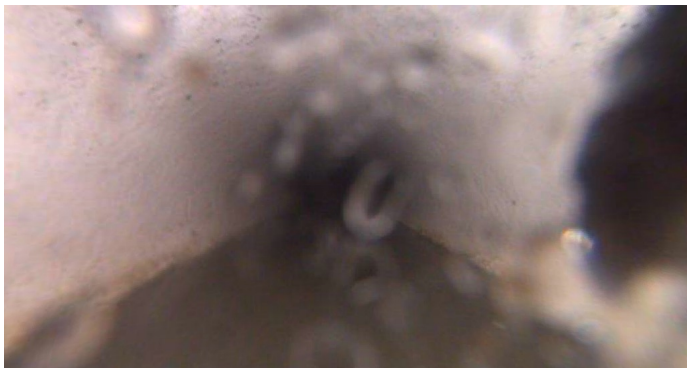
Code: **MMC**
Description: **Material Change**

Distance (ft): **98.4**
Structural Grade: **0**
O&M Grade: **0**
Clock Start/From:
Clock To:
1st Value:
2nd Value:
Value Percent:
Continuous Index:
Within 8" of Joint: **NO**
Remarks: **PVC**

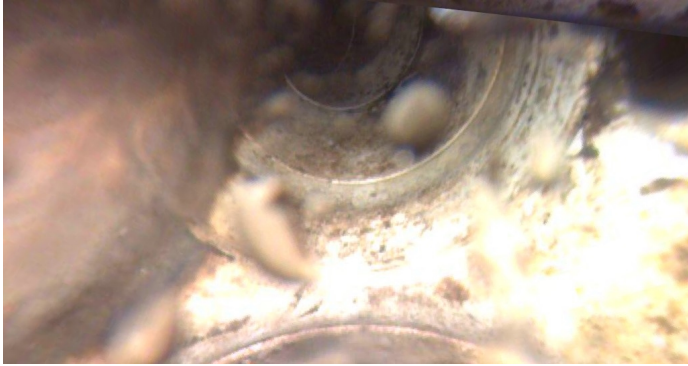
Code: **TF**
Description: **Tap Factory**

Distance (ft): **102.5**
Structural Grade: **0**
O&M Grade: **0**
Clock Start/From: **12**
Clock To:
1st Value: **4.000**
2nd Value:
Value Percent:
Continuous Index:
Within 8" of Joint:
Remarks:

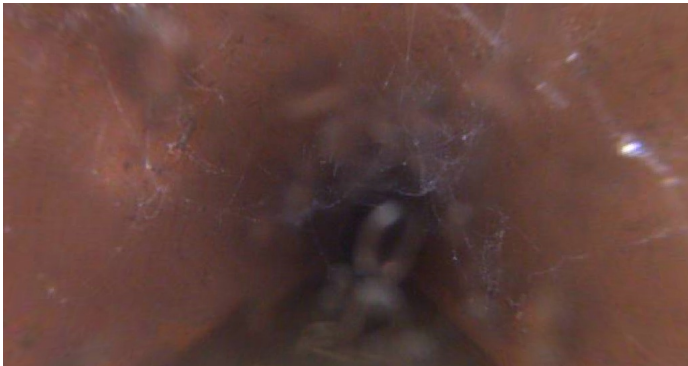
Code: **MMC**
Description: **Material Change**

Distance (ft): **104.6**
Structural Grade: **0**
O&M Grade: **0**
Clock Start/From:
Clock To:
1st Value:
2nd Value:
Value Percent:
Continuous Index:
Within 8" of Joint: **NO**
Remarks: **VCP**

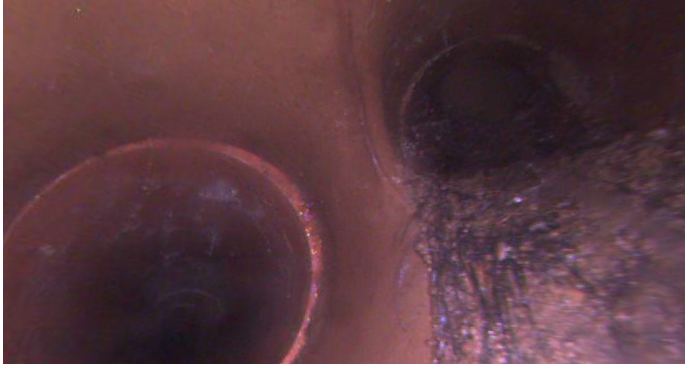
Code: **TFD**
Description: **Tap Factory Defective**

Distance (ft): **109.7**
Structural Grade: **0**
O&M Grade: **2**
Clock Start/From: **10**
Clock To:
1st Value: **4.000**
2nd Value:
Value Percent:
Continuous Index:
Within 8" of Joint:
Remarks: **RFL**

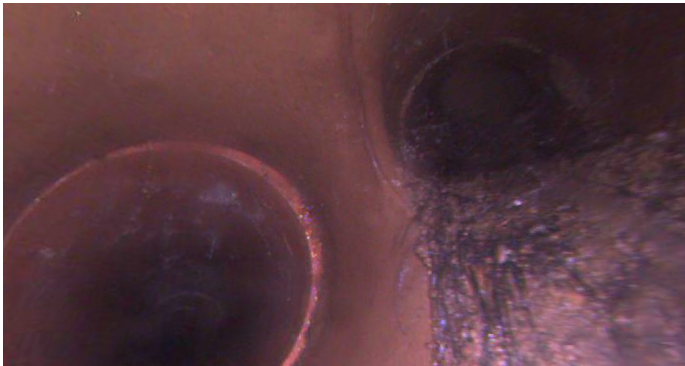
Code: **RFL**
Description: **Roots Fine Lateral**

Distance (ft): **109.7**
Structural Grade: **0**
O&M Grade: **1**
Clock Start/From: **10**
Clock To:
1st Value:
2nd Value:
Value Percent:
Continuous Index:
Within 8" of Joint: **NO**
Remarks:

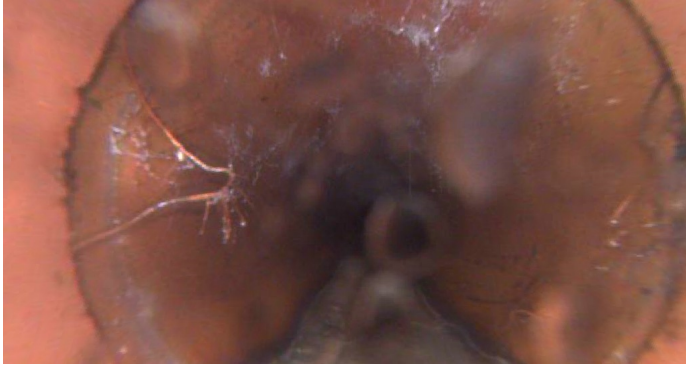
Code: **RFJ**
Description: **Roots Fine Joint**

Distance (ft): **122.4**
Structural Grade: **0**
O&M Grade: **1**
Clock Start/From: **7**
Clock To: **5**
1st Value:
2nd Value:
Value Percent:
Continuous Index:
Within 8" of Joint: **YES**
Remarks:

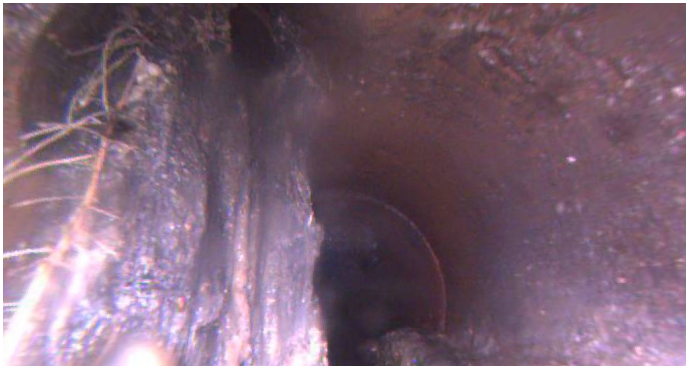
Code: **TFD**
Description: **Tap Factory Defective**

Distance (ft): **136.4**
Structural Grade: **0**
O&M Grade: **2**
Clock Start/From: **1**
Clock To:
1st Value: **4.000**
2nd Value:
Value Percent:
Continuous Index:
Within 8" of Joint:
Remarks: **RFL**

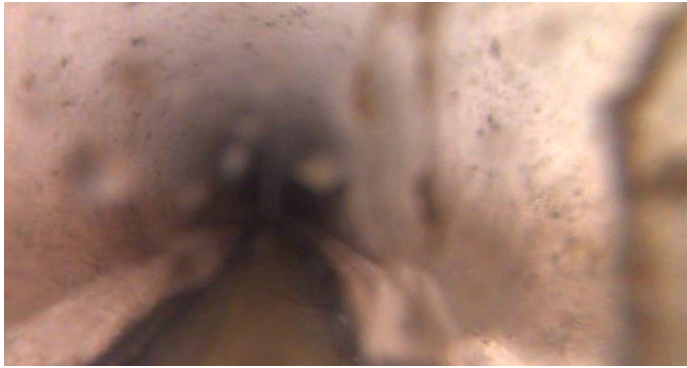
Code: **MMC**
Description: **Material Change**

Distance (ft): **177.8**
Structural Grade: **0**
O&M Grade: **0**
Clock Start/From:
Clock To:
1st Value:
2nd Value:
Value Percent:
Continuous Index:
Within 8" of Joint: **NO**
Remarks: **PVC**

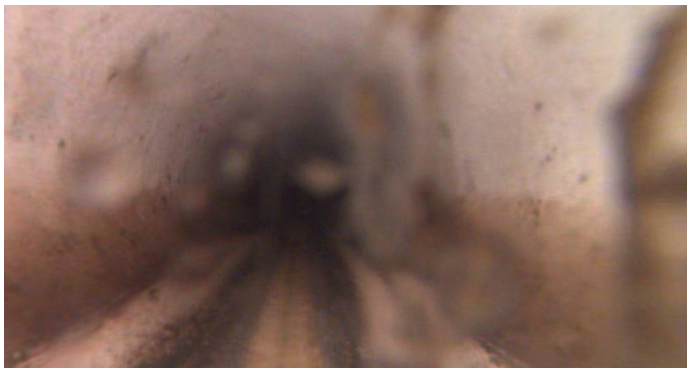
Code: **MSA**
Description: **Abandoned Survey**

Distance (ft): **184.6**
Structural Grade: **0**
O&M Grade: **0**
Clock Start/From:
Clock To:
1st Value:
2nd Value:
Value Percent:
Continuous Index:
Within 8" of Joint: **NO**
Remarks: **No blockage**
