Profile/Photo Observation Report

Date:	04/22/2018	Weather:		Coding:	PACP 6.0
Pipe Length (ft):	214.5	Owner:	NA	Pre Clean:	Not Known
P.O.#:		Surveyor:	Mark Ruby	PSR:	P-805-021-020
Customer:		Clean Date:	01/01/1900	Shape:	C

Street:	S LIBERTY PL & S JOLIET ST	Flow Control:	Not Controlled
City:	Hobart, IN	Year Renewed:	
Location:	Alley	Tape/Media #:	
Purpose:	Maintenance Related	Dia/Height:	10"
Use:	Sanitary	Material:	VCP
Drain Area:	NA	Lining:	Cured in Place
Category:	NA		
Comment:	heavy debris at 144'-flow reversed.		
Location Details:		Direction of Survey:	Upstream
US MH:	M-805-020	DS MH:	M-805-021
		Total Length Surveyed (ft):	145.3

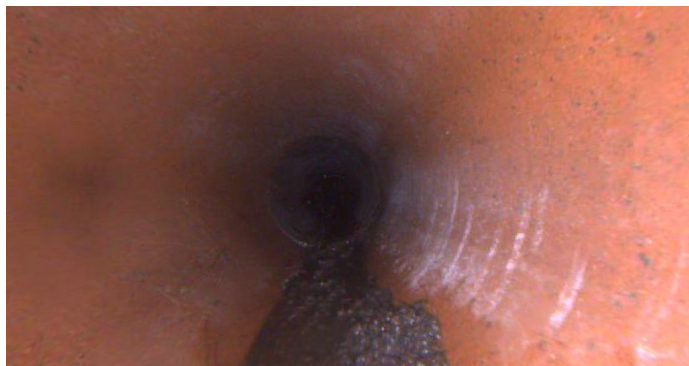
Code: **AMH**
Description: **Manhole**

Distance (ft): **.0**
Structural Grade: **0**
O&M Grade: **0**
Clock Start/From:
Clock To:
1st Value:
2nd Value:
Value Percent:
Continuous Index:
Within 8" of Joint: **NO**
Remarks: **M-805-021**

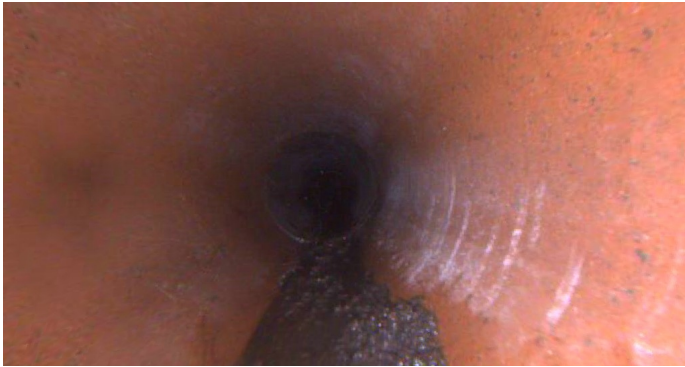
Code:	MWL
Description:	Water Level

Distance (ft):	.0
Structural Grade:	0
O&M Grade:	0
Clock Start/From:	
Clock To:	
1st Value:	
2nd Value:	
Value Percent:	10.000
Continuous Index:	
Within 8" of Joint:	NO
Remarks:

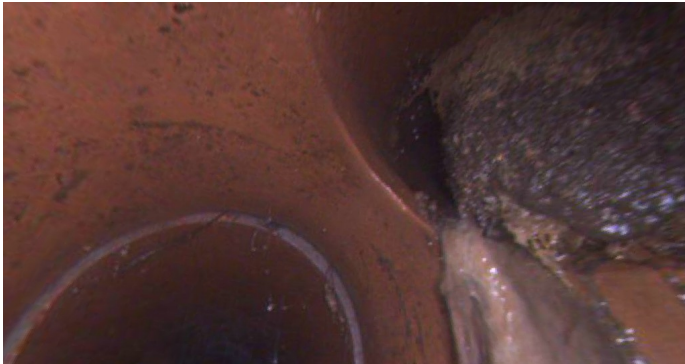
Code:	TFD
Description:	Tap Factory Defective

Distance (ft):	7.9
Structural Grade:	0
O&M Grade:	2
Clock Start/From:	2
Clock To:	
1st Value:	4.000
2nd Value:	
Value Percent:	
Continuous Index:	
Within 8" of Joint:	
Remarks:	RFL

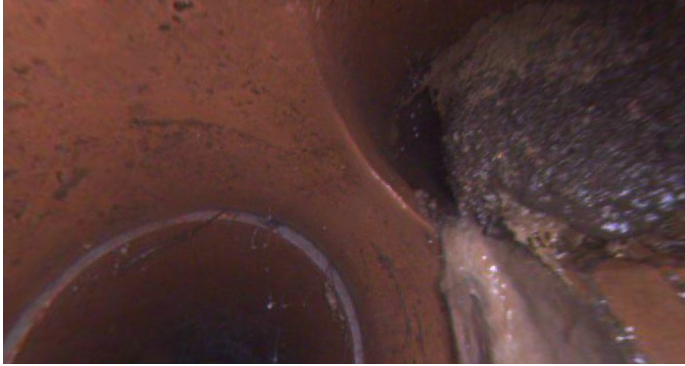
Code: **RFL**
Description: **Roots Fine Lateral**

Distance (ft): **7.9**
Structural Grade: **0**
O&M Grade: **1**
Clock Start/From: **10**
Clock To:
1st Value:
2nd Value:
Value Percent:
Continuous Index:
Within 8" of Joint: **NO**
Remarks:

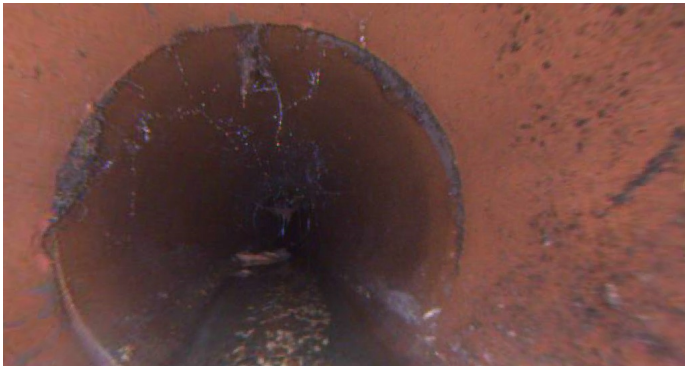
Code: **RFJ**
Description: **Roots Fine Joint**

Distance (ft): **8.3**
Structural Grade: **0**
O&M Grade: **1**
Clock Start/From: **7**
Clock To: **5**
1st Value:
2nd Value:
Value Percent:
Continuous Index: **S01**
Within 8" of Joint: **YES**
Remarks:

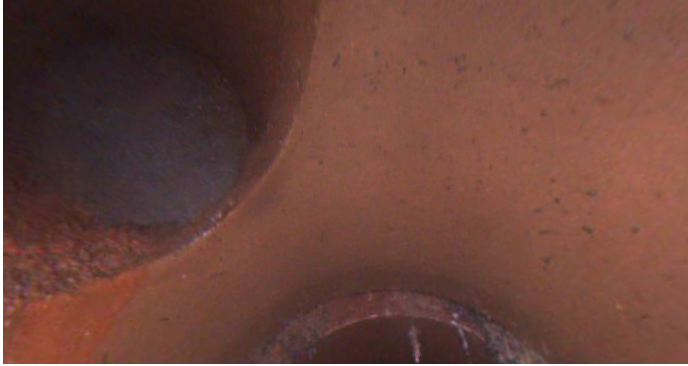
Code: **TFC**
Description: **Tap Factory Capped**

Distance (ft): **22.2**
Structural Grade: **0**
O&M Grade: **0**
Clock Start/From: **2**
Clock To:
1st Value: **4.000**
2nd Value:
Value Percent:
Continuous Index:
Within 8" of Joint:
Remarks:

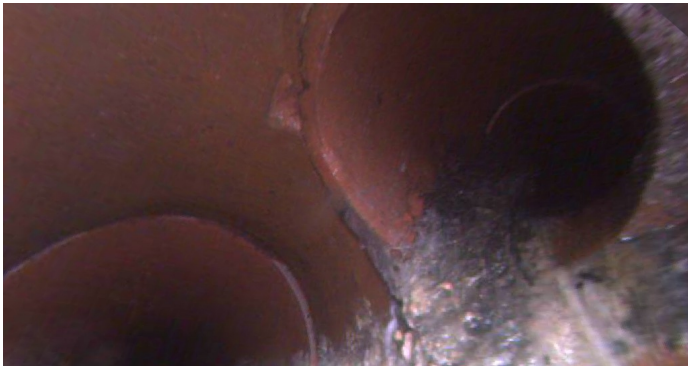
Code: **TB**
Description: **Tap Break-in**

Distance (ft): **36.7**
Structural Grade: **0**
O&M Grade: **0**
Clock Start/From: **10**
Clock To:
1st Value: **4.000**
2nd Value:
Value Percent:
Continuous Index:
Within 8" of Joint:
Remarks:

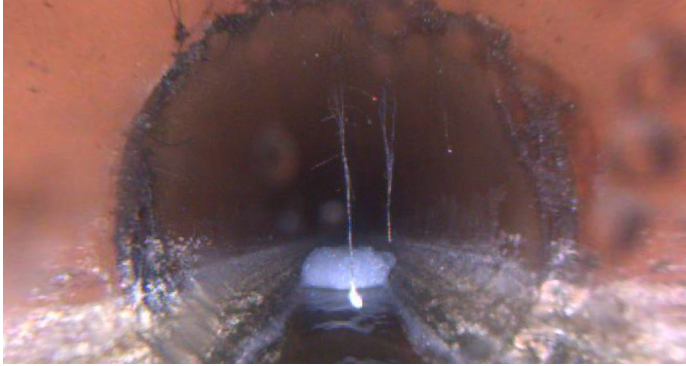
Code: **RFJ**
Description: **Roots Fine Joint**

Distance (ft): **57.4**
Structural Grade: **0**
O&M Grade: **1**
Clock Start/From: **7**
Clock To: **5**
1st Value:
2nd Value:
Value Percent:
Continuous Index: **F01**
Within 8" of Joint: **YES**
Remarks:

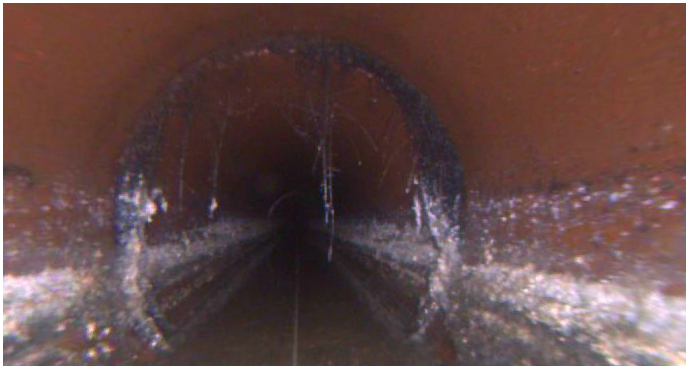
Code: **RFJ**
Description: **Roots Fine Joint**

Distance (ft): **75.0**
Structural Grade: **0**
O&M Grade: **1**
Clock Start/From: **5**
Clock To: **7**
1st Value:
2nd Value:
Value Percent:
Continuous Index:
Within 8" of Joint: **YES**
Remarks:

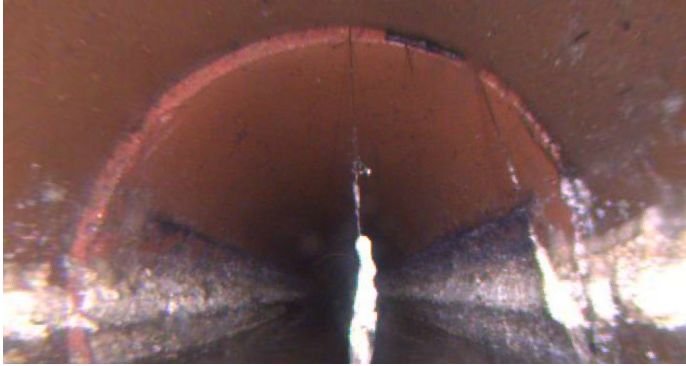
Code: **RFJ**
Description: **Roots Fine Joint**

Distance (ft): **86.9**
Structural Grade: **0**
O&M Grade: **1**
Clock Start/From: **12**
Clock To: **7**
1st Value:
2nd Value:
Value Percent:
Continuous Index:
Within 8" of Joint: **YES**
Remarks:

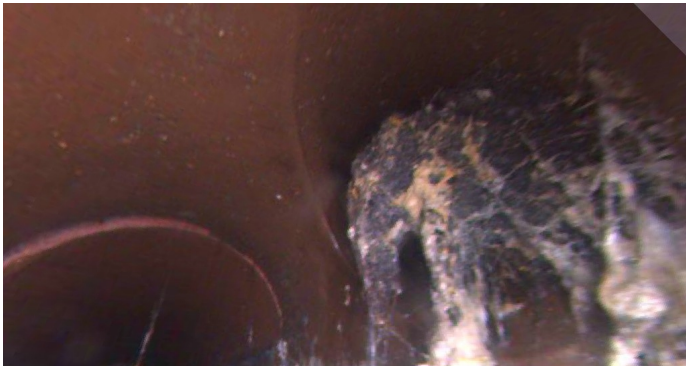
Code: **TFD**
Description: **Tap Factory Defective**

Distance (ft): **87.5**
Structural Grade: **0**
O&M Grade: **2**
Clock Start/From: **10**
Clock To:
1st Value: **4.000**
2nd Value:
Value Percent:
Continuous Index:
Within 8" of Joint:
Remarks: **RFL**

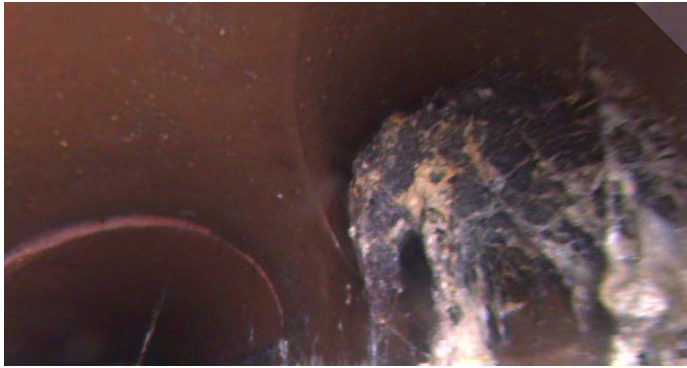
Code: **RFL**
Description: **Roots Fine Lateral**

Distance (ft): **87.5**
Structural Grade: **0**
O&M Grade: **1**
Clock Start/From: **10**
Clock To:
1st Value:
2nd Value:
Value Percent:
Continuous Index:
Within 8" of Joint: **NO**
Remarks:

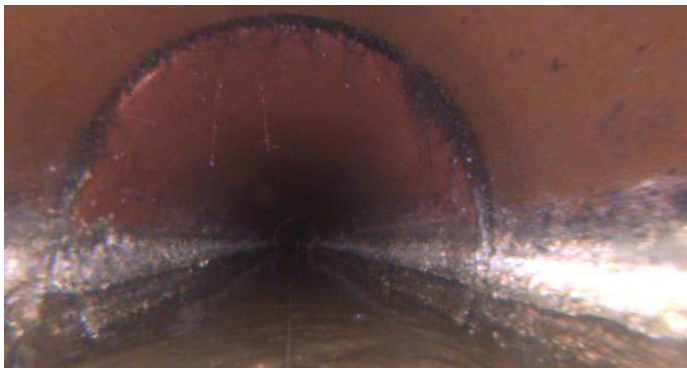
Code: **RFJ**
Description: **Roots Fine Joint**

Distance (ft): **93.2**
Structural Grade: **0**
O&M Grade: **1**
Clock Start/From: **5**
Clock To: **7**
1st Value:
2nd Value:
Value Percent:
Continuous Index:
Within 8" of Joint: **YES**
Remarks:

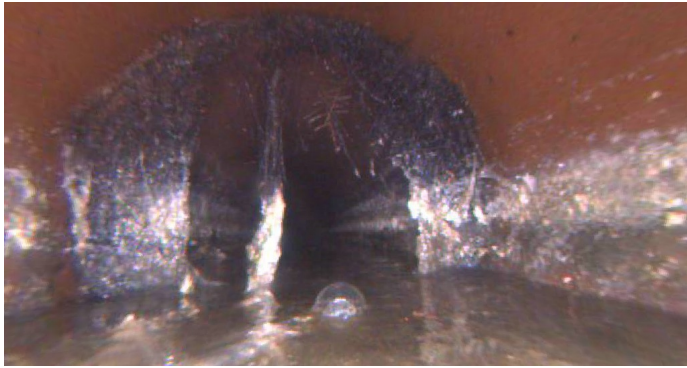
Code: **RMJ**
Description: **Roots Medium Joint**

Distance (ft): **109.4**
Structural Grade: **0**
O&M Grade: **3**
Clock Start/From: **5**
Clock To: **7**
1st Value:
2nd Value:
Value Percent: **10.000**
Continuous Index: **S02**
Within 8" of Joint: **YES**
Remarks:

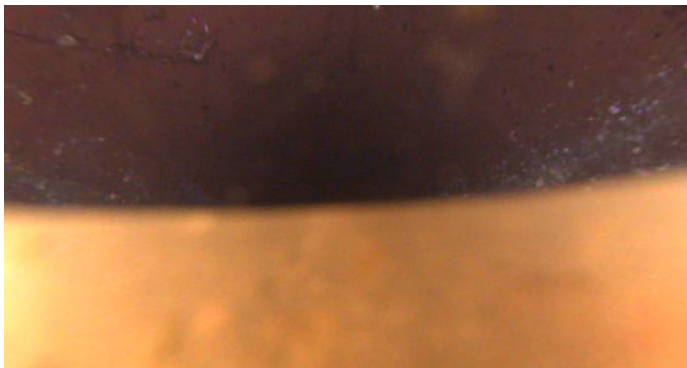
Code: **RMJ**
Description: **Roots Medium Joint**

Distance (ft): **125.2**
Structural Grade: **0**
O&M Grade: **3**
Clock Start/From: **5**
Clock To: **7**
1st Value:
2nd Value:
Value Percent: **10.000**
Continuous Index: **F02**
Within 8" of Joint: **YES**
Remarks:
