Profile/Photo Observation Report

Date:	04/22/2018	Weather:		Coding:	PACP 6.0
Pipe Length (ft):	214.5	Owner:	NA	Pre Clean:	Not Known
P.O.#:		Surveyor:	Mark Ruby	PSR:	P-805-021-020
Customer:		Clean Date:	01/01/1900	Shape:	C

Street:	Capitol	Flow Control:	Not Controlled
City:	Hobart, IN	Year Renewed:	
Location:	Alley	Tape/Media #:	
Purpose:	Maintenance Related	Dia/Height:	10"
Use:	Sanitary	Material:	VCP
Drain Area:	NA	Lining:	Cured in Place
Category:	NA		
Comment:	heavy debris at 144'-flow reversed.		
Location Details:		Direction of Survey:	Upstream
US MH:	M-805-020	DS MH:	M-805-021
		Total Length Surveyed (ft):	145.3

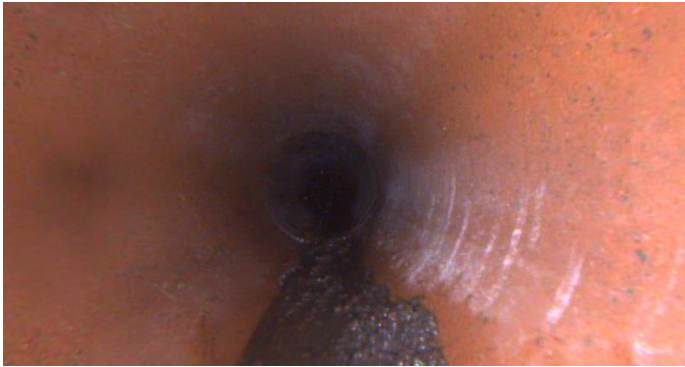
Code:	MWL
Description:	Water Level

Distance (ft):	.0
Structural Grade:	0
O&M Grade:	0
Clock Start/From:	
Clock To:	
1st Value:	
2nd Value:	
Value Percent:	10.000
Continuous Index:	
Within 8" of Joint:	NO
Remarks:

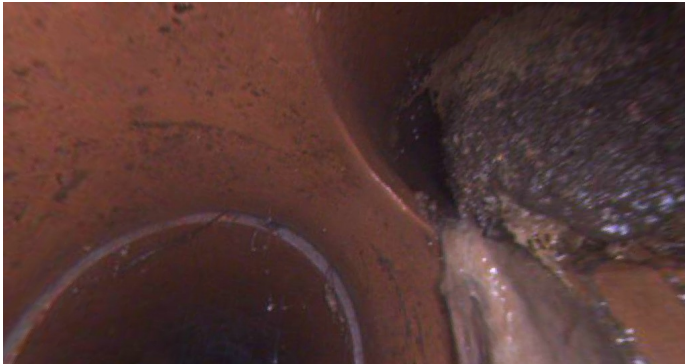
Code:	TFD
Description:	Tap Factory Defective

Distance (ft):	7.9
Structural Grade:	0
O&M Grade:	2
Clock Start/From:	2
Clock To:	
1st Value:	4.000
2nd Value:	
Value Percent:	
Continuous Index:	
Within 8" of Joint:	
Remarks:	RFL

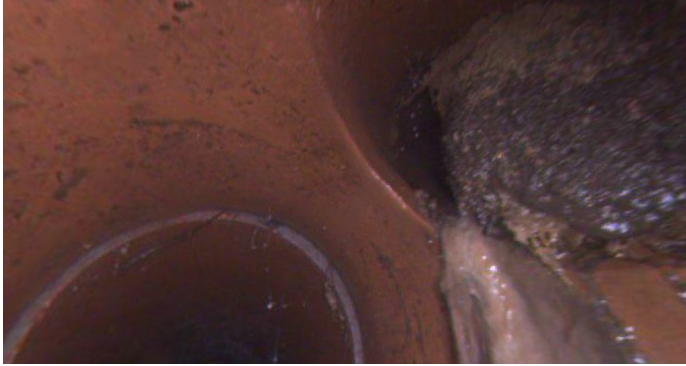
Code: **RFL**
Description: **Roots Fine Lateral**

Distance (ft): **7.9**
Structural Grade: **0**
O&M Grade: **1**
Clock Start/From: **10**
Clock To:
1st Value:
2nd Value:
Value Percent:
Continuous Index:
Within 8" of Joint: **NO**
Remarks:

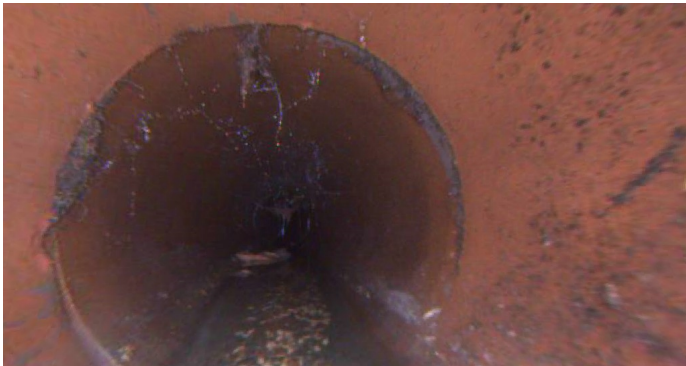
Code: **RFJ**
Description: **Roots Fine Joint**

Distance (ft): **8.3**
Structural Grade: **0**
O&M Grade: **1**
Clock Start/From: **7**
Clock To: **5**
1st Value:
2nd Value:
Value Percent:
Continuous Index: **S01**
Within 8" of Joint: **YES**
Remarks:

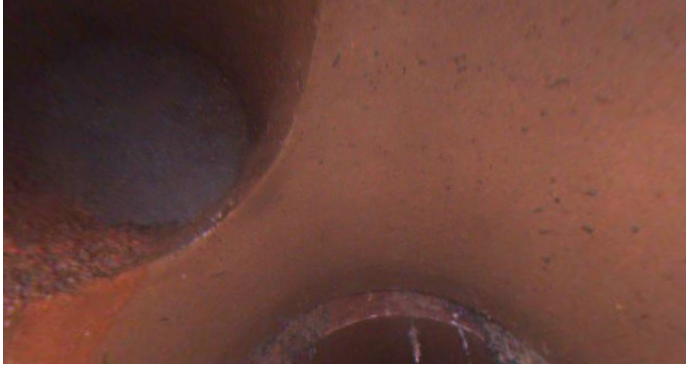
Code: **TFC**
Description: **Tap Factory Capped**

Distance (ft): **22.2**
Structural Grade: **0**
O&M Grade: **0**
Clock Start/From: **2**
Clock To:
1st Value: **4.000**
2nd Value:
Value Percent:
Continuous Index:
Within 8" of Joint:
Remarks:

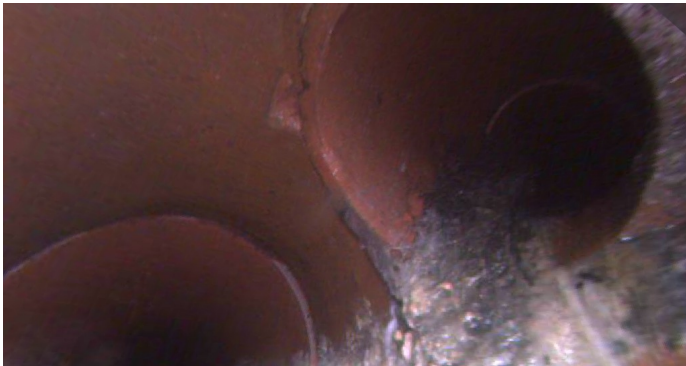
Code: **TB**
Description: **Tap Break-in**

Distance (ft): **36.7**
Structural Grade: **0**
O&M Grade: **0**
Clock Start/From: **10**
Clock To:
1st Value: **4.000**
2nd Value:
Value Percent:
Continuous Index:
Within 8" of Joint:
Remarks:

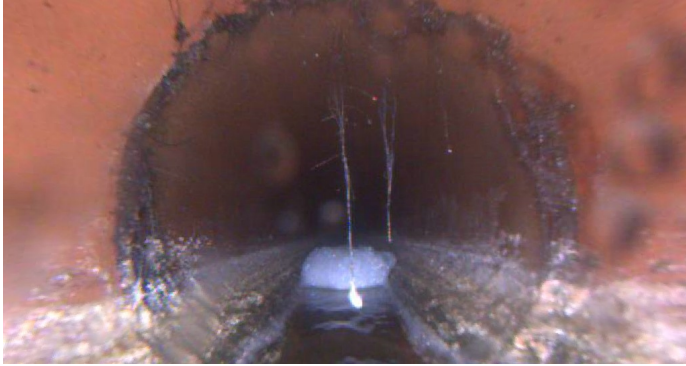
Code: **RFJ**
Description: **Roots Fine Joint**

Distance (ft): **57.4**
Structural Grade: **0**
O&M Grade: **1**
Clock Start/From: **7**
Clock To: **5**
1st Value:
2nd Value:
Value Percent:
Continuous Index: **F01**
Within 8" of Joint: **YES**
Remarks:

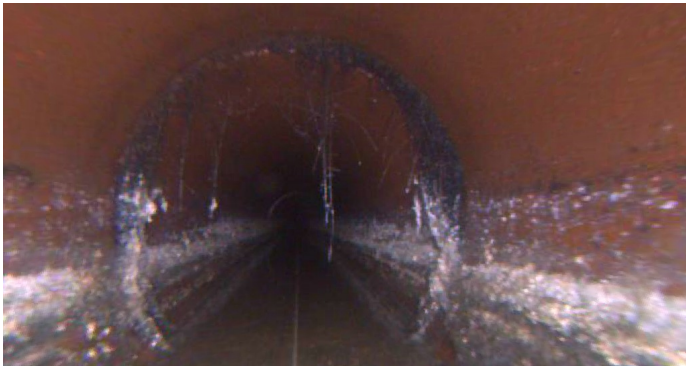
Code: **RFJ**
Description: **Roots Fine Joint**

Distance (ft): **75.0**
Structural Grade: **0**
O&M Grade: **1**
Clock Start/From: **5**
Clock To: **7**
1st Value:
2nd Value:
Value Percent:
Continuous Index:
Within 8" of Joint: **YES**
Remarks:

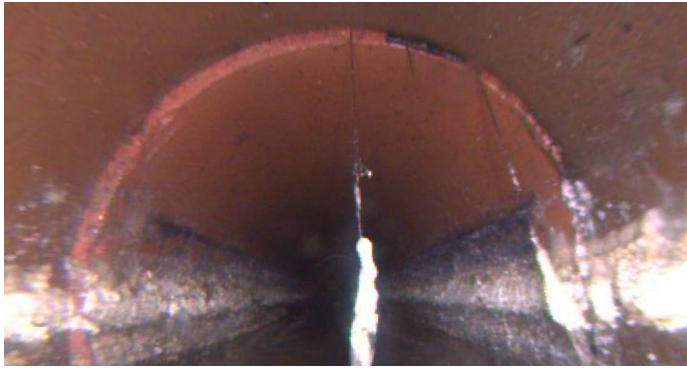
Code: **RFJ**
 Description: **Roots Fine Joint**

Distance (ft): **86.9**
 Structural Grade: **0**
 O&M Grade: **1**
 Clock Start/From: **12**
 Clock To: **7**
 1st Value:
 2nd Value:
 Value Percent:
 Continuous Index:
 Within 8" of Joint: **YES**
 Remarks:

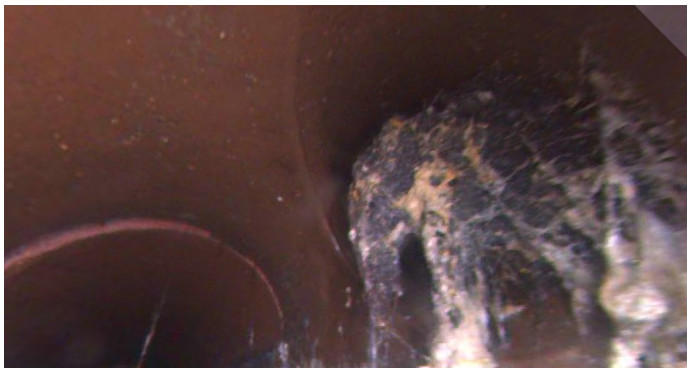
Code: **TFD**
 Description: **Tap Factory Defective**

Distance (ft): **87.5**
 Structural Grade: **0**
 O&M Grade: **2**
 Clock Start/From: **10**
 Clock To:
 1st Value: **4.000**
 2nd Value:
 Value Percent:
 Continuous Index:
 Within 8" of Joint:
 Remarks: **RFL**

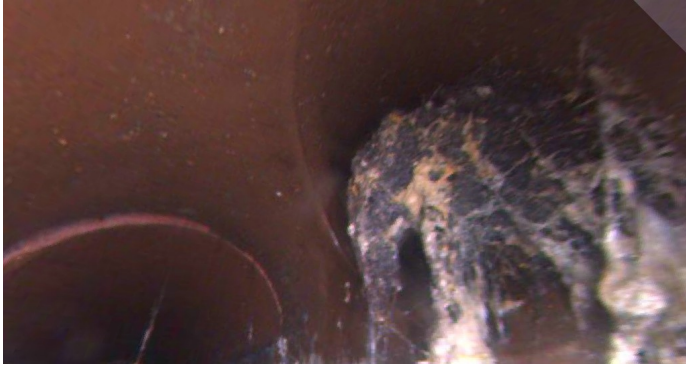
Code: **RFL**
Description: **Roots Fine Lateral**

Distance (ft): **87.5**
Structural Grade: **0**
O&M Grade: **1**
Clock Start/From: **10**
Clock To:
1st Value:
2nd Value:
Value Percent:
Continuous Index:
Within 8" of Joint: **NO**
Remarks:

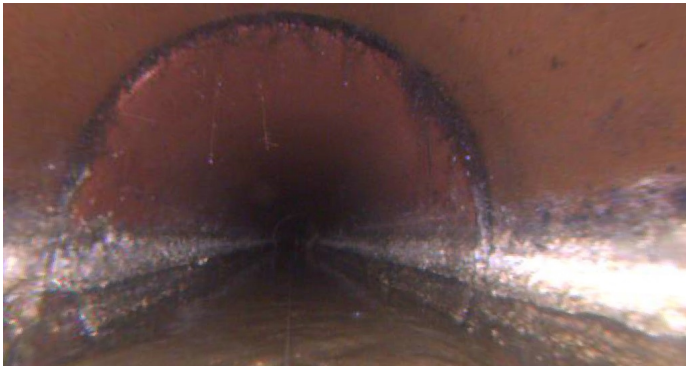
Code: **RFJ**
Description: **Roots Fine Joint**

Distance (ft): **93.2**
Structural Grade: **0**
O&M Grade: **1**
Clock Start/From: **5**
Clock To: **7**
1st Value:
2nd Value:
Value Percent:
Continuous Index:
Within 8" of Joint: **YES**
Remarks:

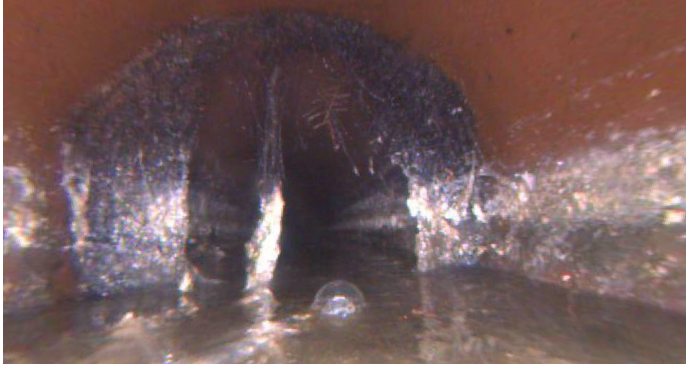
Code: **RMJ**
Description: **Roots Medium Joint**

Distance (ft): **109.4**
Structural Grade: **0**
O&M Grade: **3**
Clock Start/From: **5**
Clock To: **7**
1st Value:
2nd Value:
Value Percent: **10.000**
Continuous Index: **S02**
Within 8" of Joint: **YES**
Remarks:

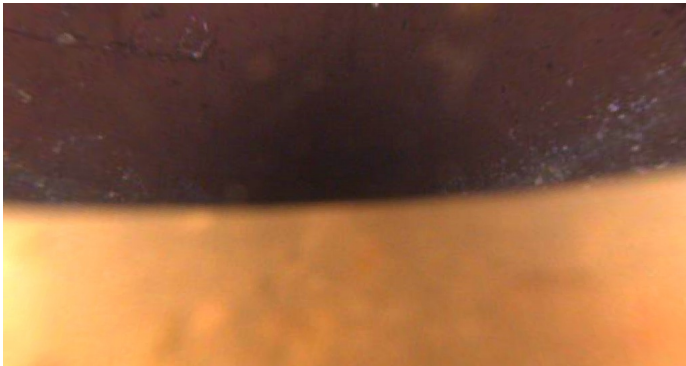
Code: **RMJ**
Description: **Roots Medium Joint**

Distance (ft): **125.2**
Structural Grade: **0**
O&M Grade: **3**
Clock Start/From: **5**
Clock To: **7**
1st Value:
2nd Value:
Value Percent: **10.000**
Continuous Index: **F02**
Within 8" of Joint: **YES**
Remarks:
