Profile/Photo Observation Report

Date:	02/16/2024	Weather:		Coding:	PACP 7.0
Pipe Length (ft):	214.0	Owner:	City of Hobart	Pre Clean:	Heavy Cleaning
P.O.#:	YES502259	Surveyor:	S. Bucklin	PSR:	P-805-021-020
Customer:	City of Hobart	Clean Date:	08/26/2022	Shape:	C

Street:	S LIBERTY PL	Flow Control:	Not Controlled
City:	Hobart, IN	Year Renewed:	
Location:	Alley	Tape/Media #:	
Purpose:	Routine Assessment	Dia/Height:	10"
Use:	Sanitary Sewage Pipe	Material:	VCP
Drain Area:		Lining:	None
Category:	NA		
Comment:

Location Details:		Direction of Survey:	Upstream
US MH:	M-805-020	DS MH:	M-805-021
		Total Length Surveyed (ft):	50.7

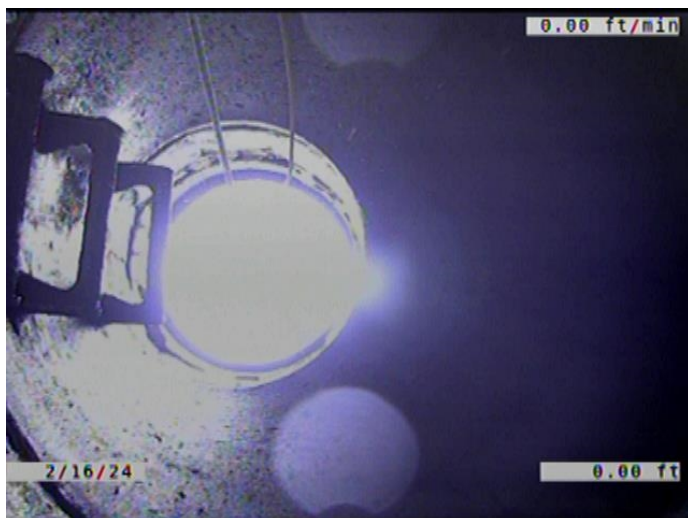
Code: **AMH**
 Description: **Manhole**

Distance (ft): **.0**
 Structural Grade: **0**
 O&M Grade: **0**
 Clock Start/From:
 Clock To:
 1st Value:
 2nd Value:
 Value Percent:
 Continuous Index:
 Within 8" of Joint: **NO**
 Remarks: **M-805-021**

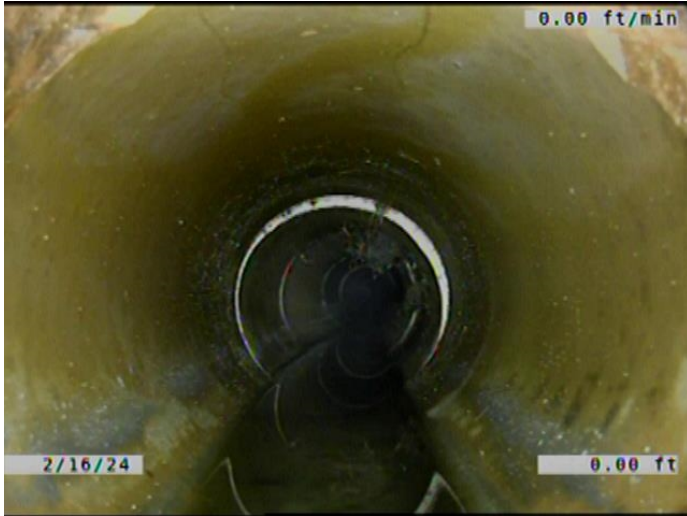
Code:	MWL
Description:	Miscellaneous Water Level
Distance (ft):	.0
Structural Grade:	0
O&M Grade:	0
Clock Start/From:	
Clock To:	
1st Value:	
2nd Value:	
Value Percent:	5.000
Continuous Index:	
Within 8" of Joint:	NO
Remarks:

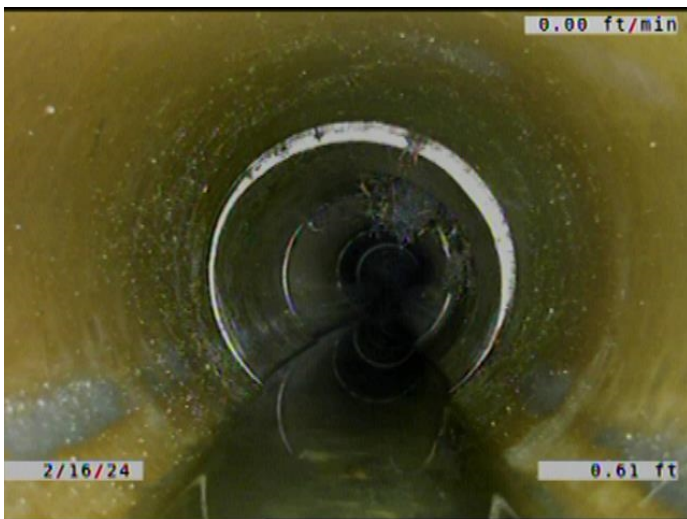
Code:	MWLS
Description:	Miscellaneous Water Level Sag
Distance (ft):	.6
Structural Grade:	2
O&M Grade:	0
Clock Start/From:	
Clock To:	
1st Value:	
2nd Value:	
Value Percent:	10.000
Continuous Index:	S01
Within 8" of Joint:	NO
Remarks:

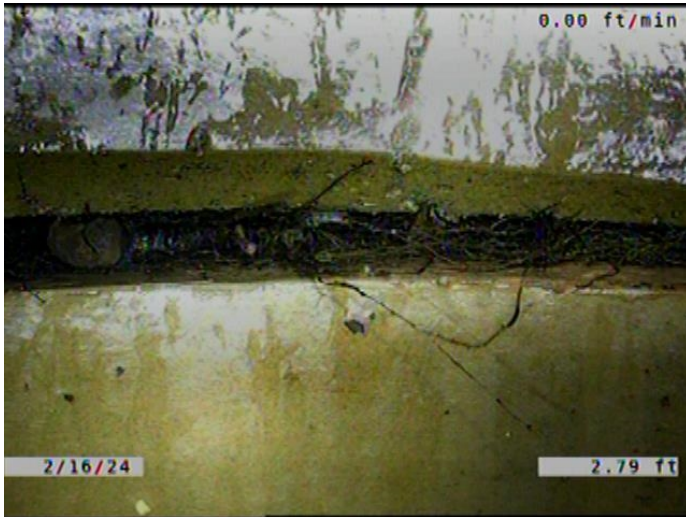
Code: **RFJ**
Description: **Roots Fine Joint**

Distance (ft): **2.8**
Structural Grade: **0**
O&M Grade: **1**
Clock Start/From: **7**
Clock To: **5**
1st Value:
2nd Value:
Value Percent:
Continuous Index: **S02**
Within 8" of Joint: **YES**
Remarks:

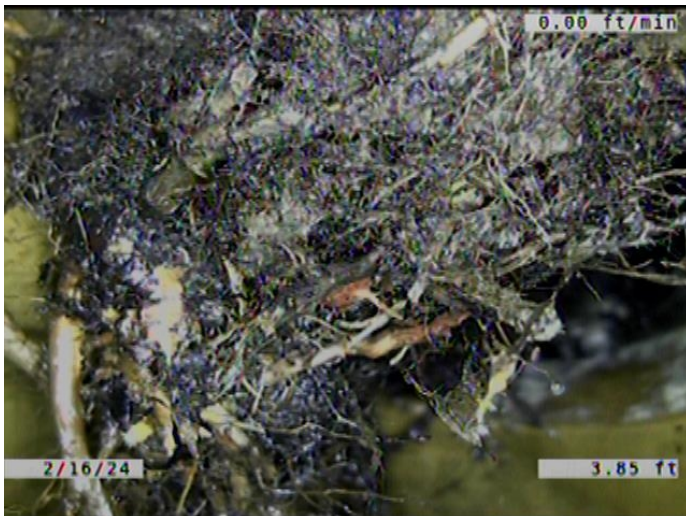
Code: **RML**
Description: **Roots Medium Lateral**

Distance (ft): **3.9**
Structural Grade: **0**
O&M Grade: **3**
Clock Start/From: **1**
Clock To: **2**
1st Value:
2nd Value:
Value Percent: **5.000**
Continuous Index:
Within 8" of Joint: **NO**
Remarks:

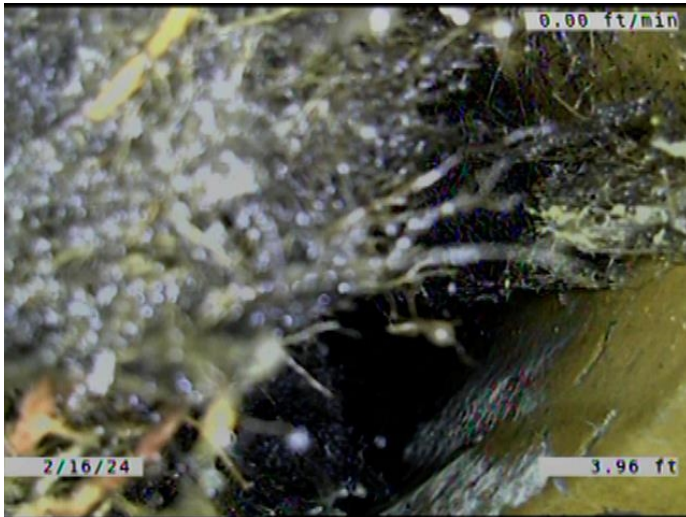
Code:	TFD
Description:	Tap Factory Defective
Distance (ft):	4.0
Structural Grade:	0
O&M Grade:	3
Clock Start/From:	1
Clock To:	
1st Value:	6.000
2nd Value:	
Value Percent:	
Continuous Index:	
Within 8" of Joint:	YES
Remarks:	95% PLUGGED WITH ROOTS. ROOTS GROWING OUT OF THE SERVICE INT

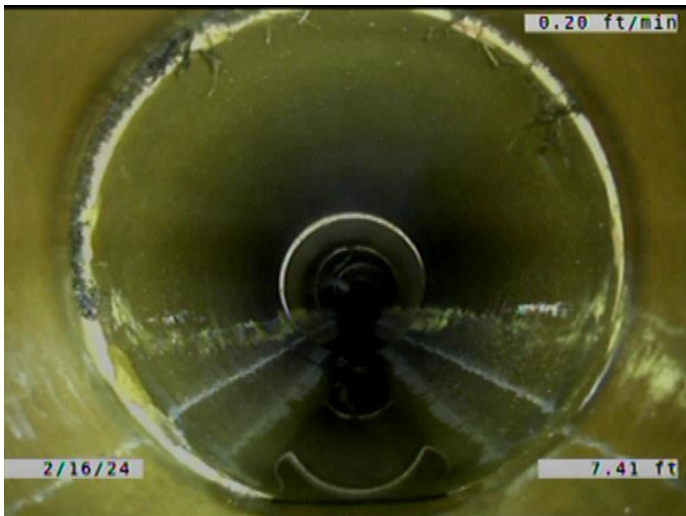
Code:	MWLS
Description:	Miscellaneous Water Level Sag
Distance (ft):	7.4
Structural Grade:	2
O&M Grade:	0
Clock Start/From:	
Clock To:	
1st Value:	
2nd Value:	
Value Percent:	10.000
Continuous Index:	F01
Within 8" of Joint:	NO
Remarks:

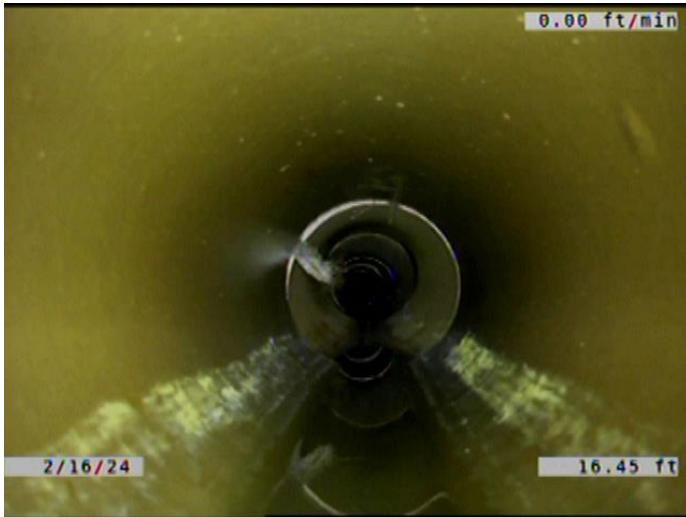
Code: **MWLS**
Description: **Miscellaneous Water Level Sag**

Distance (ft): **16.4**
Structural Grade: **2**
O&M Grade: **0**
Clock Start/From:
Clock To:
1st Value:
2nd Value:
Value Percent: **5.000**
Continuous Index: **S03**
Within 8" of Joint: **NO**
Remarks:

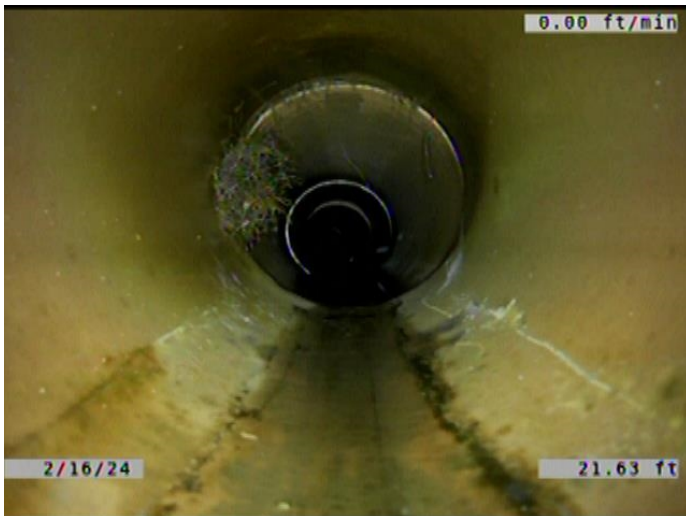
Code: **MWLS**
Description: **Miscellaneous Water Level Sag**

Distance (ft): **21.6**
Structural Grade: **2**
O&M Grade: **0**
Clock Start/From:
Clock To:
1st Value:
2nd Value:
Value Percent: **5.000**
Continuous Index: **F03**
Within 8" of Joint: **NO**
Remarks:

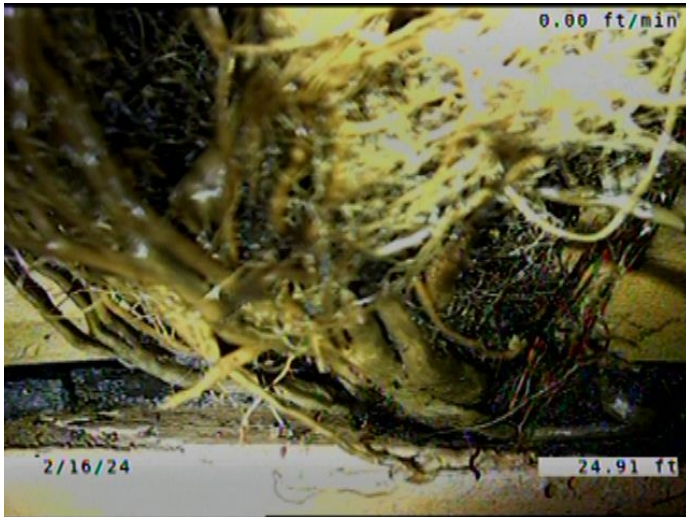
Code: **RMJ**
Description: **Roots Medium Joint**

Distance (ft): **24.9**
Structural Grade: **0**
O&M Grade: **3**
Clock Start/From: **9**
Clock To: **3**
1st Value:
2nd Value:
Value Percent: **5.000**
Continuous Index:
Within 8" of Joint: **YES**
Remarks:

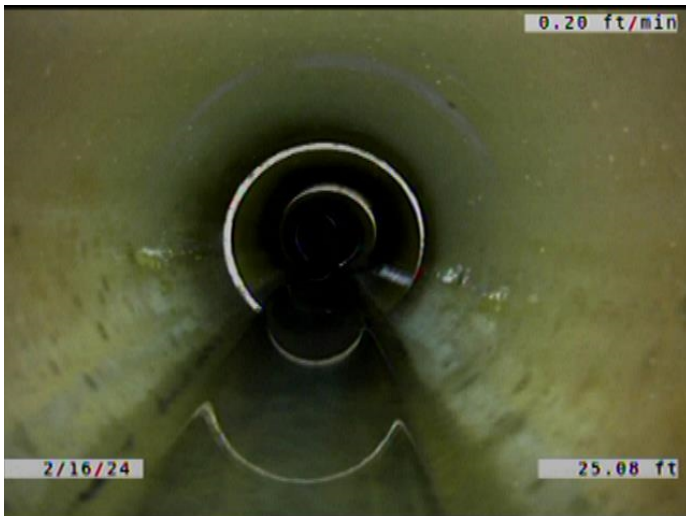
Code: **MWLS**
Description: **Miscellaneous Water Level Sag**

Distance (ft): **25.1**
Structural Grade: **2**
O&M Grade: **0**
Clock Start/From:
Clock To:
1st Value:
2nd Value:
Value Percent: **10.000**
Continuous Index: **S04**
Within 8" of Joint: **NO**
Remarks:

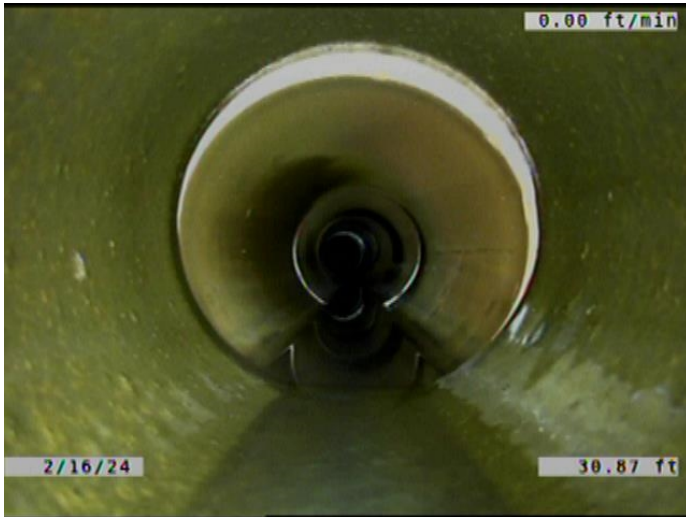
Code: **RFJ**
Description: **Roots Fine Joint**

Distance (ft): **30.9**
Structural Grade: **0**
O&M Grade: **1**
Clock Start/From: **7**
Clock To: **5**
1st Value:
2nd Value:
Value Percent:
Continuous Index: **F02**
Within 8" of Joint: **YES**
Remarks:

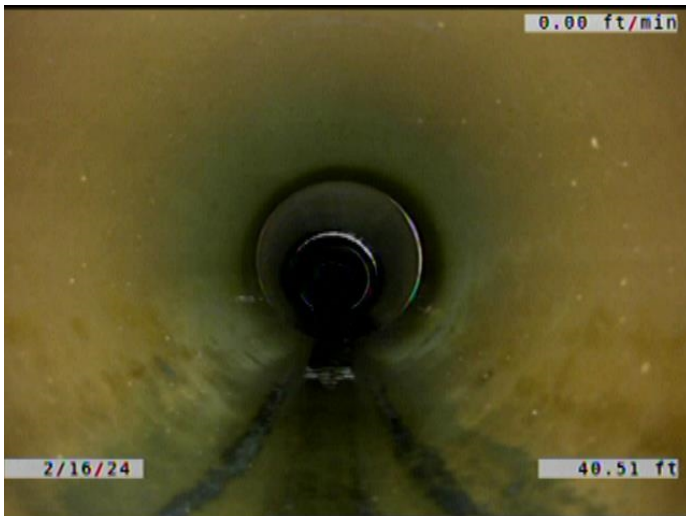
Code: **MWLS**
Description: **Miscellaneous Water Level Sag**

Distance (ft): **40.5**
Structural Grade: **2**
O&M Grade: **0**
Clock Start/From:
Clock To:
1st Value:
2nd Value:
Value Percent: **10.000**
Continuous Index: **F04**
Within 8" of Joint: **NO**
Remarks:

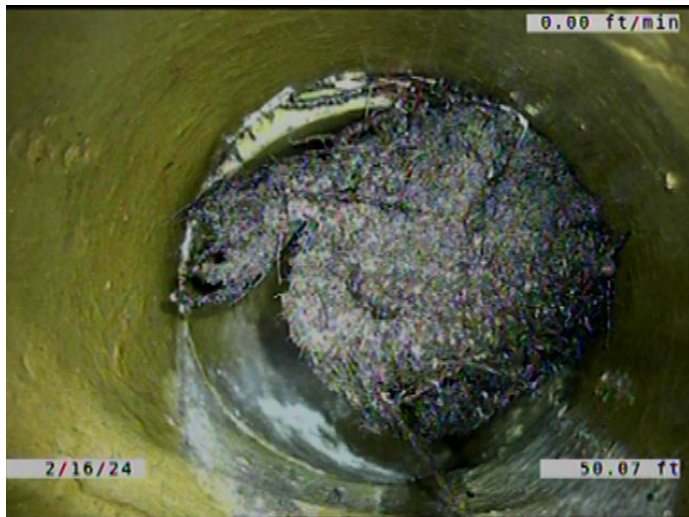
Code:	TF
Description:	Tap Factory
Distance (ft):	50.1
Structural Grade:	0
O&M Grade:	0
Clock Start/From:	1
Clock To:	
1st Value:	6.000
2nd Value:	
Value Percent:	
Continuous Index:	
Within 8" of Joint:	YES
Remarks:	ROOTS GROWING AT THE SERVICE TO MAIN CONNECTION. SERVICE 85

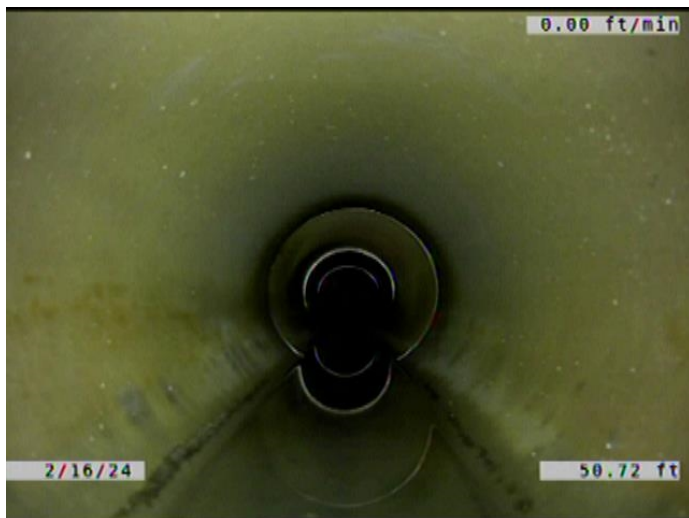
Code:	MSA
Description:	Miscellaneous Survey Abandoned
Distance (ft):	50.7
Structural Grade:	0
O&M Grade:	0
Clock Start/From:	
Clock To:	
1st Value:	
2nd Value:	
Value Percent:	
Continuous Index:	
Within 8" of Joint:	NO
Remarks:	MADE IT TO THE POINT OF OVERLAP. REVERSAL COMPLETE.
